May 31, 2011

**Re: Sovereign at Shipyard – Response to Boswell Underwater Engineering Draft Report
Hoboken, NJ**

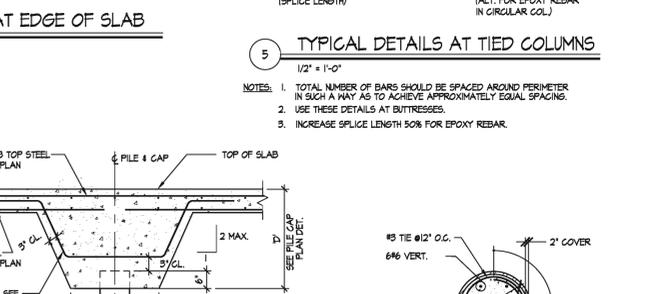
TYPICAL 16" Ø PILE SECTION
 1" = 1'-0"

The building structure was designed to be supported on 100 ton piles. The piles supporting the portion of the building over the river were reinforced so as not to require the steel casing (pipe) in order to carry the building loads (reference Foundation Notes on drawing S-001 and section 13 on

drawing S-002, attached). The piles in this area (north-east corner of the building) were designed in anticipation of the section of the pipe above the river mud line corroding away over time, which is consistent with the conditions depicted in photographs 6.11 and 6.12 of Boswell's report. The concrete filled pipes were reinforced with epoxy coated reinforcing steel so as to be maintenance free in the long term.

The writer also recommends that a routine procedure be established where the steel pipe piles are cleaned and a protective coating is applied to the sections of the piles within the tidal zone to prevent further corrosion. As we explained above (see the response to Section 6.3), the steel casing of these piles above the mud line are nonstructural and therefore the corrosion noted, as well as potential further corrosion, does not diminish the load carrying capacity of the piles in any way.

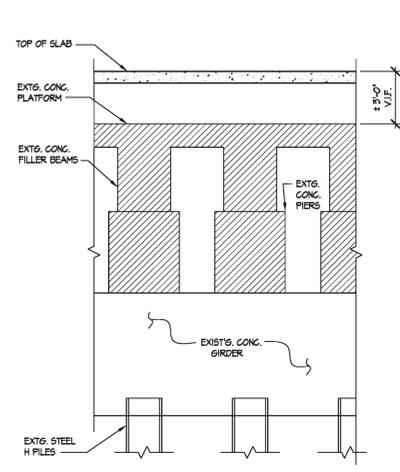
6 TYPICAL SECTION THROUGH EXISTING PIER CONSTRUCTION
NT.S.
NOTE: CONTRACTOR SHOULD ASSUME THAT THE CONCRETE PLATFORM FILLER BEAMS, PIERS WILL REQUIRE REMOVAL AT ALL NEW PILE CAP & GRADE BEAM LOCATIONS.

No bulkhead wall was encountered at the north-east corner of the building during the inspection because it is located on the land side of the wood platform supporting the existing sea wall. A new bulkhead wall was installed in the form of corrugated steel sheet piles which were driven inland of the existing wood platform to retain the soil beneath the remainder of the building (reference plans on S-100 and S-300 and details 6, 7A, and 7B on drawing S-100, attached).
