HOBOKEN PRIVATELY-OWNED WATERFRONT STRUCTURES INSPECTION

File No. BUE-1010

BOSWELL UNDERWATER ENGINEERING

June 2011

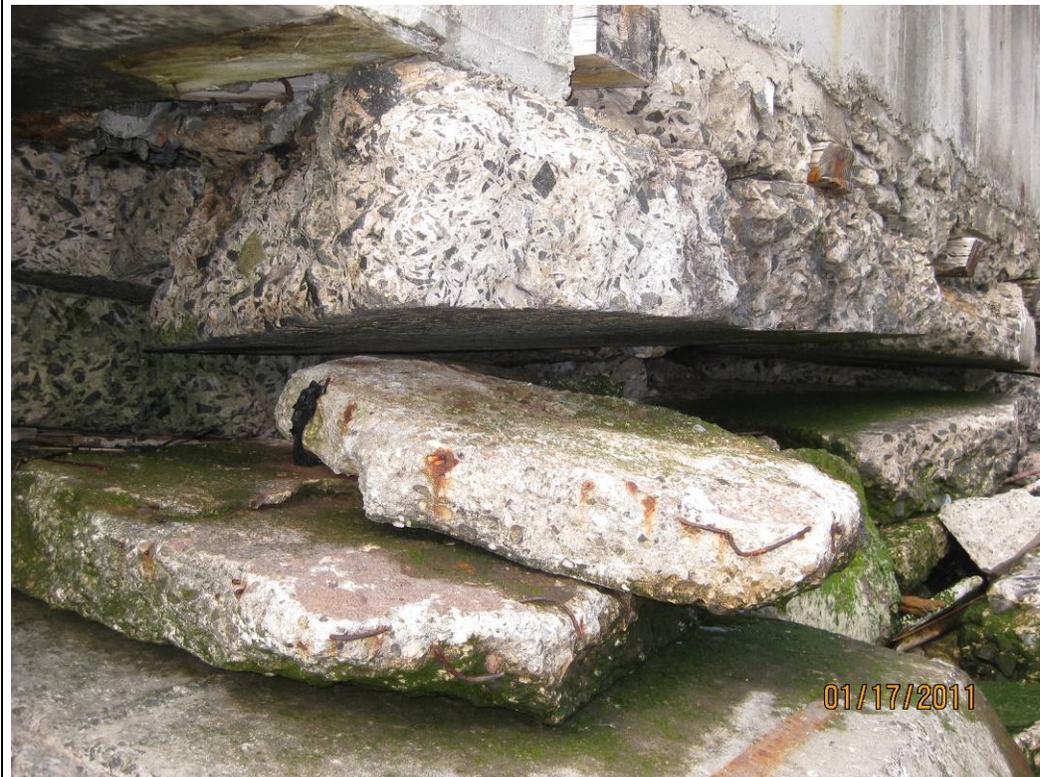
Photo No. 2.14

Loose stacked concrete foundation and voids beneath concrete cap

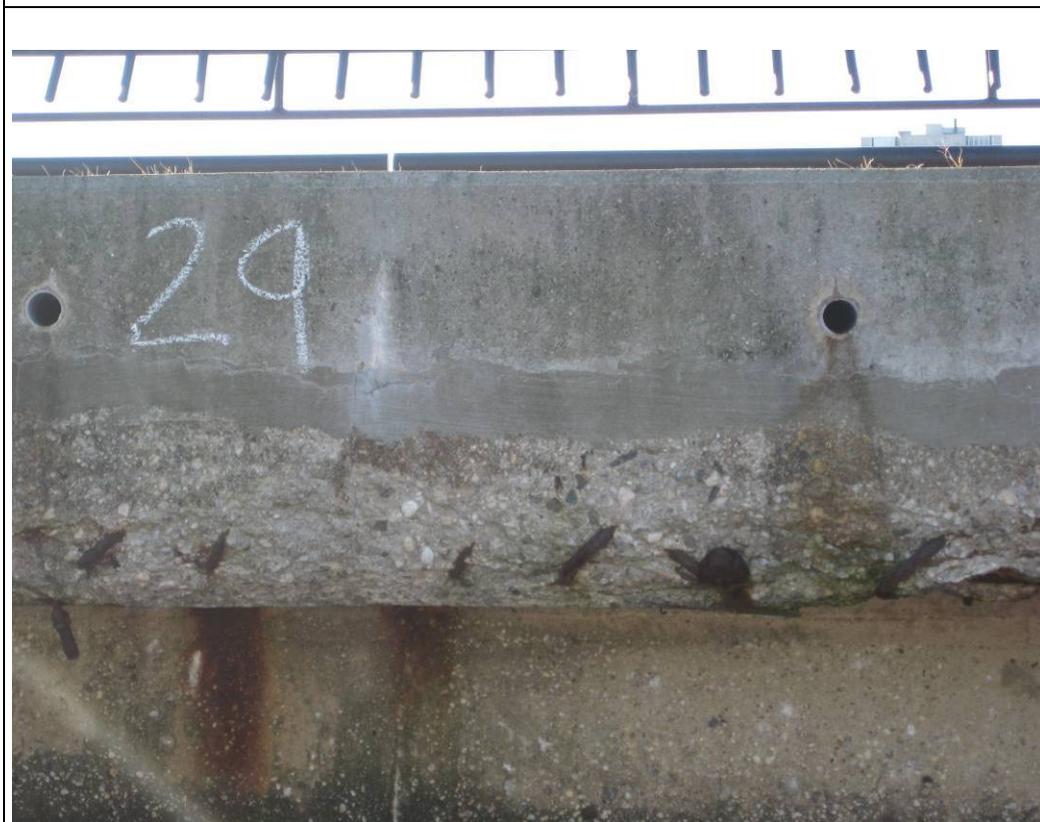
Photo No. 4.8

Spall at underdeck exposing severely corroded reinforcing steel

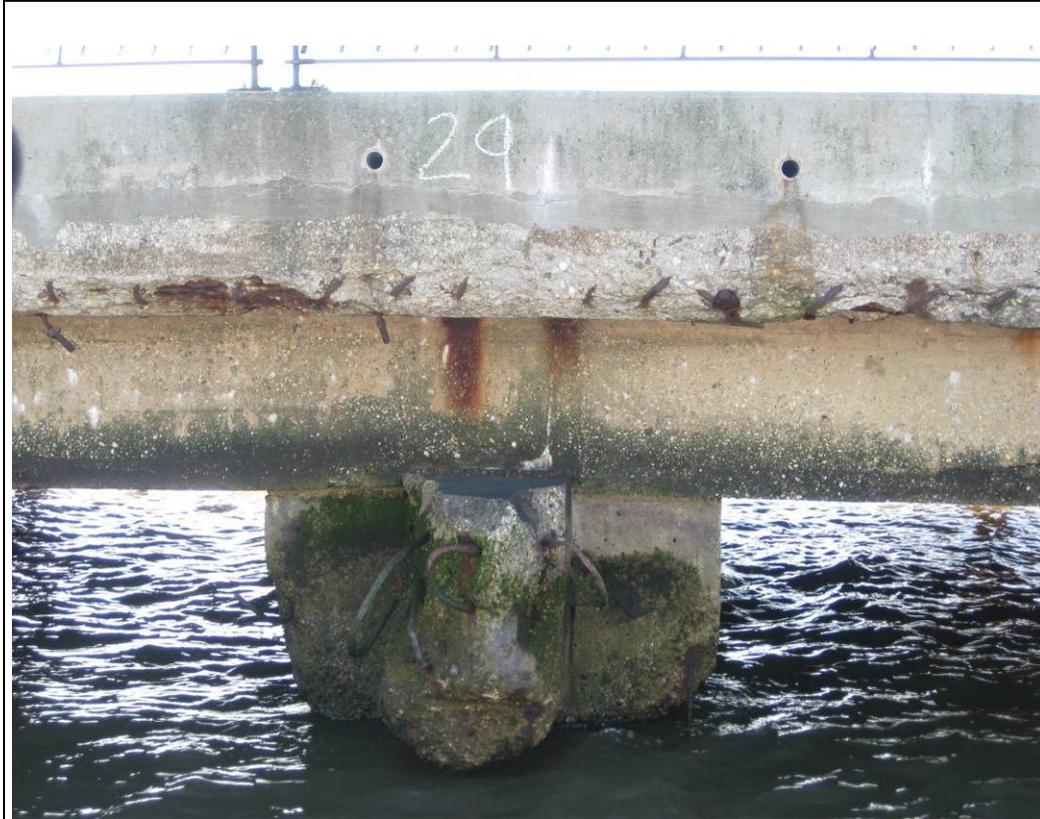
Photo No. 4.9

Spall at bottom edge of deck fascia with exposed corroded reinforcing steel

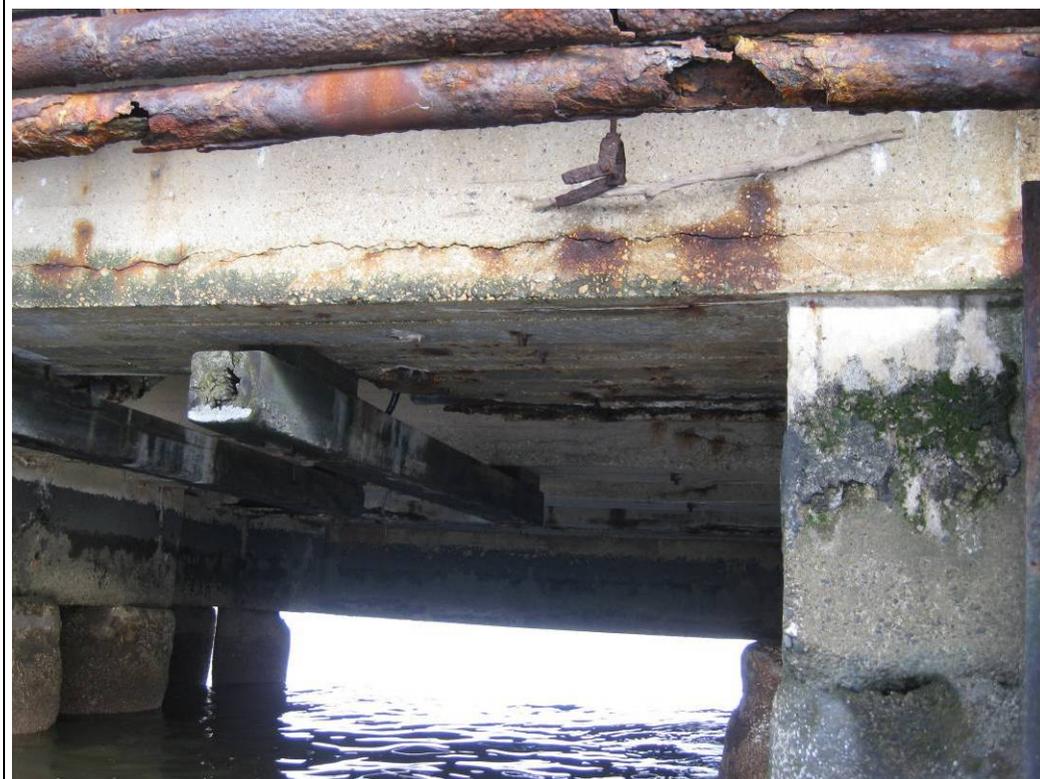
Photo No. 4.10

Spall at end of pile cap showing exposed reinforcing steel

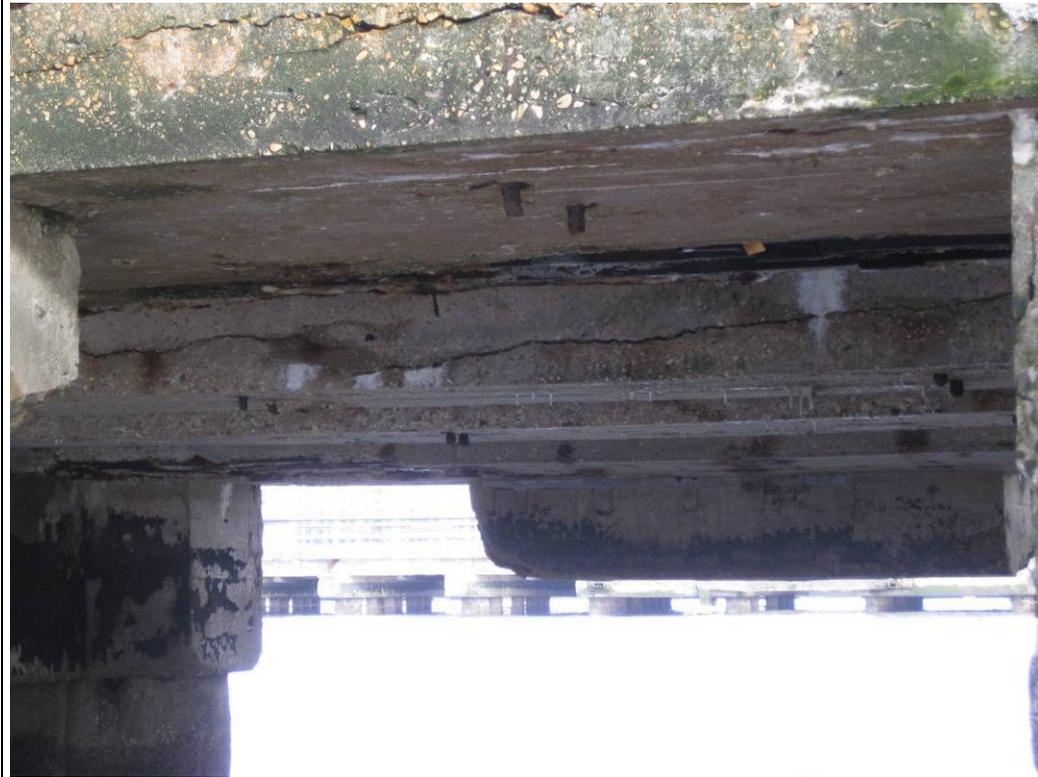
Photo No. 4.11

1/4" wide crack with
rust staining along
lower side

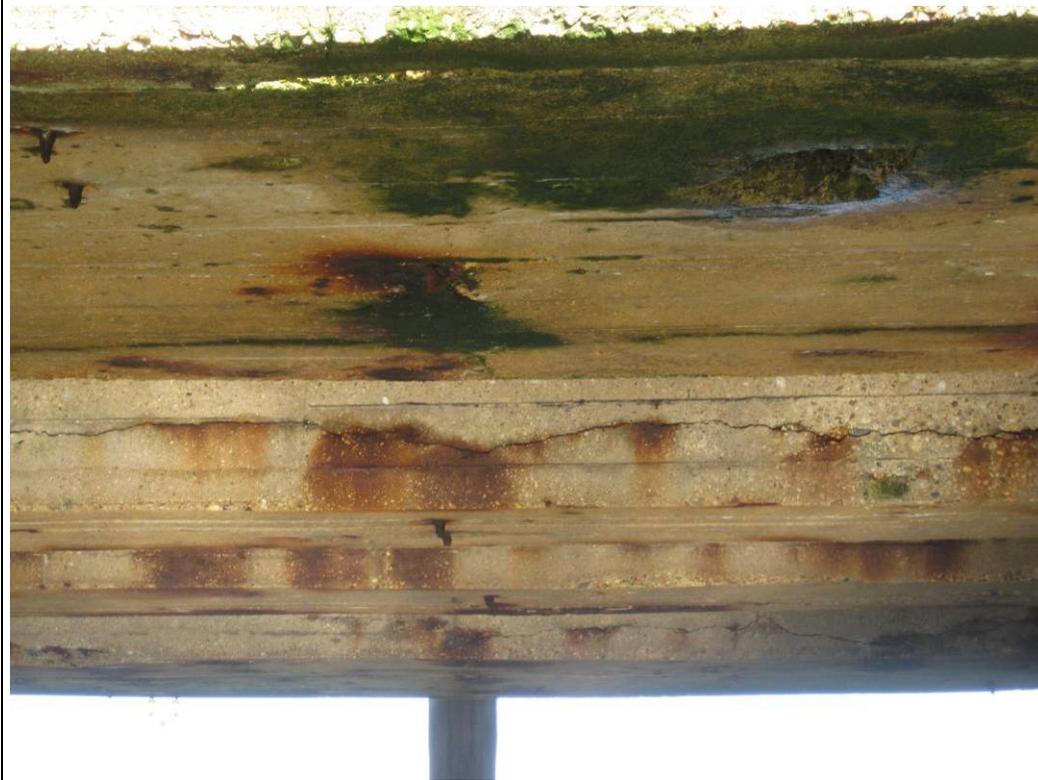
Photo No. 4.12

1/4" – 1/2" wide
cracks on vertical face
of beam

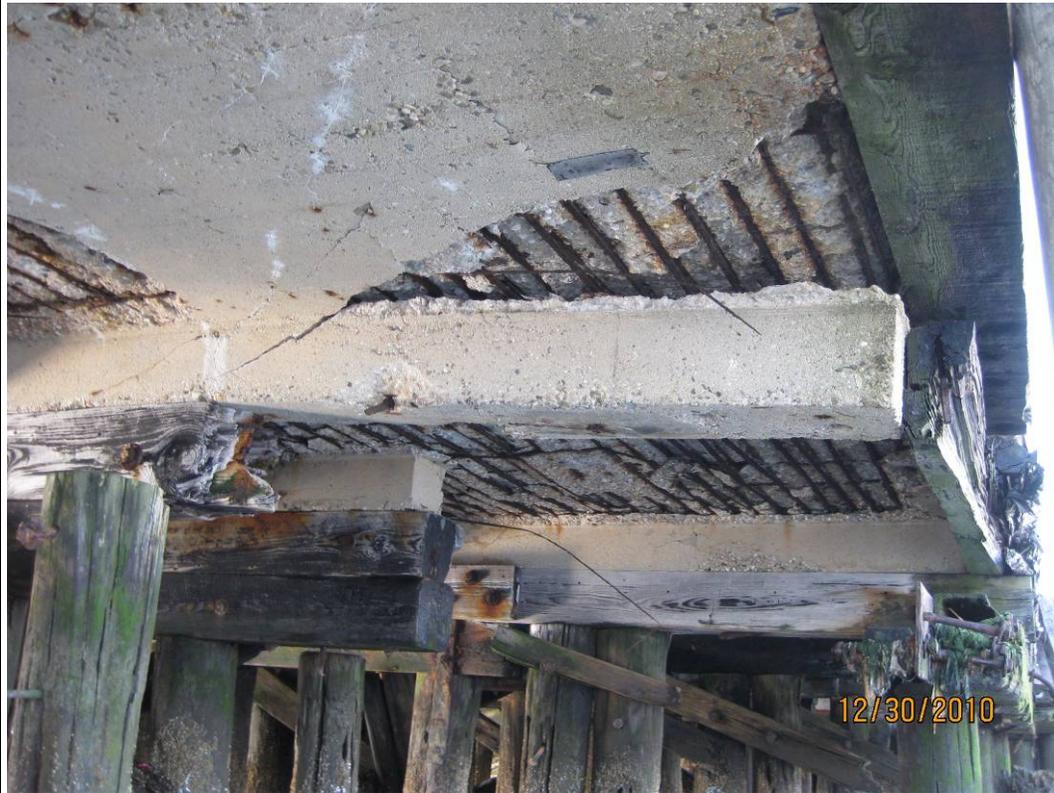
Photo No. 4.19

Timber piles missing; concrete pile cap broken; massive spalling of concrete underdeck showing exposed, corroded steel reinforcement

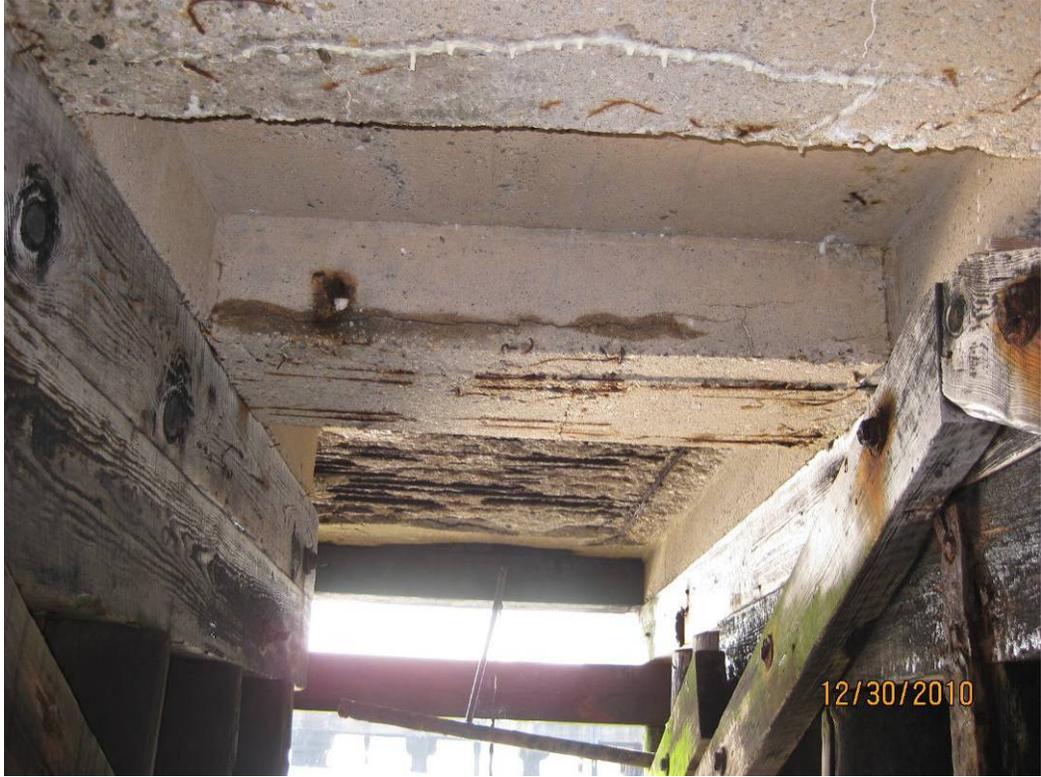
<p>Photo No. 4.28</p> <p>Location: Pier B Bent 62 to 63</p> <p>Description: Delamination at bottom of longitudinal concrete beam</p>

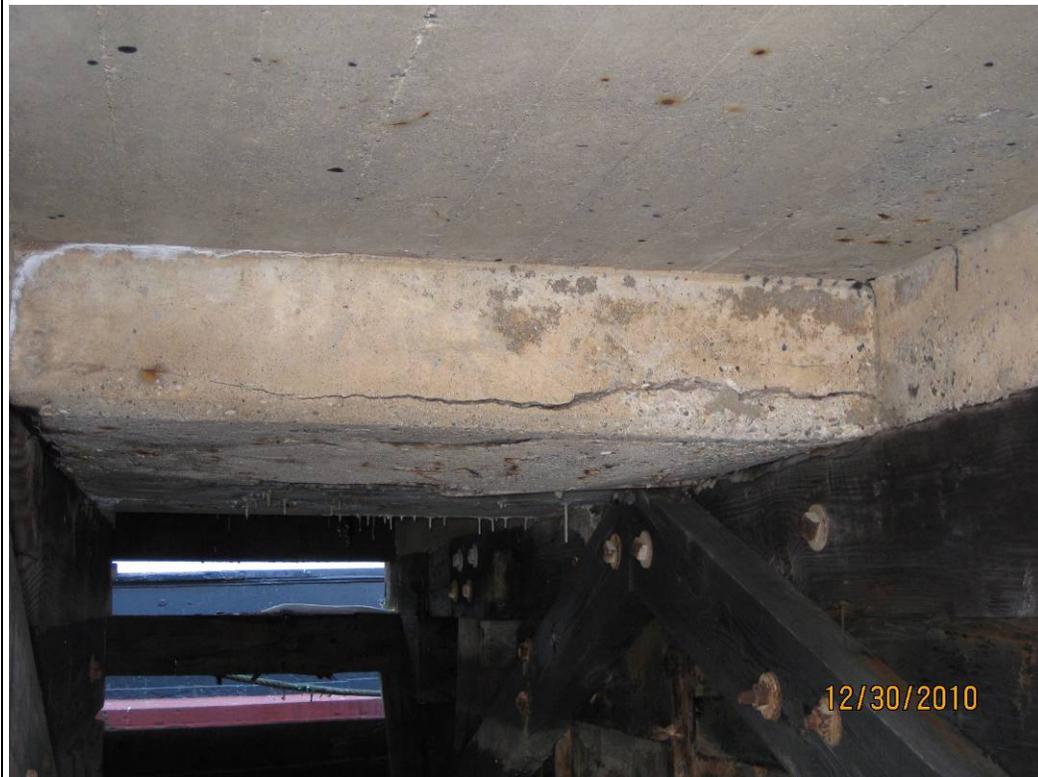
Photo No. 4.30

Spall at bottom of longitudinal concrete beam

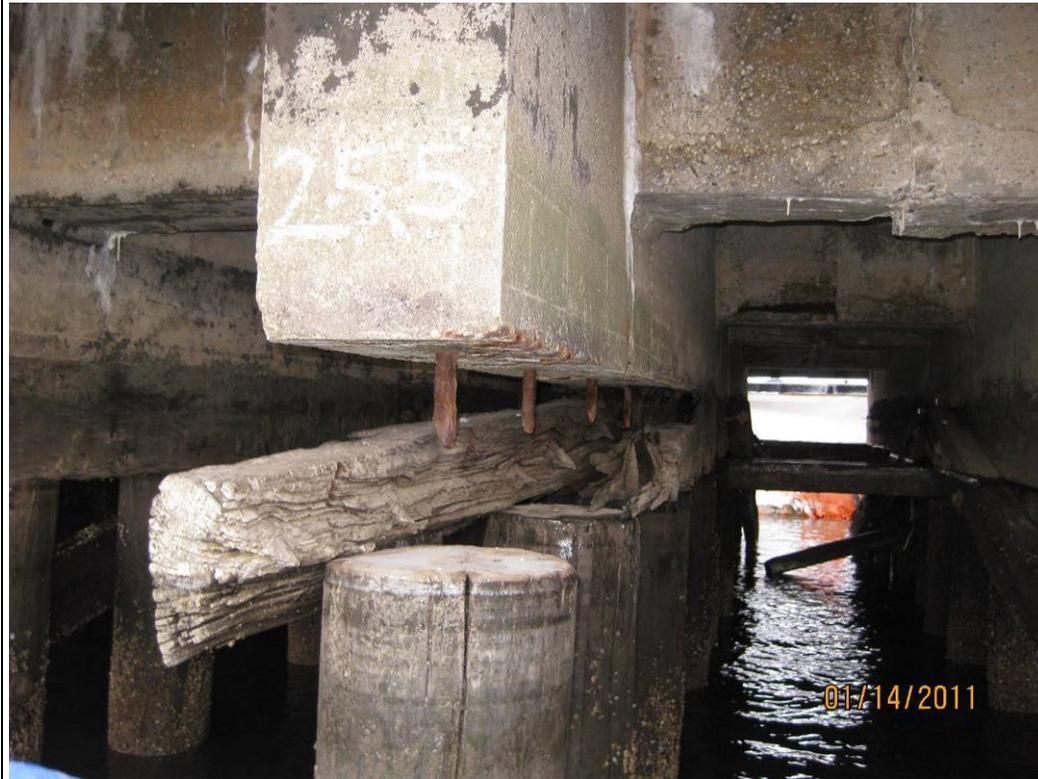
Photo No. 4.33

Severe deterioration of timber pile cap

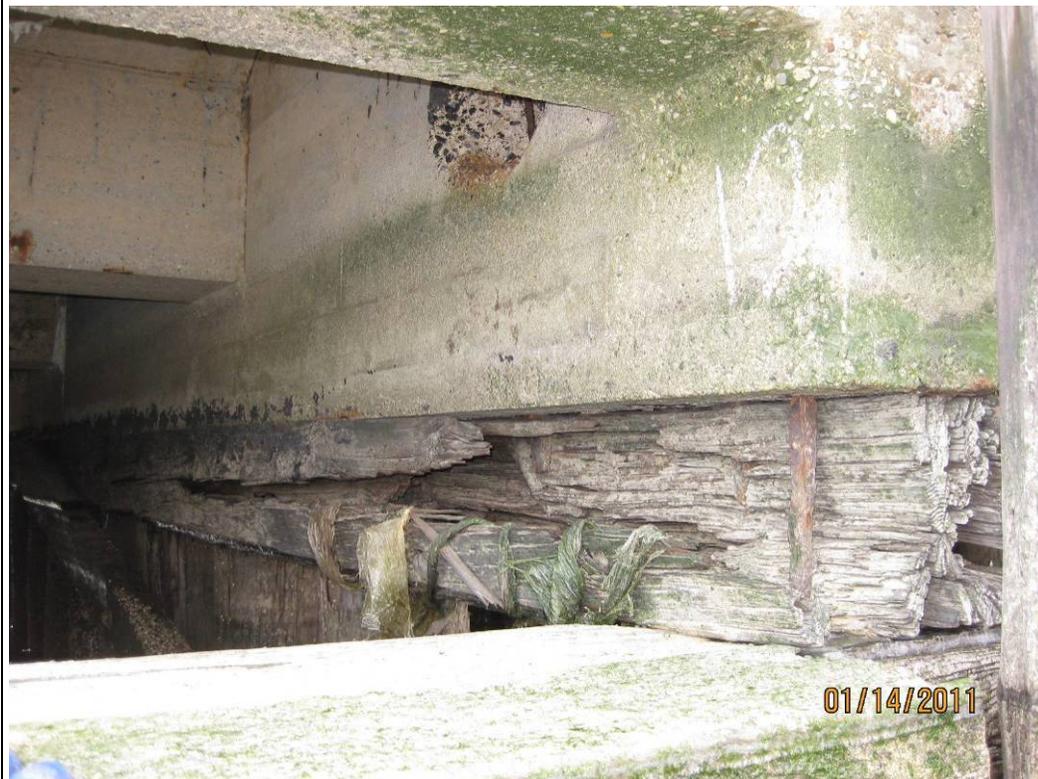
Photo No. 4.34

Severe deterioration
of timber pile cap

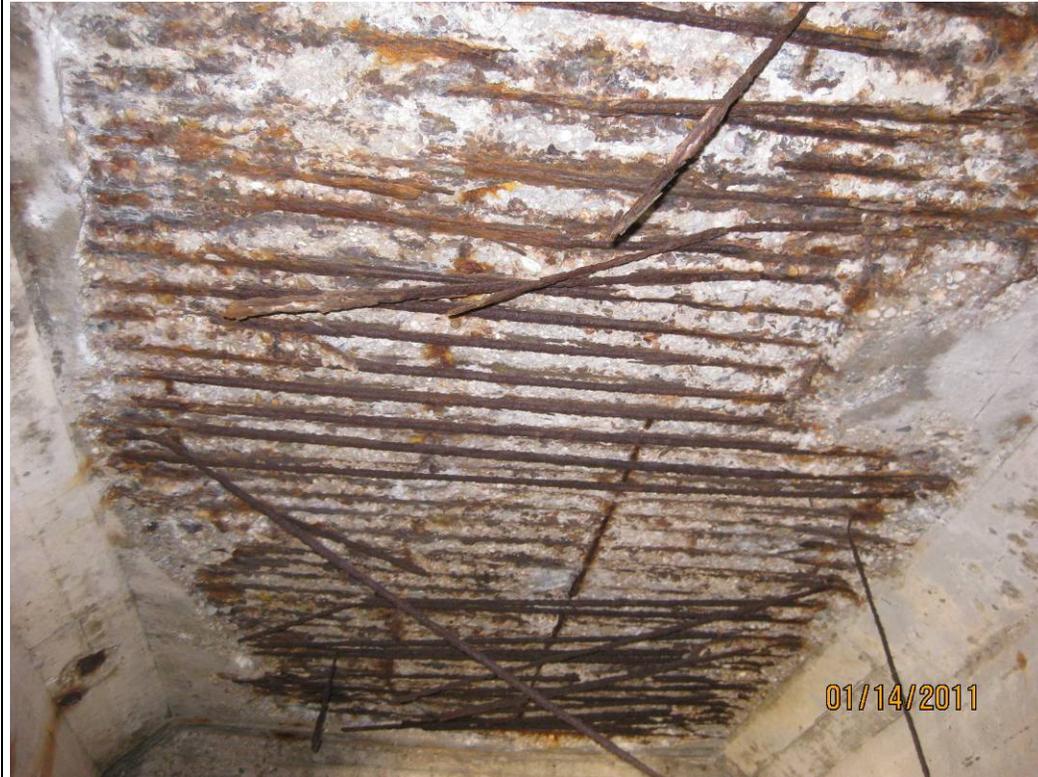
Photo No. 4.37

Steel pipe pile is 0% bearing; spalling of concrete pile cap showing exposed, corroded steel reinforcement

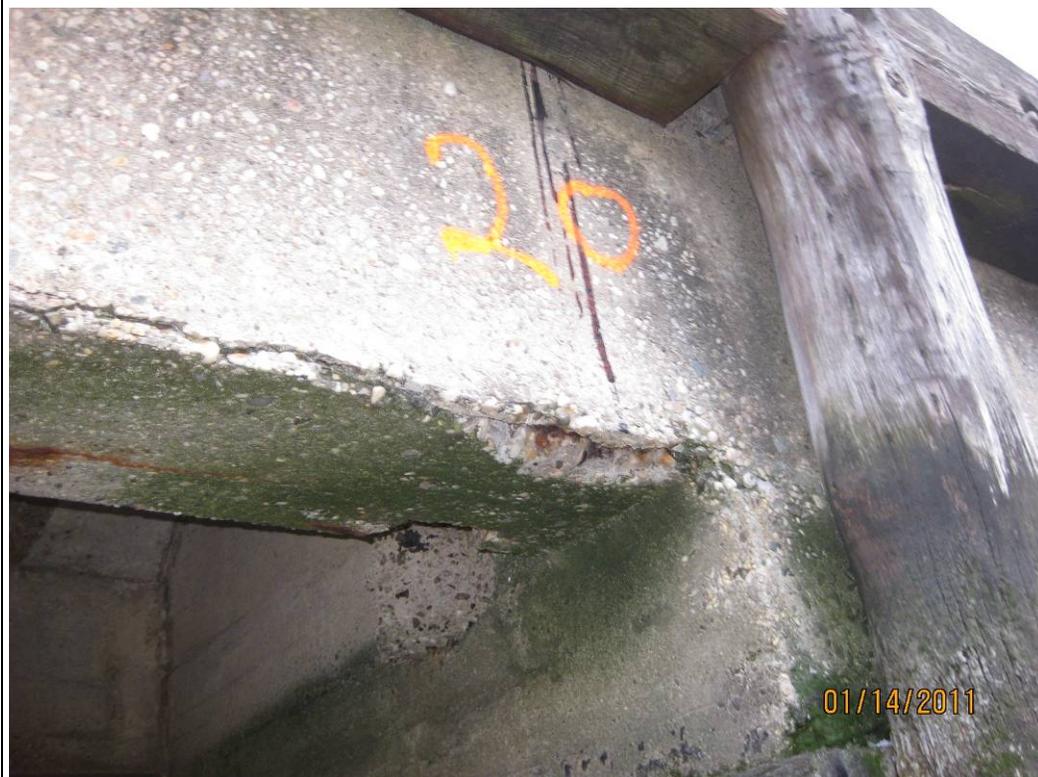
Photo No. 4.42

Concrete spall at
bottom of southern
fascia beam

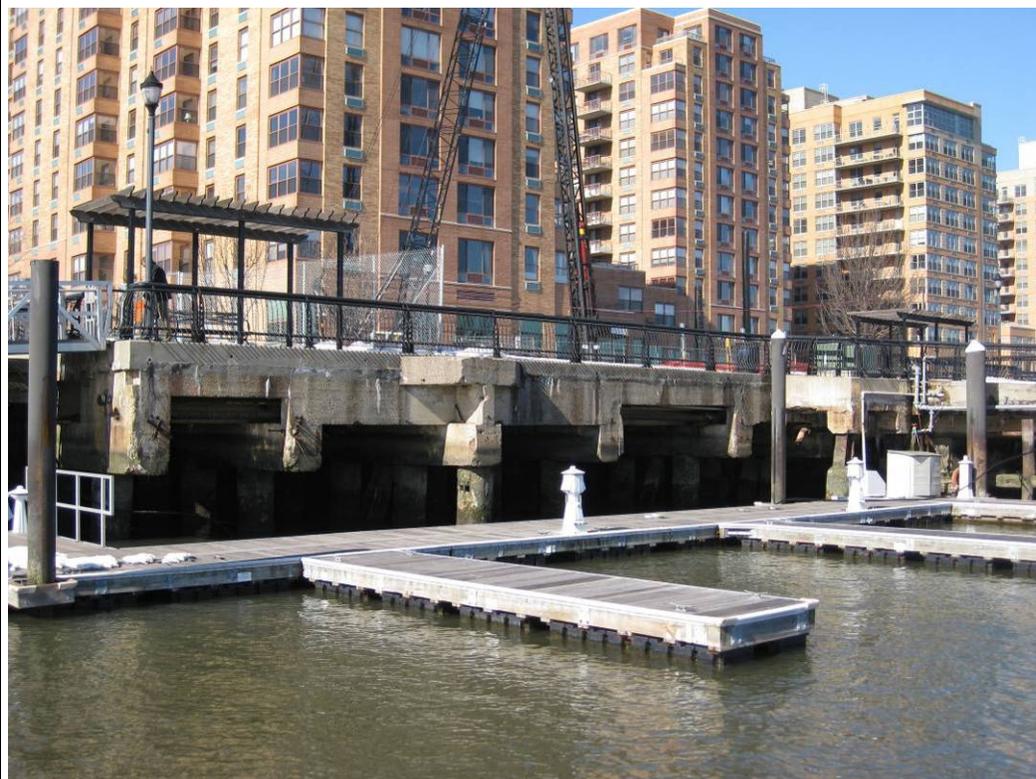
Photo No. 4.44

Spall at north end of
concrete pile cap

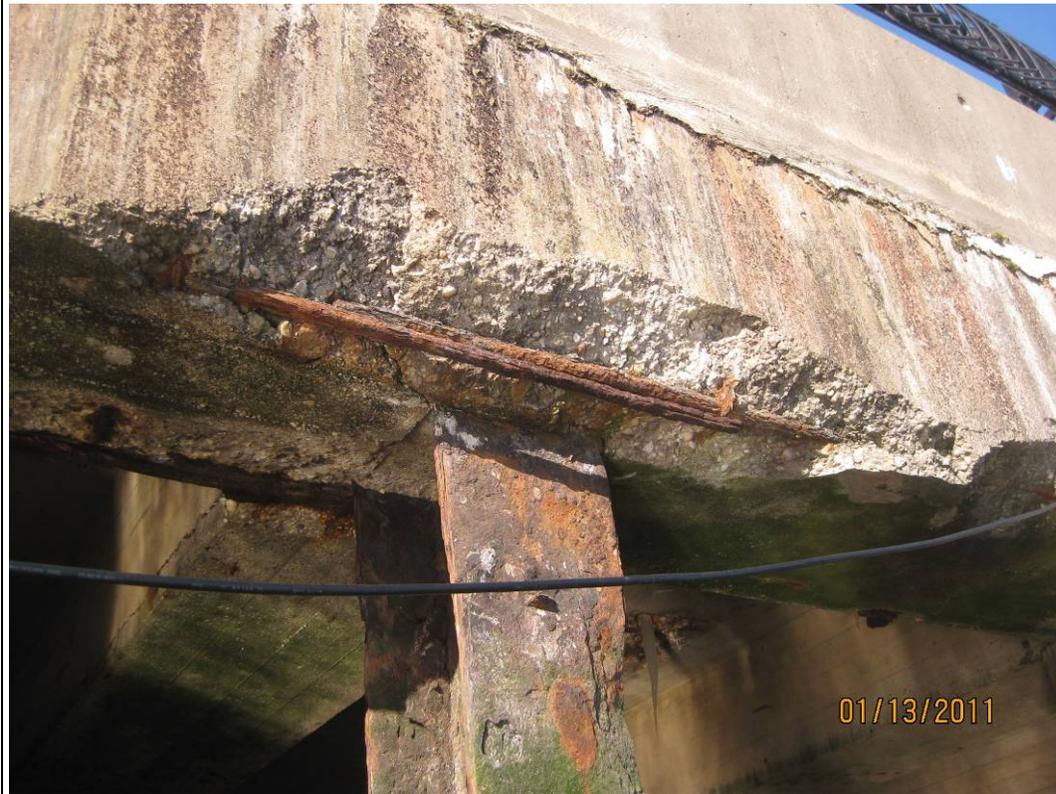
Photo No. 4.55

Spall at bottom of
concrete beam,
exposing corroded
rebar

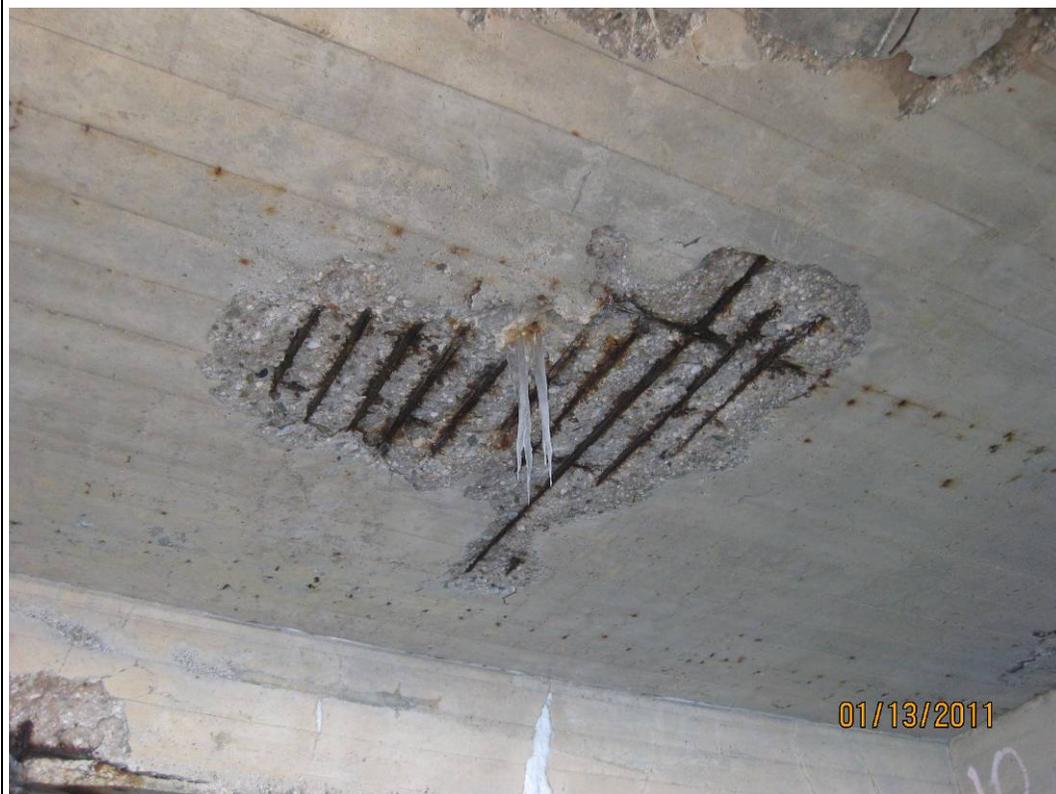
Photo No. 4.56

Spall at concrete
fascia beam with
exposed corroded
steel reinforcement;
corroded steel H-pile

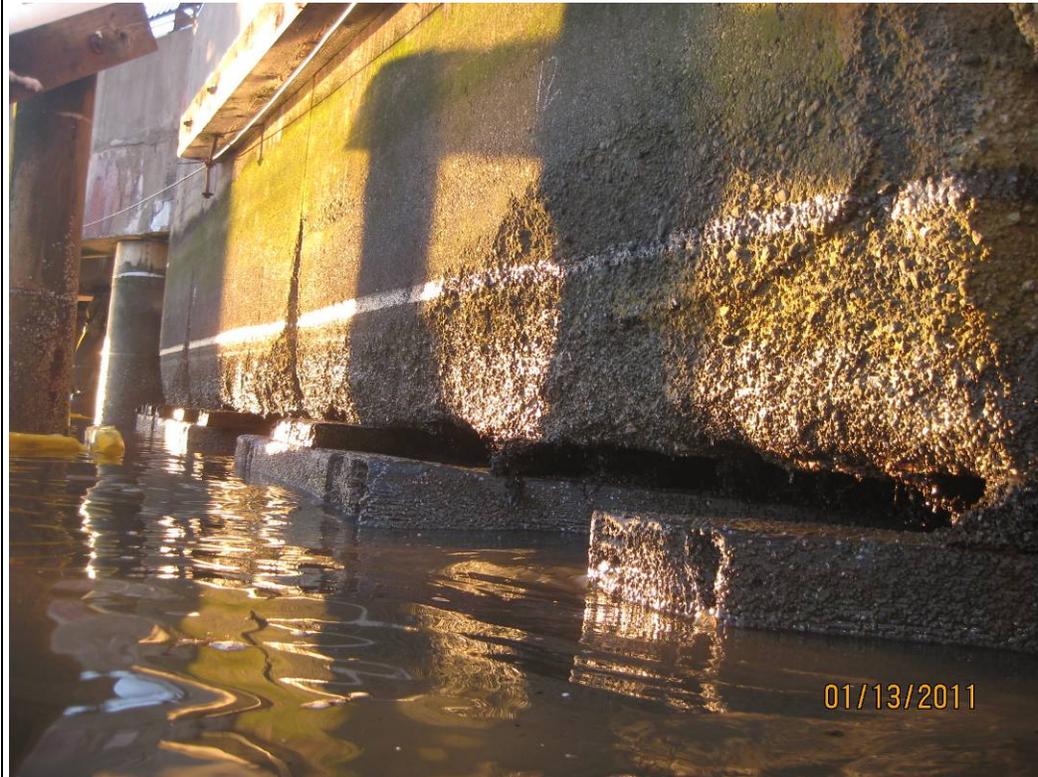
Photo No. 4.65

Void behind cribbing,
loose fill visible

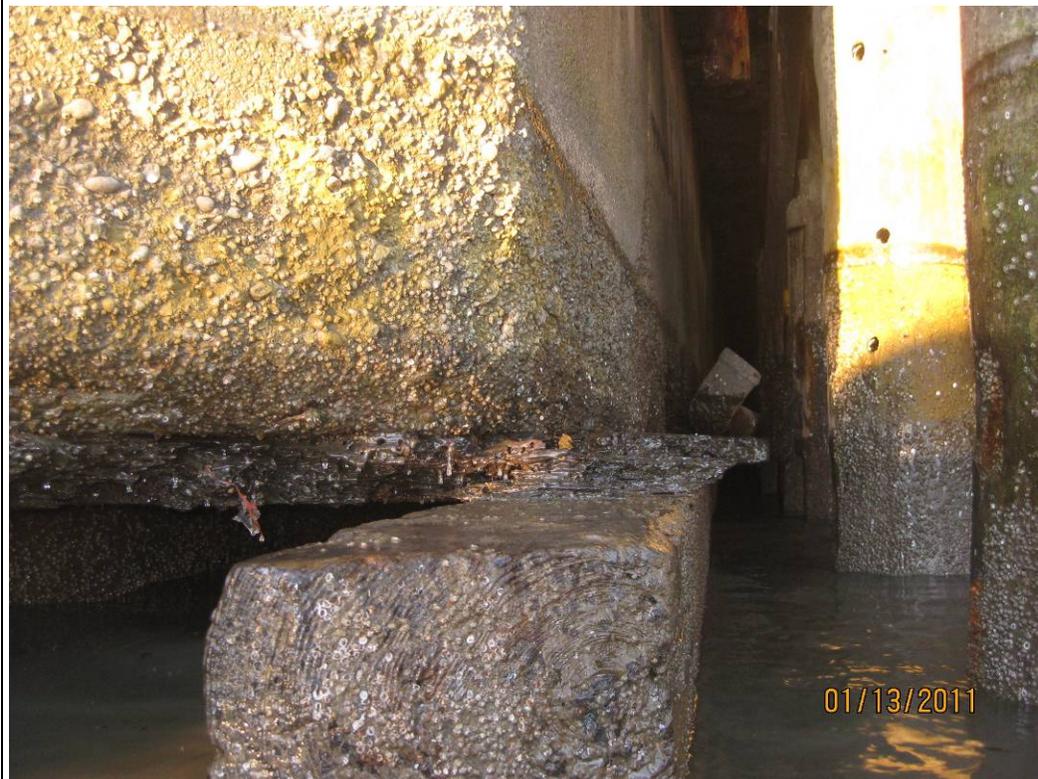
Photo No. 4.66

General view of low-
level platform, outer
plank missing

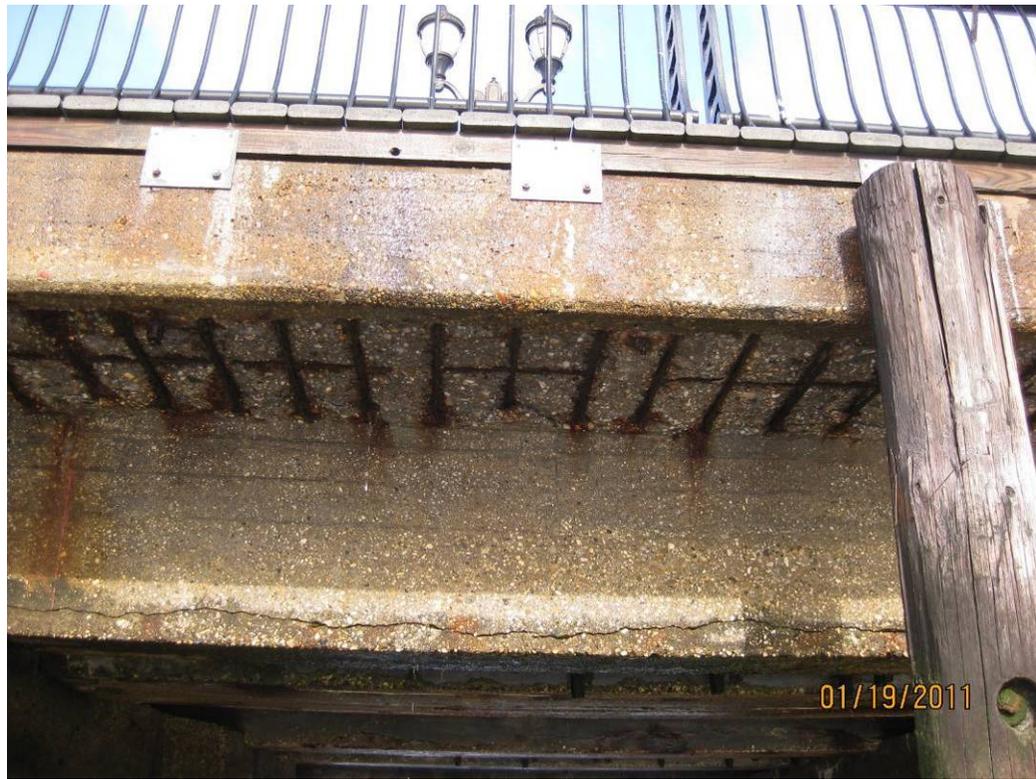
Photo No. 5.13

30 SF spall at manhole showing corroded steel rebars

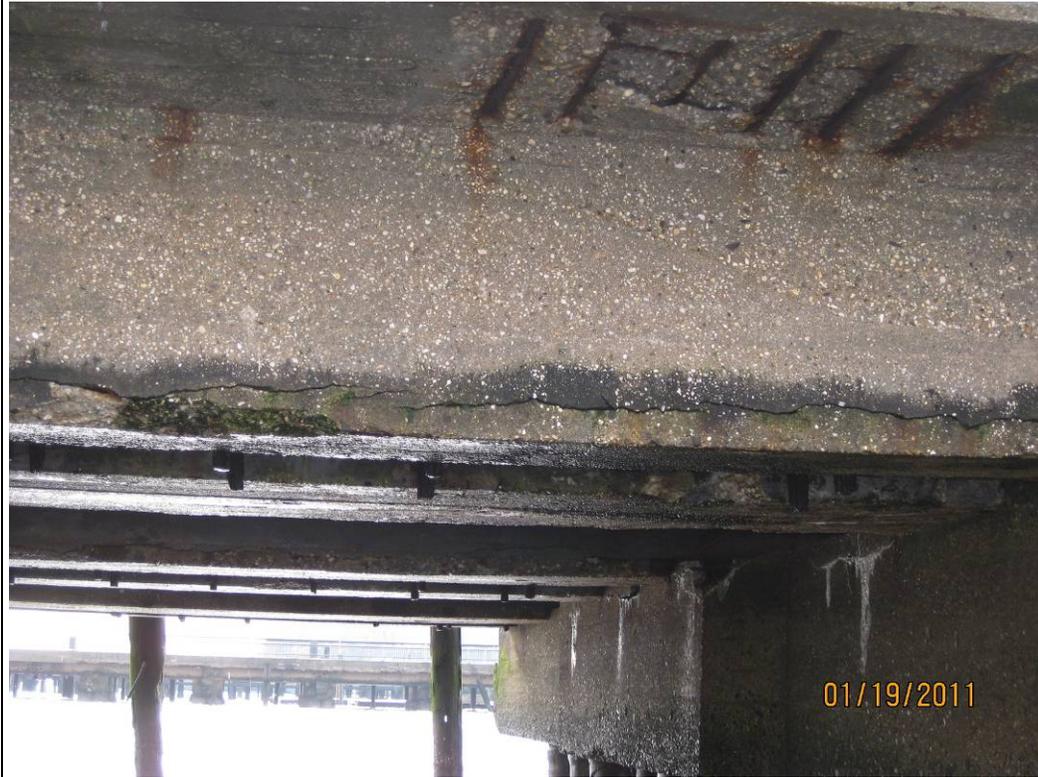
Photo No. 5.15

Spall with corroded
reinforcing steel at
bottom of beam

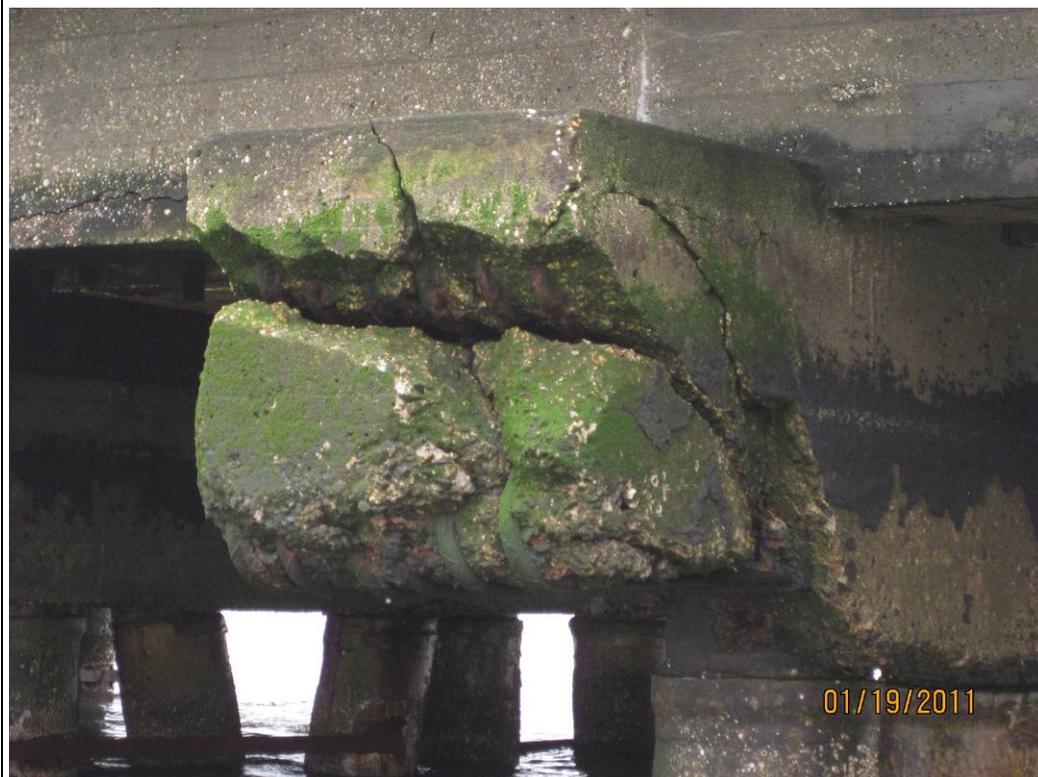
Photo No. 5.16

Incipient spall at
bottom of concrete
beam

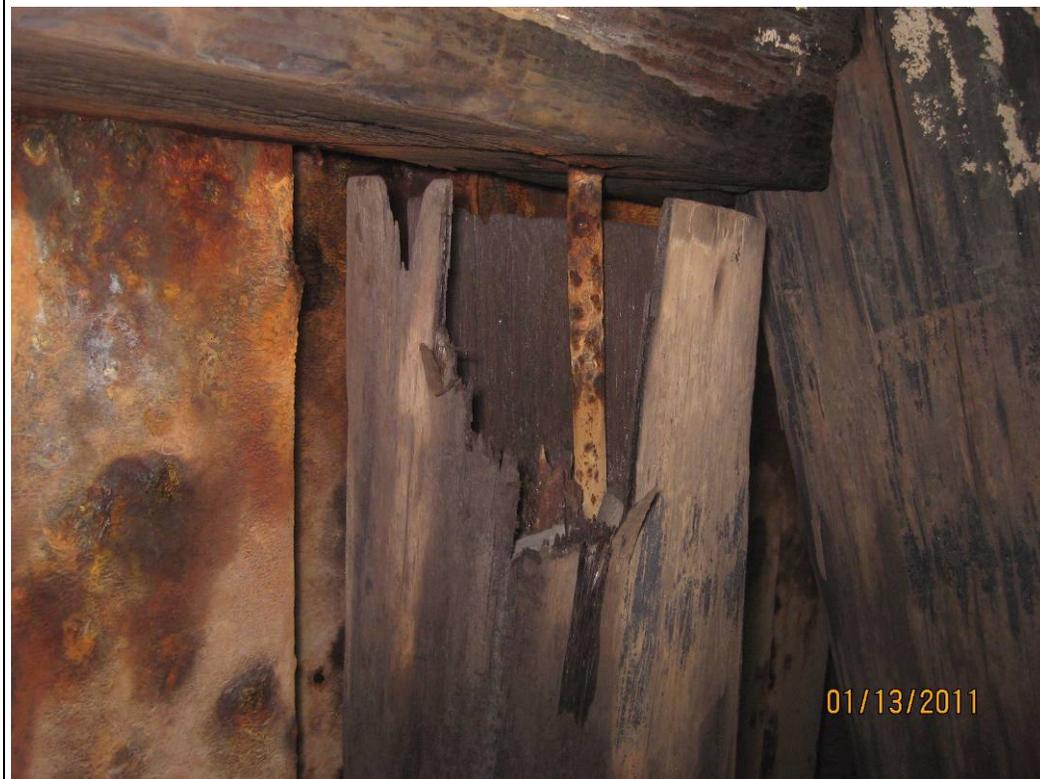
Photo No. 5.22

Severe rot and hollowing at top 2.5 ft; fire damage of timber pile cap

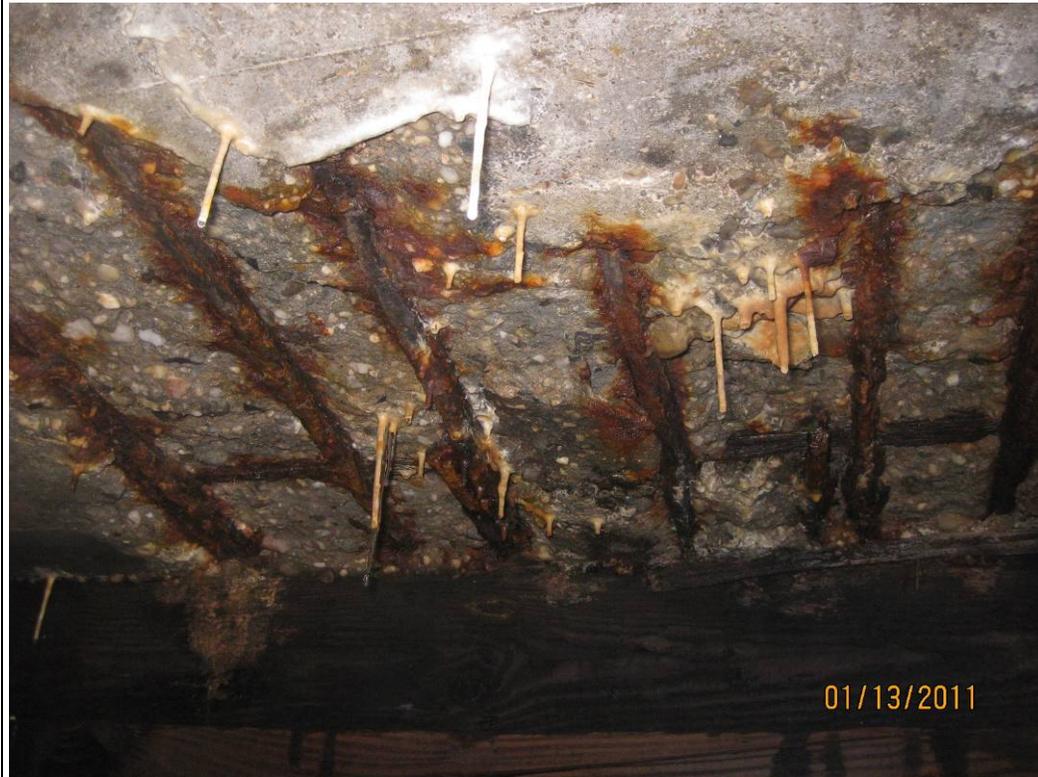
Photo No. 5.27

40 SF underdeck spall with exposed, corroded steel reinforcement

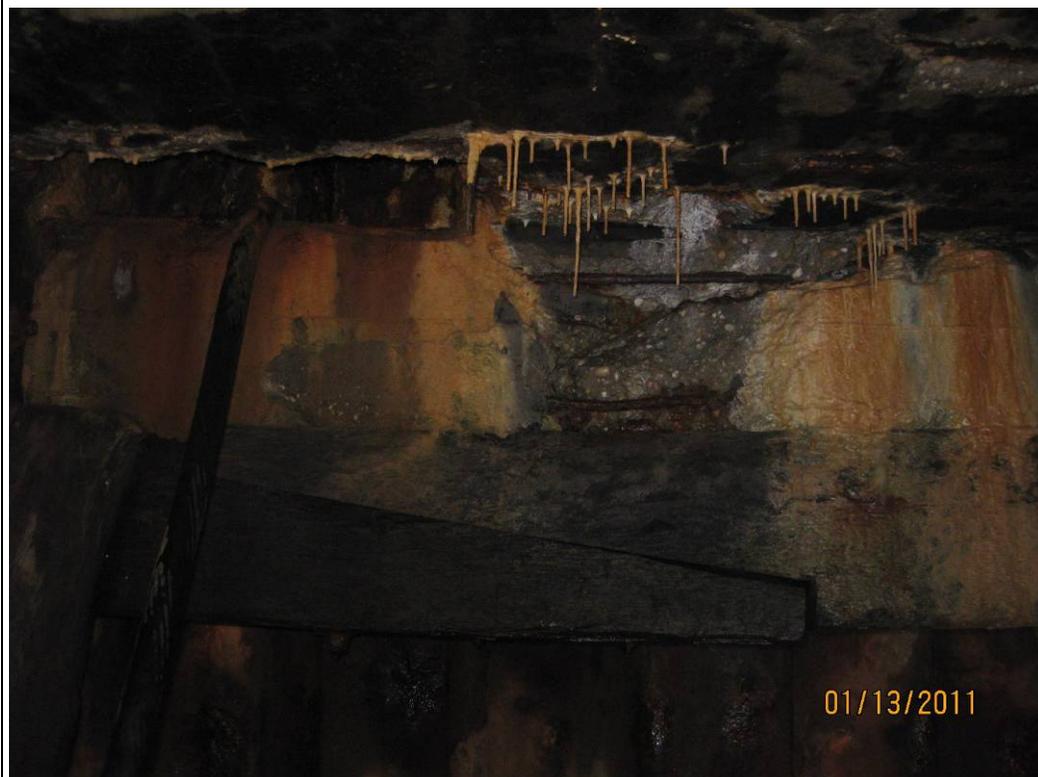
Photo No. 5.28

30 SF underdeck spall
exhibiting corroded
steel reinforcement

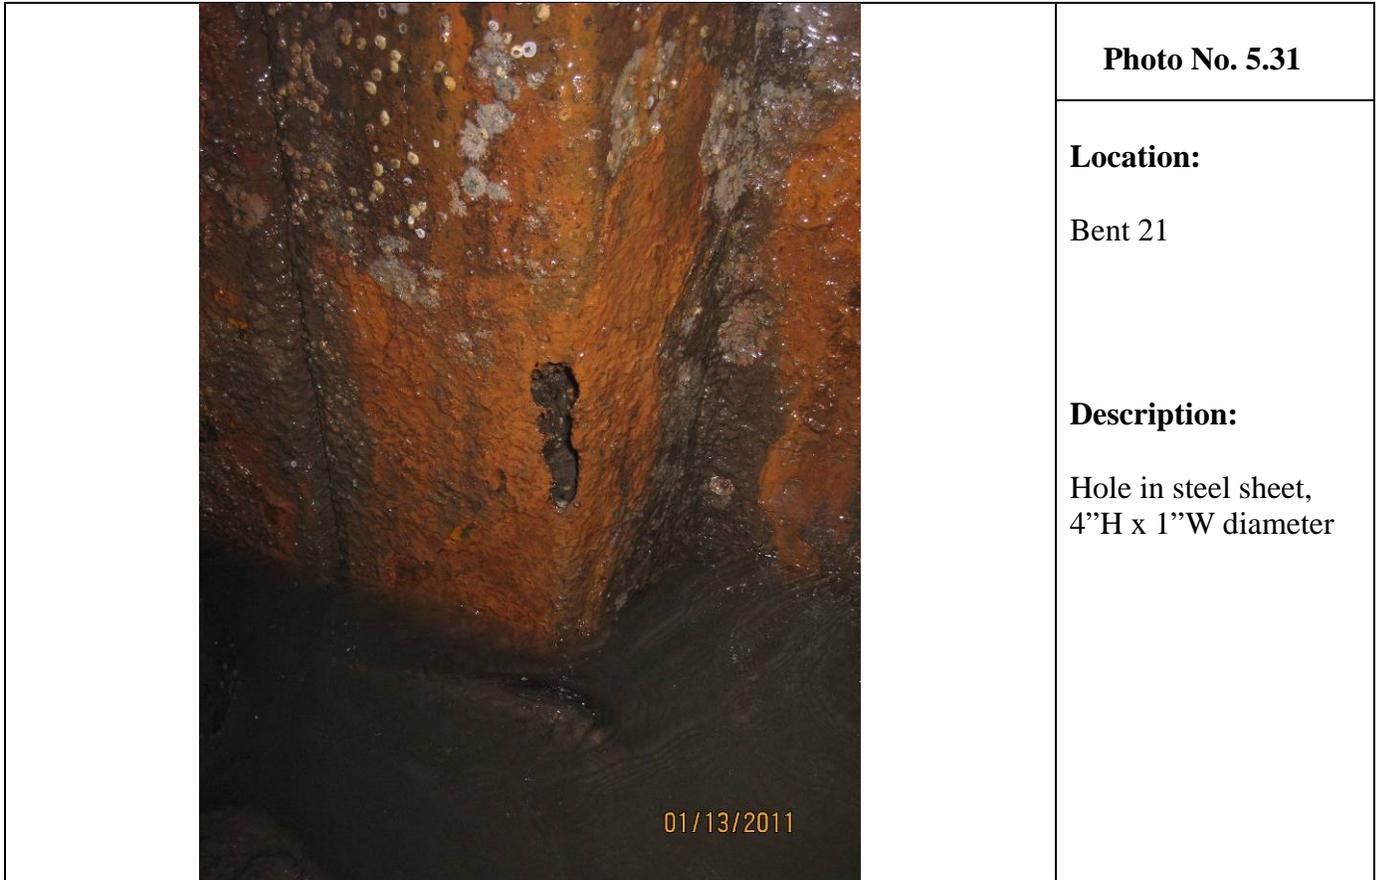
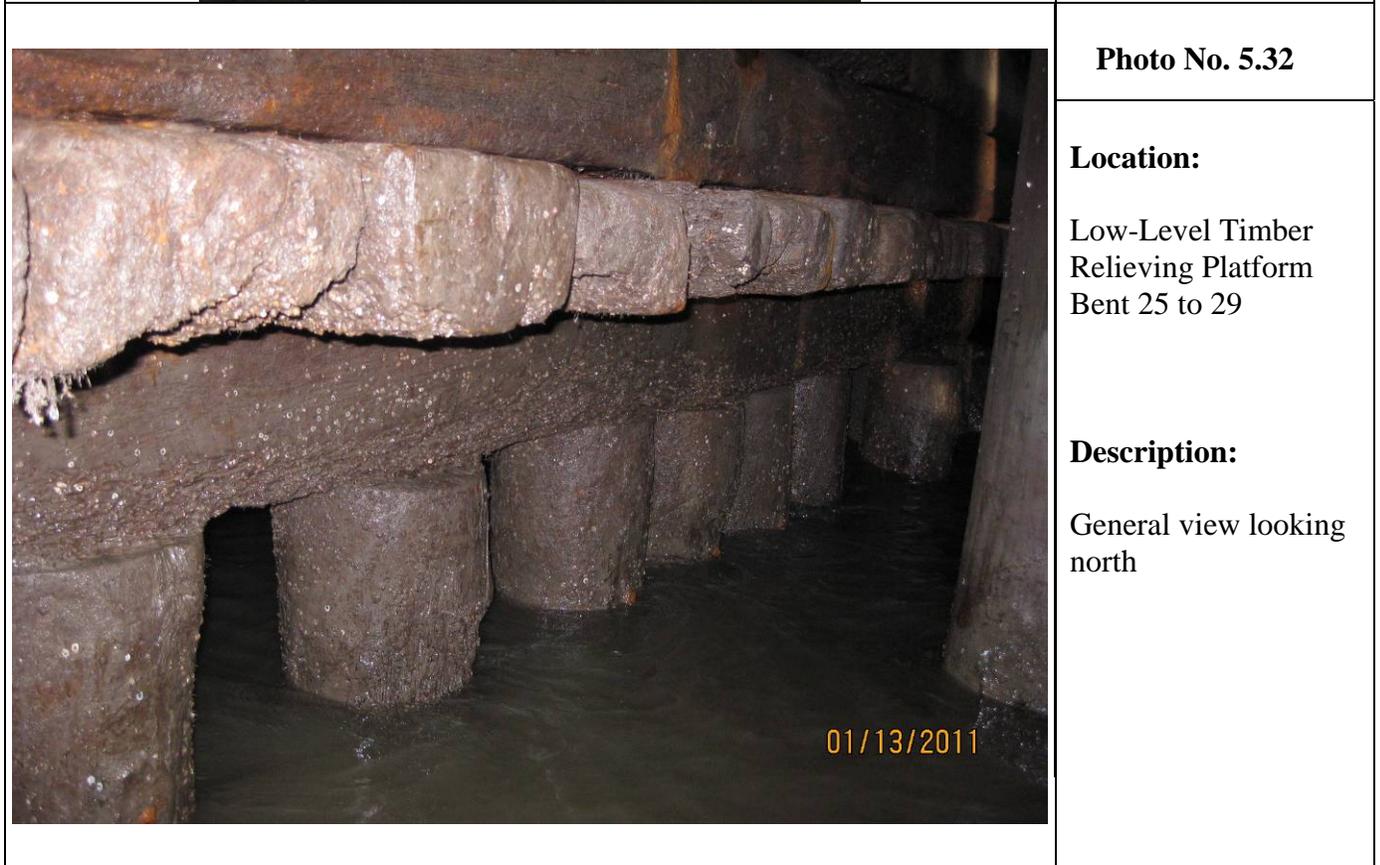
Water leaking from deck onto sheet pile bulkhead

- Pier – Repair severely corroded steel pipe piles and H-piles, and piles with loss of bearing.
- High-Level Timber Platform – Repair timber piles and pile caps with deterioration rated severe.
- High-Level Steel H-Pile Platform – Repair two piles with section loss rated severe.
- Steel Sheet Pile Bulkhead – Stop water from leaking onto steel sheeting; repair hole in sheeting.
