HOBOKEN PRIVATELY-OWNED WATERFRONT STRUCTURES INSPECTION

File No. BUE-1010

BOSWELL UNDERWATER ENGINEERING

June 2011

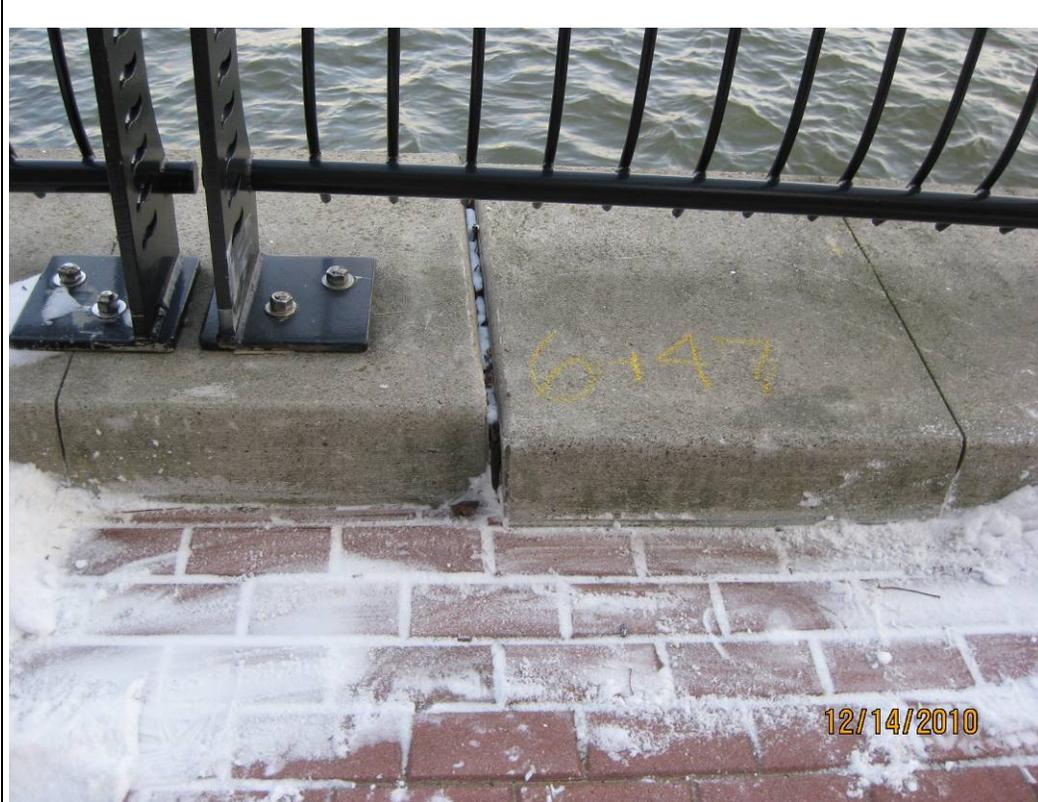
Photo No. 7.5

Cracking at joint
