SOUTHWEST AREA REDEVELOPMENT STUDY

January 5, 2012

**Preliminary Investigation for a Determination of
Area in Need of Redevelopment and Area in Need
of Rehabilitation Designations for the
Southwest Area of the City of Hoboken**

In Accordance with the Local Redevelopment & Housing Law
(N.J.S.A. 40A:12A-1 et seq.)

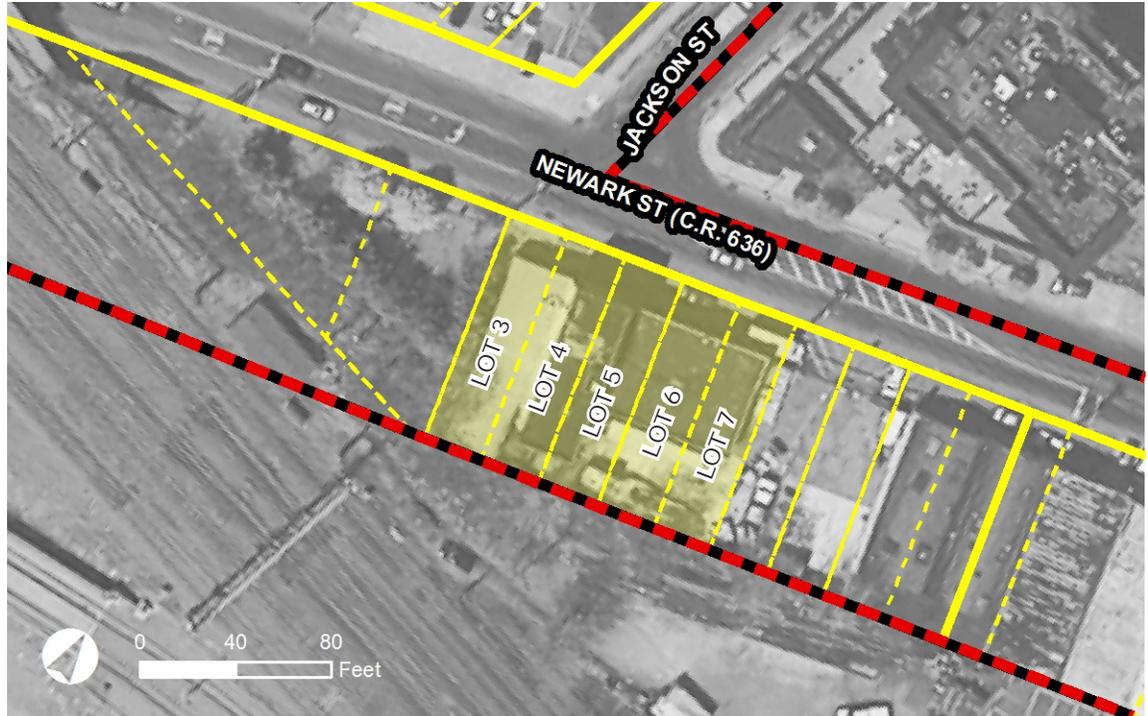
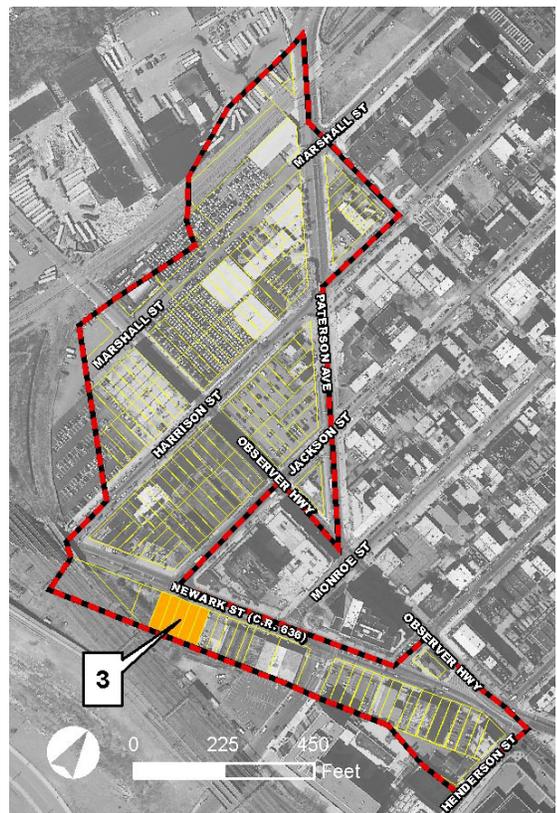
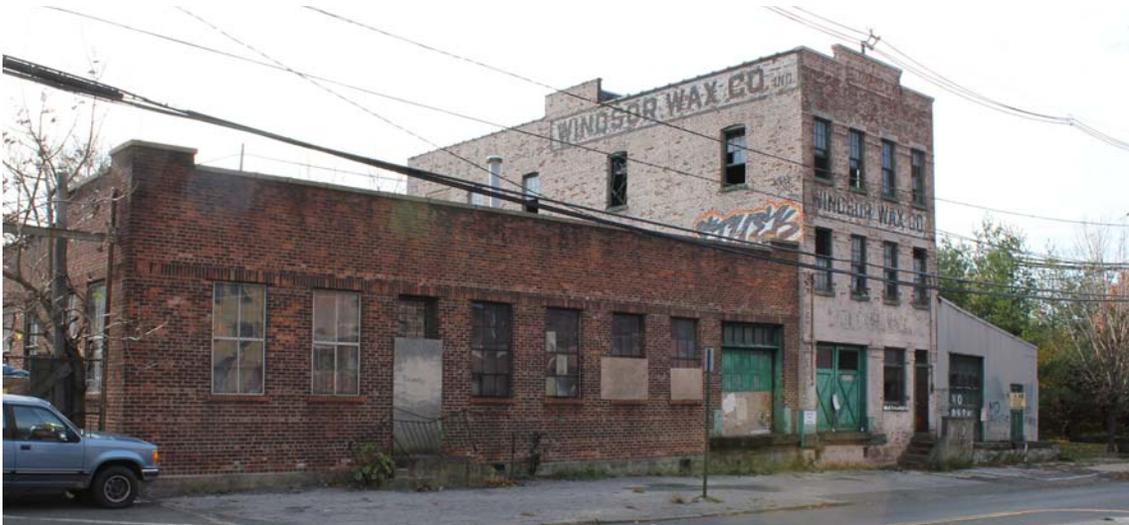
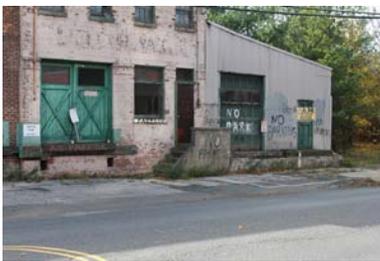
PROPERTY 3

This property, which is approximately 1/4 acre in size, contains a series of former industrial/commercial buildings spanning several lots. The property is within the I-2 district.

The building on lot 3 is a one-story addition with corrugated metal siding and a sloping roof. The building on lot 4 is a three-story brick building with wood interior structure. Portions of the interior have collapsed. Loading docks open directly on the front sidewalk. Several of the upper windows are missing. The building on lots 5, 6 and 7 is a one-story brick building, also with wood interior structure. The roof and roof structure are in extremely poor condition. Holes in the roof are large enough to see through the windows from the front sidewalk.

There are many problems with the conditions of the buildings. These include, but are not limited to, peeling paint, missing floor boards, and damaged plaster walls and ceilings. All three connected structures have been vacant since at least 2007 and are not safe for access.

A burglary occurred on the property in 2004. Vandalism is evident with graffiti and other damage to the property.

- Building deterioration has occurred. The buildings are substandard, unsanitary, dilapidated and are conducive to unwholesome working conditions.
- None of the building systems, including safety systems, are operational.
- There are major structural issues, both on the interior and exterior, and several of the roofs are leaking.
- The buildings' roofs, gutters, parapets, exterior doors and windows are in disrepair and in need of replacement.
- There have been structural collapses on the interior, and daylight can be seen through the roof structure.
- Since the previous use of these buildings has been discontinued, the condition has fallen into such disrepair as to become untenable.

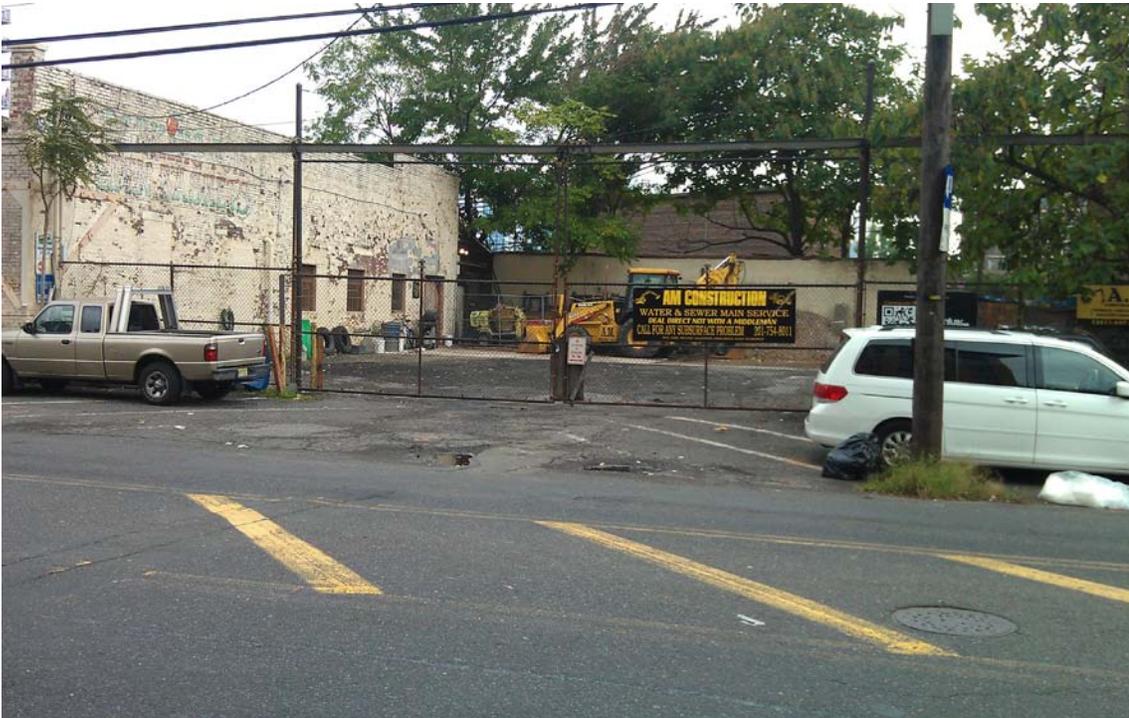
PROPERTY 4

- The storage of construction equipment and bulk materials is a deleterious land use that is detrimental to the health and welfare of the community.
- Bulk materials and mechanical lubricants stored outside have the potential to contaminate surface water.
- The storage of construction equipment and bulk materials creates an eyesore along Newark Avenue.

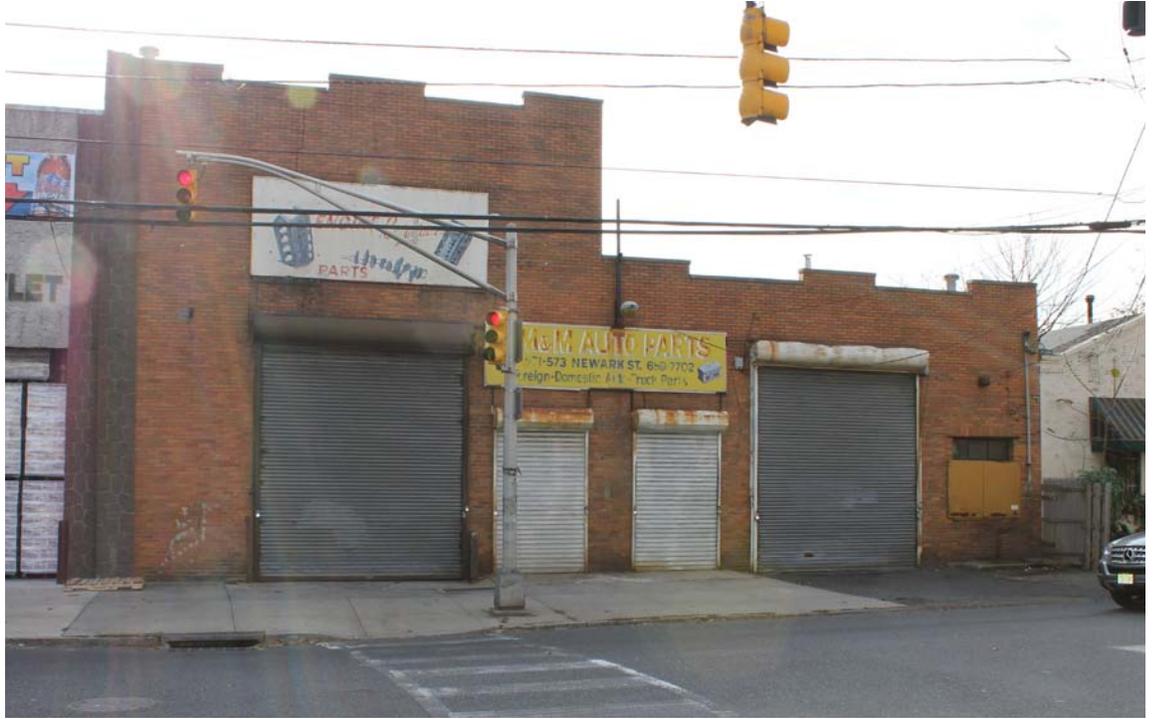
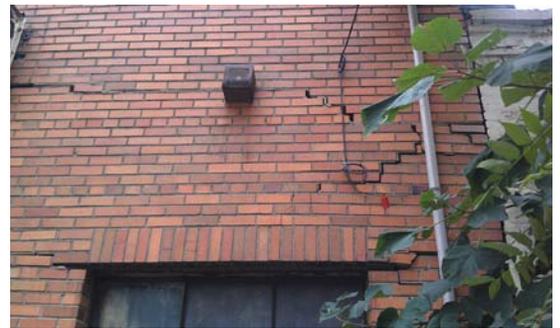
PROPERTY 6

Cracking in the facade is indicative of instability that could result in damage to property or injury to persons. The property has a history of fire code violations, with seven violations between 2002 and 2009.

- 2002: Open wiring and exit signs out
- 2003: Blocked electrical panels Violation
- 2004: Open wiring

- 2007: Open wiring and propane tanks
- 2008: Obstruction in two areas regarding access to electrical/gas meters
- 2008: Holes in ceiling
- 2009: Propane on site and removed

These fire code violations represent a pattern of neglect and a history of unsafe conditions.

- The condition of the facade, which shows signs of instability, is a potential safety hazard.
- The building is dilapidated. A pattern of substandard conditions have been documented by fire code violations over 7 years. Additionally, structural cracking on the facade abutting the public street creates a potential hazard.

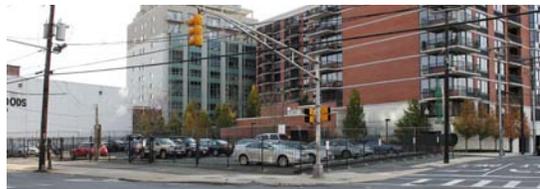
This property consists of 0.25 acres at the corner of Newark and Grove Streets. The site is completely covered with asphalt and surrounded by a metal picket fence. It is a 36 space surface parking lot lawfully created by variance (residential) in association with the Skyline condominium building. It is used by Skyline valet to shuttle residents' cars. If this were a "stand-alone" lot, it would be a permitted use in the I-2 district.

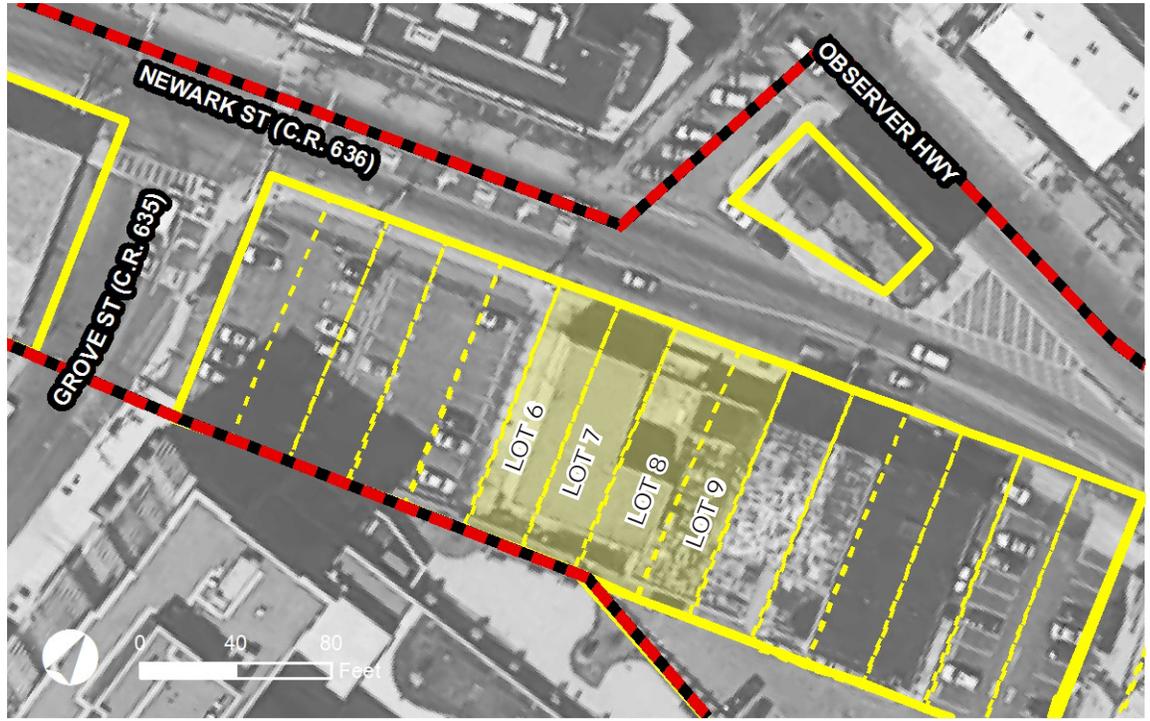
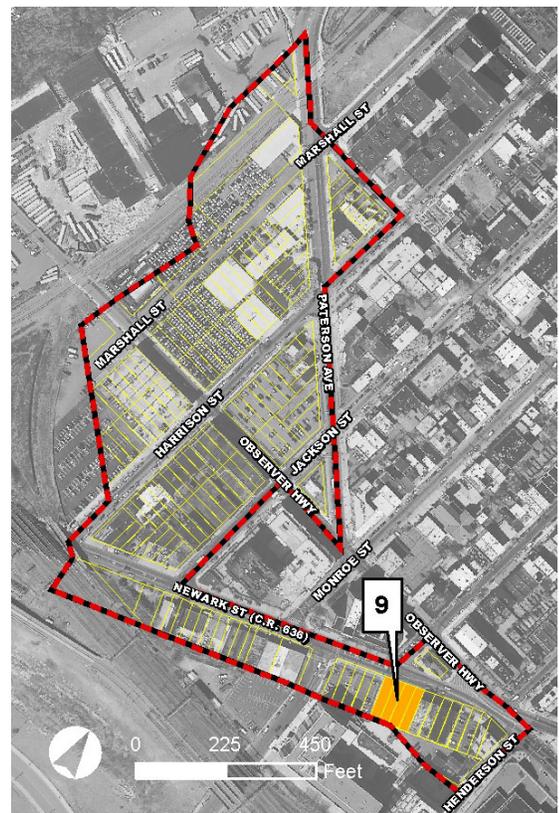
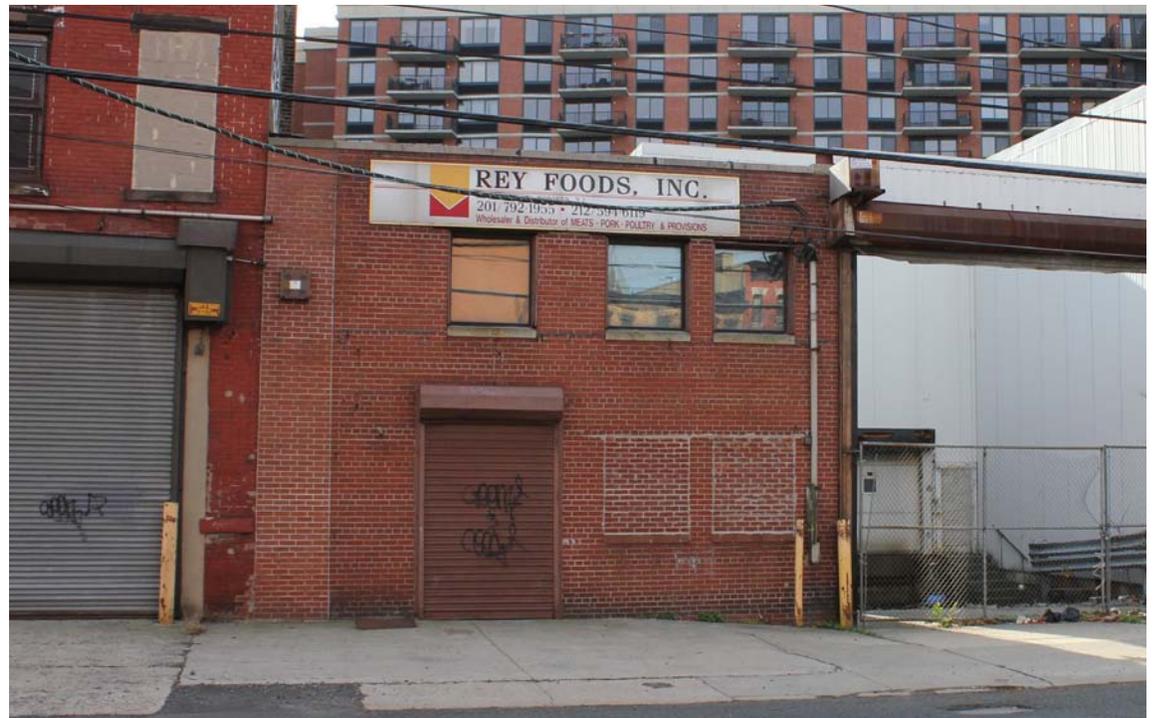
PROPERTY 9

This property consists of four lots consisting of .2 acres and contains the former Rey Foods building. Lots 6, 7 and 8 (.15 acres) consists of a tall one-story building faced with metal siding. This building was used as a warehouse for a wholesale food distribution business. There is a driveway along the right side of the taller part of the building. The left portion of the building is set back. A driveway leads to a two-bay loading dock. The loading bays are separated from the sidewalk by eight-foot high chain link gates. There are no windows apparent. The exterior condition of the building appears to be fair. The interior configuration and condition is unknown since this office was not granted access to the building interior by the property owner.

Lot 9 (0.05 acre) contains a two story brick building with a flat roof that was used by the former business, Rey Foods, Inc. for meat packing. The ground floor includes an entrance door (covered by a steel roll-up door), and two windows that have been “bricked” over. There are three windows on the second floor. The exterior of the building appears to be in good condition. The

- Since the site and building have not been maintained, and have been unoccupied, the building has deteriorated. Refuse and stagnant water has collected and the conditions provide safe harbor for carriers of disease and waste, such as rats, insects and other animals, which are detrimental to health, safety and welfare.
- The property is an attractive nuisance. Refuse is strewn on the site and evidence of vandalism, including reports of fires and gaps in the chain link fence where trespassers have gained entrance. These conditions are evidence of dilapidation and are detrimental to health, safety and welfare.

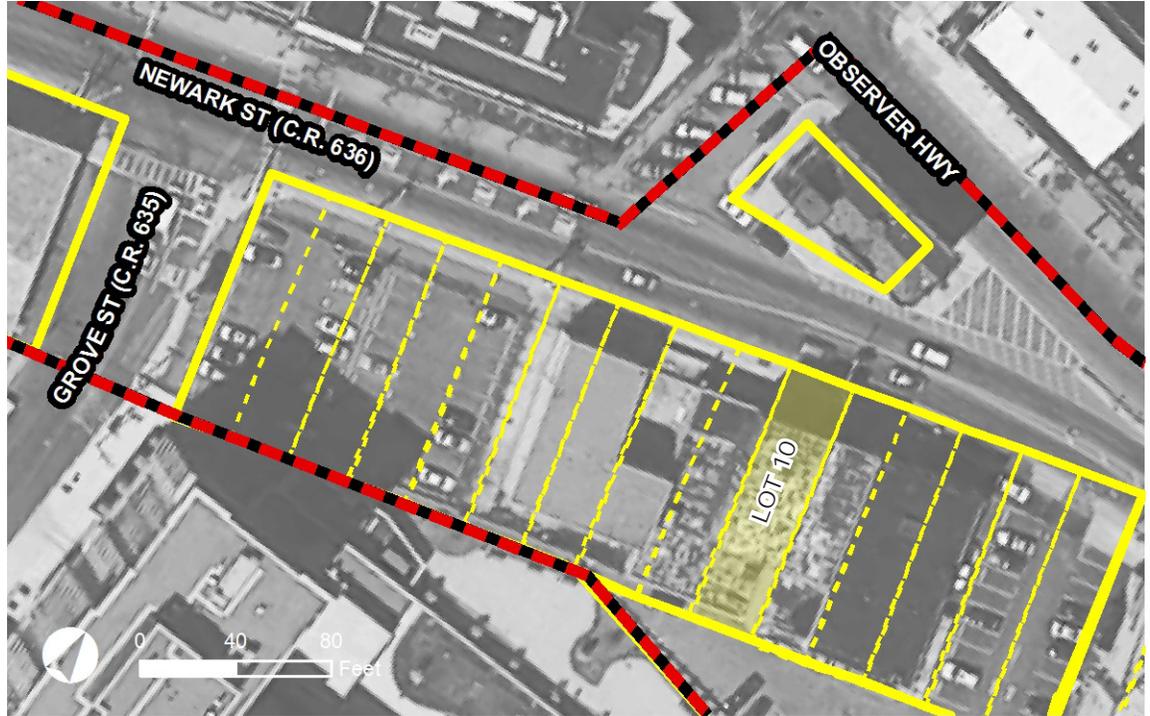
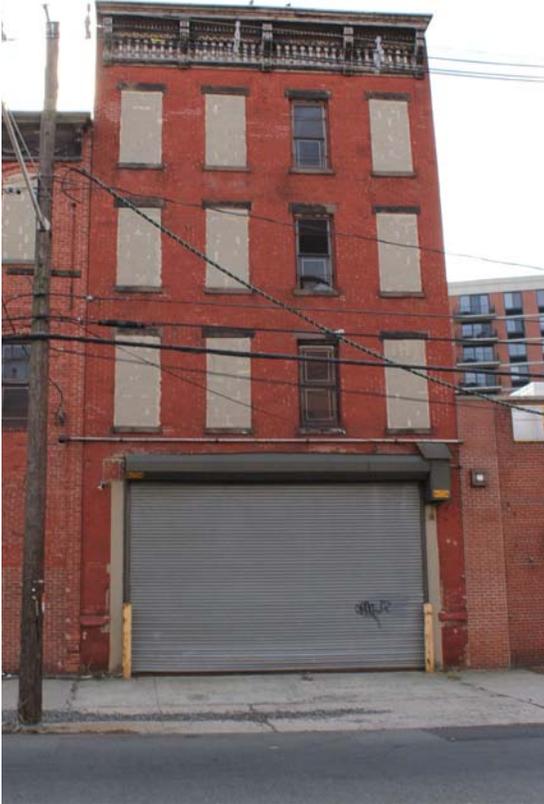
PROPERTY 10

513 Newark Street contains a four-story, four-bay late 19th century Italianate structure. Its entire first floor has been reconfigured with a roll up door to provide access. Most of the upper floor windows have been filled in with concrete block, allowing virtually no light or air to the interior. The building is vacant. The structure occupies the entire lot. There are no side or rear windows, and there is no on-site parking. This property contains 0.05 acres.

- The former commercial use has been discontinued for several years. Vacancy attracts vandalism and the potential for greater damage to the property, which would be detrimental to the safety and welfare of the properties and adjacent public rights-of-way in the district.
- The blocking up of the windows has created a lack of light and air that is conducive to unwholesome living or working conditions.
- An exterior observation of the building shows evidence of vandalism (graffiti and damage), lack of tenancy (vacancy) of this building can be expected to continue an environment that is prone to criminal activity (i.e. vandalism) which is detrimental to the public welfare.

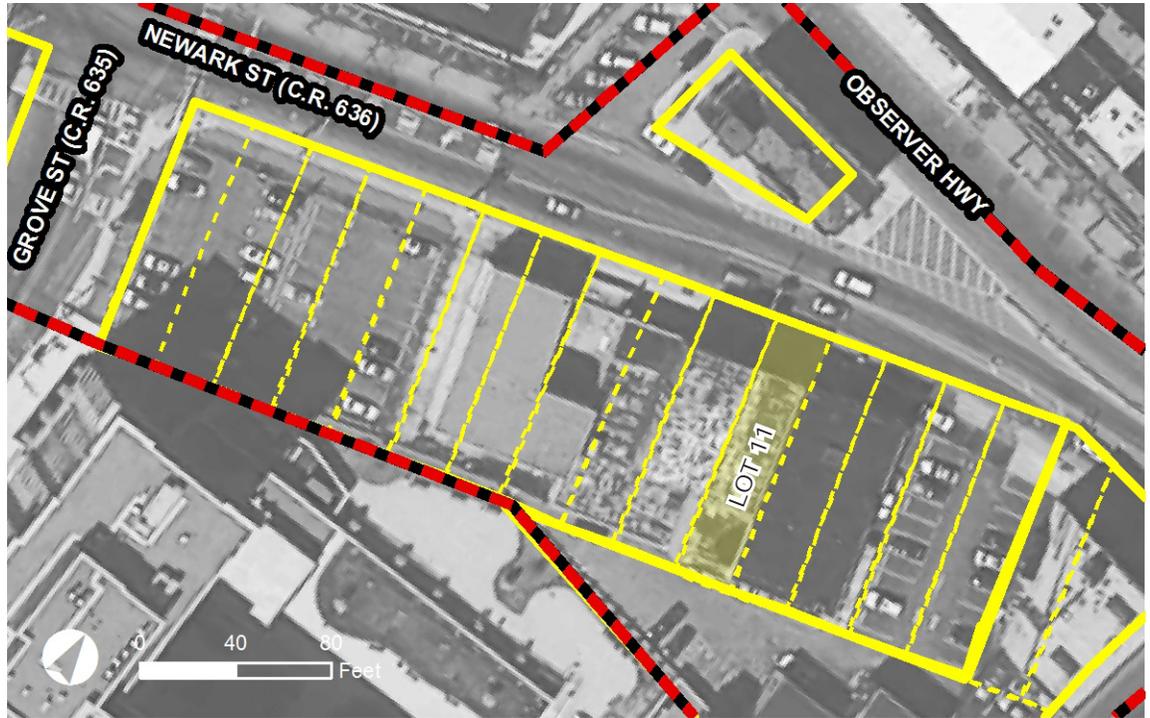
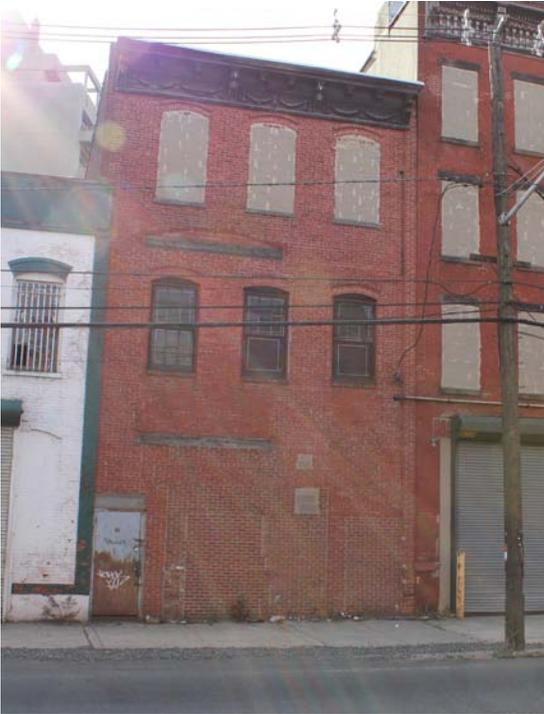
PROPERTY 11

511 Newark Avenue contains a three story, three bay late 19th century Italianate structure. There is a single steel door that provides access on the first floor. All of the other openings on that level have been bricked over. The third floor windows have been filled in with concrete block. The building is vacant. The structure occupies the entire lot. There are no side or rear windows, and there is no on-site parking. This property is 0.05 acres.

- The former commercial use has been discontinued for several years. Vacancy attracts vandalism and the potential for greater damage to the property, which would be detrimental to the safety and welfare of the properties and adjacent public rights-of-way in the district.
- The blocking up of the windows has created a lack of light and air that is conducive to unwholesome living or working conditions.
- An exterior observation of the building shows evidence of vandalism (graffiti and damage), lack of tenancy (vacancy) of this building can be expected to continue an environment that is prone to criminal activity (i.e. vandalism) which is detrimental to the public welfare.

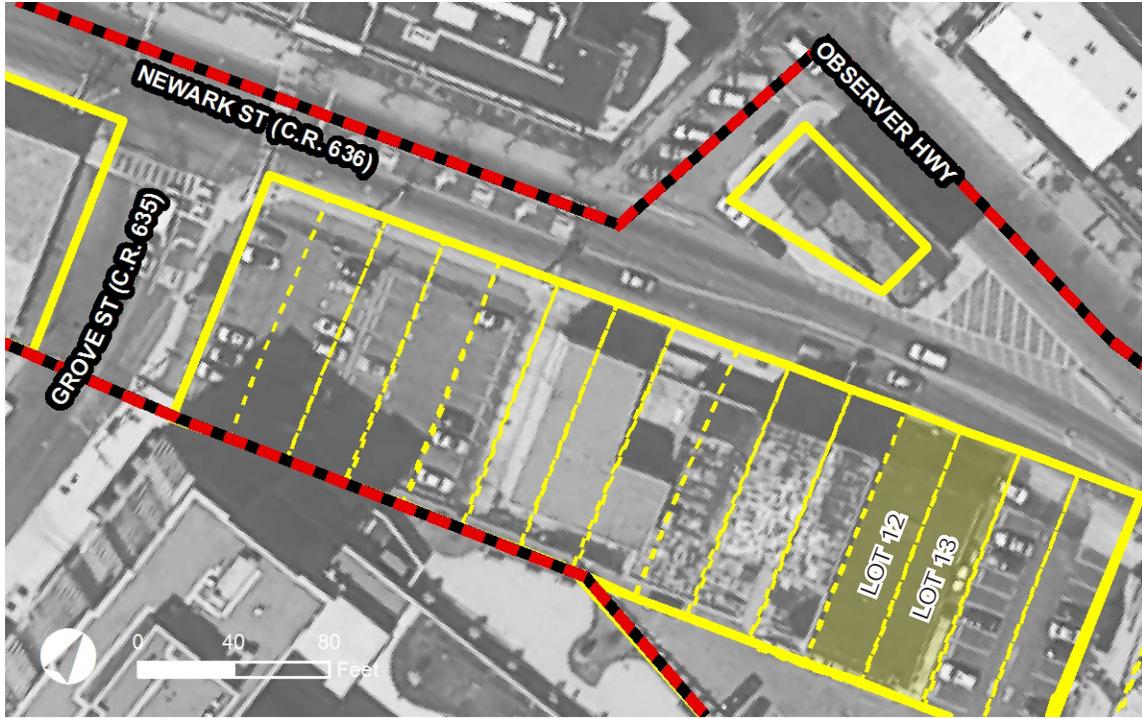
ADDRESS: 507 - 509 Newark Street
BLOCK: 3.2 **LOTS:** 12 and 13

507-509 Newark Street is a cleared site where a former commercial building was recently razed. This property contains 0.1 acres.

The property has been fenced off from the public sidewalk. The ground remains disturbed with demolition debris. There are no buildings or improvements on the property.

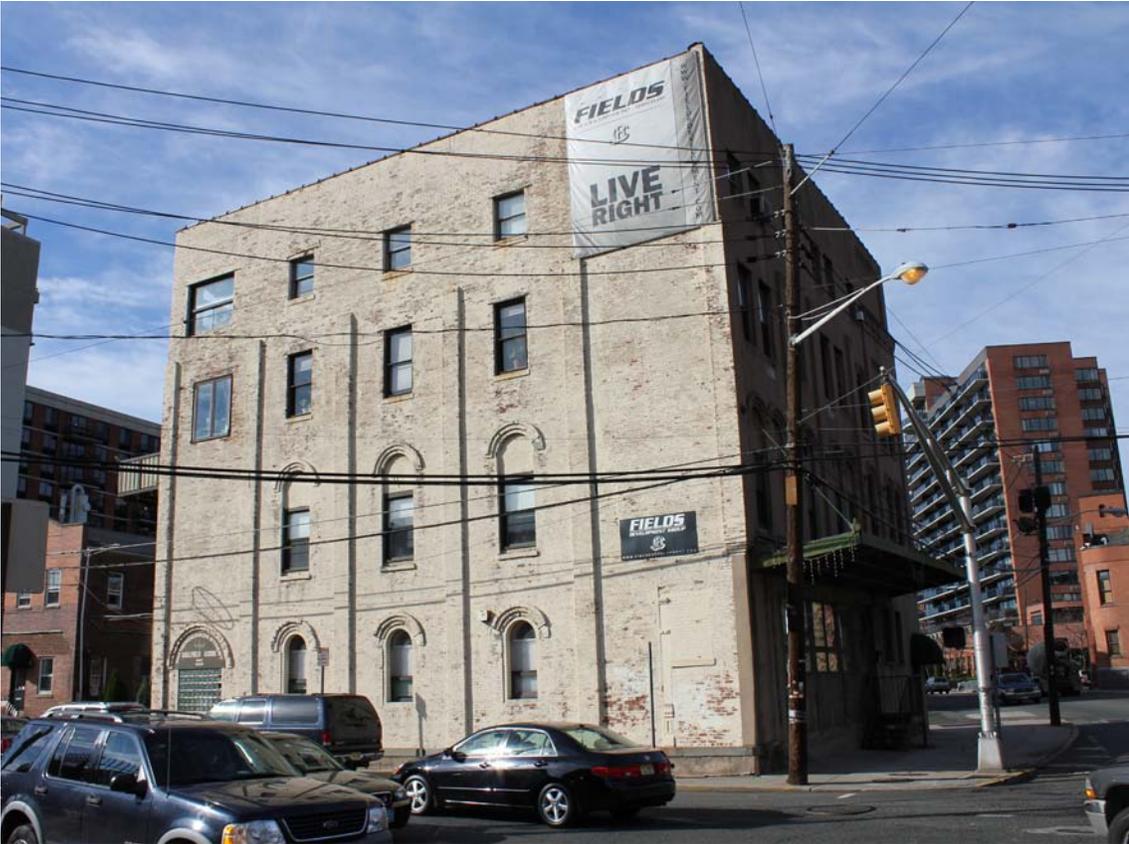
PROPERTY 13

The site contains a four-story commercial building and surface parking lot at the intersection of Newark Street, Henderson Street and Observer Highway. It houses a real estate development and construction company (Fields), which is a permitted office use in the I-2 zone district. The building sits on an irregularly shaped lot, which it nearly occupies fully.

The building represents a thoughtful adaptive reuse of a former industrial building. The exterior walls are brick that have been partially painted and parged. The masonry is in fair condition. There is also a metal awning along Henderson Street. The interior of the building has been renovated and is in excellent condition.

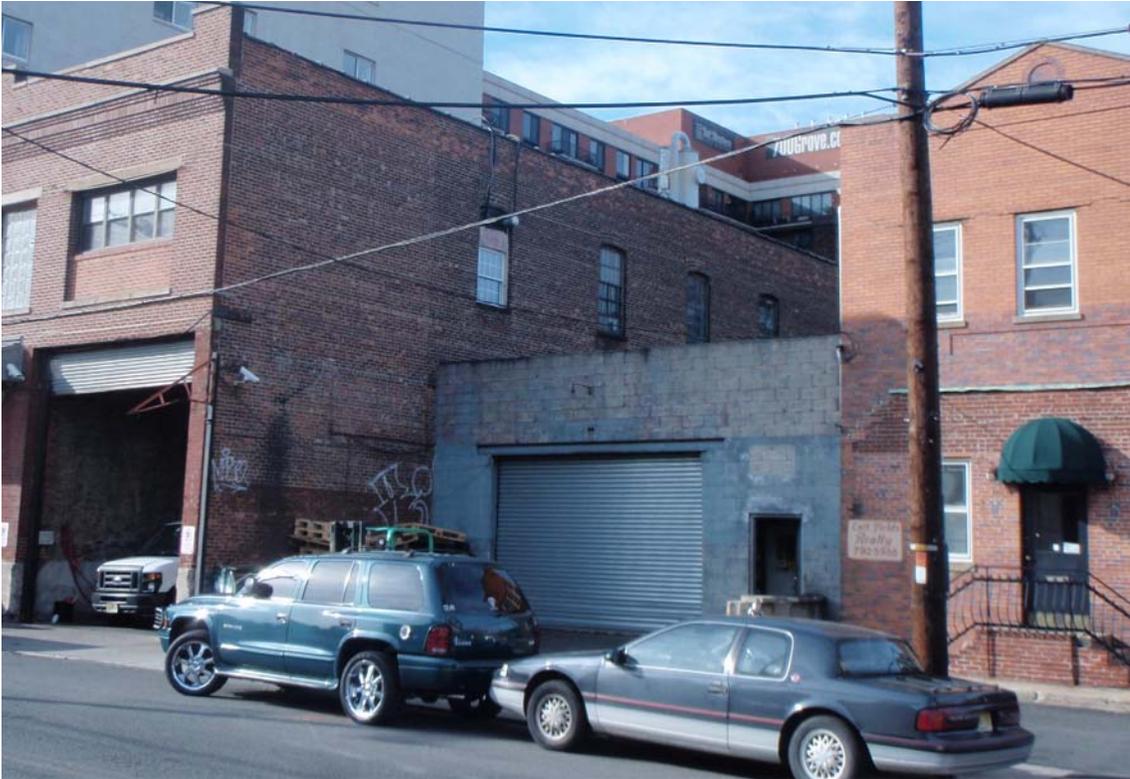
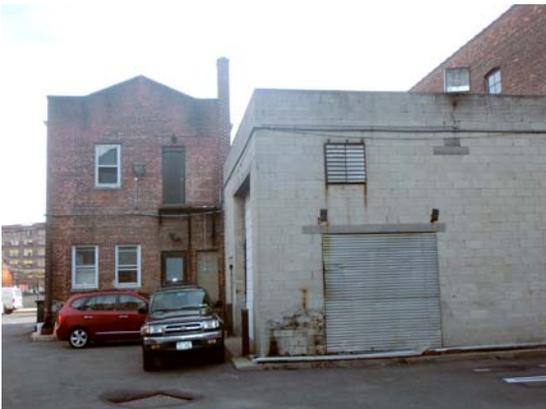
PROPERTY 14

This irregularly shaped lot (approximately a triangle) fronts onto Henderson Street and provides access to several lots and parking lots that front onto Newark Street. It is .26 acres. The lot contains several structures, including a two story brick structure and a one story concrete block structure. The brick structure has most recently been used as an office, although vacant as of the writing of this report. The one story concrete block building is without windows and has a loading dock and a steel entry door facing Henderson Street. It is used as accessory storage. As an accessory storage building, the lack of windows do not negatively impact the working conditions created by the building. The building uses are permitted in the I-2 district.

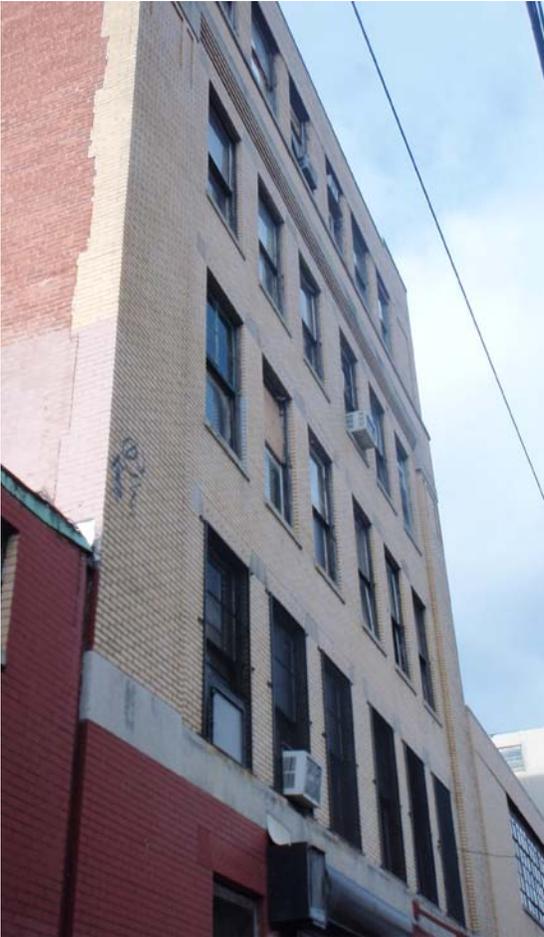
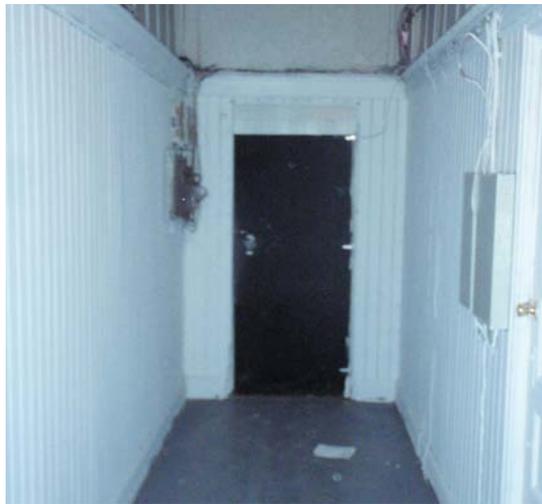
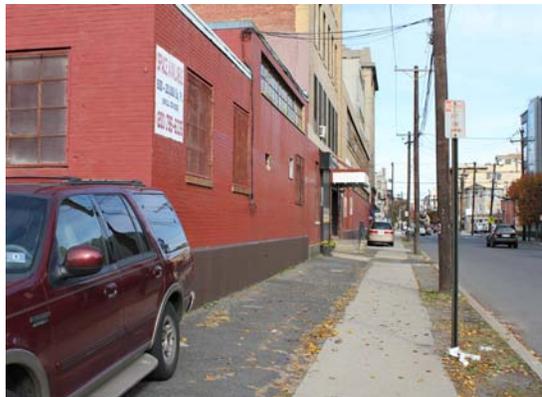
PROPERTY 19

This building, likely dating from the 1930's, faces Jackson Street. It is five stories with a tan brick exterior. The interior is accessed by an enclosed stair and non-working elevator. The building is partially occupied with small commercial tenants occupying each floor or a portion of a floor. The existing retail goods and service uses are permitted in the zone district. The overall structure appears to be in fair to good condition, although the interior is in poor shape with peeling paint, and ad hoc space configuration, etc. The building occupies the entire

lot. There is no on-site parking to serve the building. Loading and parking occur within the public right-of-way. It is partially occupied by permitted retail businesses.

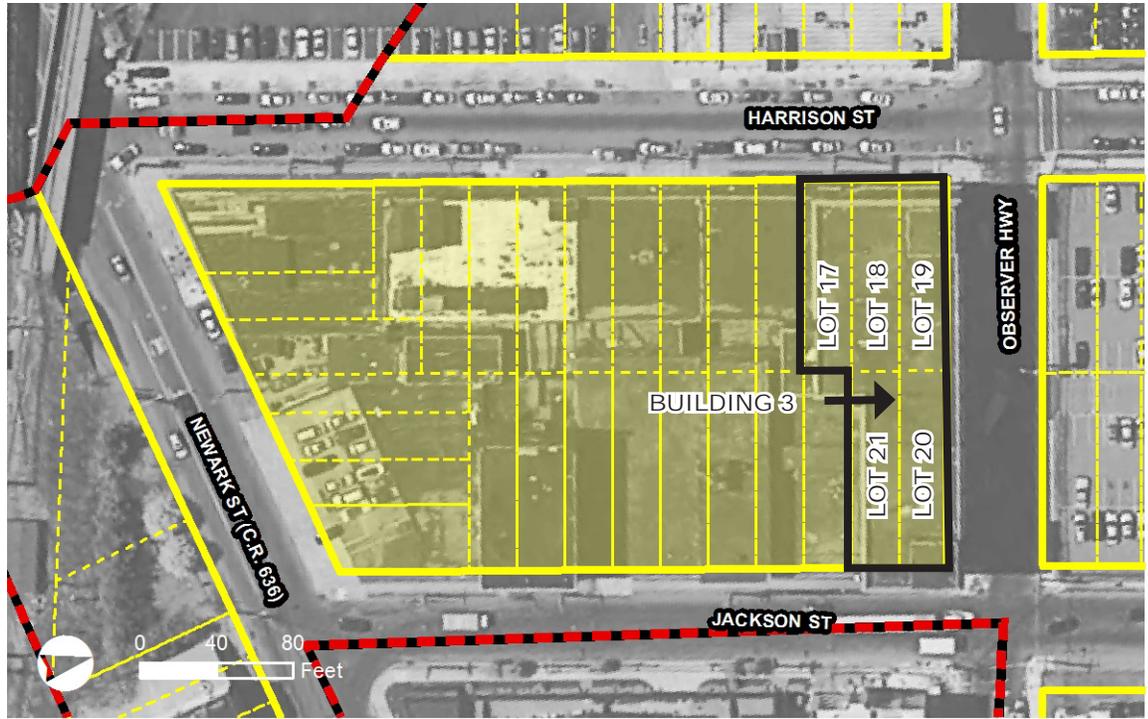
BUILDING 3: LOTS 17 THROUGH 21

The exterior of the building is in fair to poor condition. There is spalling of the concrete at most of the windows. The windows themselves are in poor condition; most are not operable and are leaky.

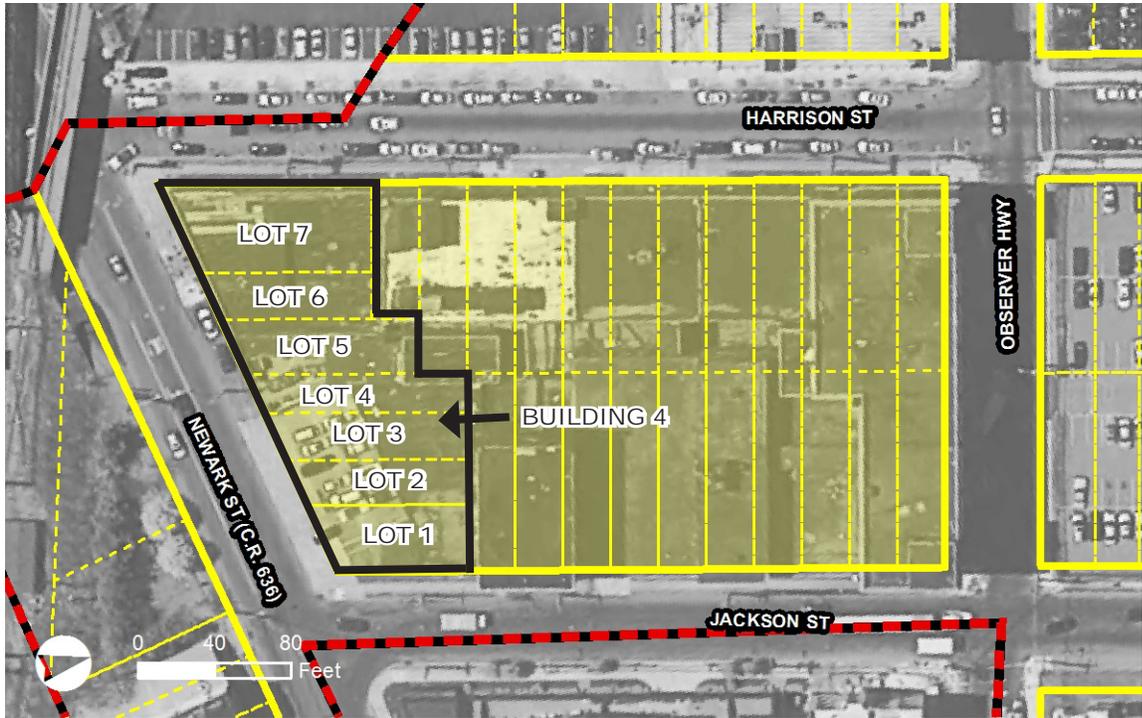
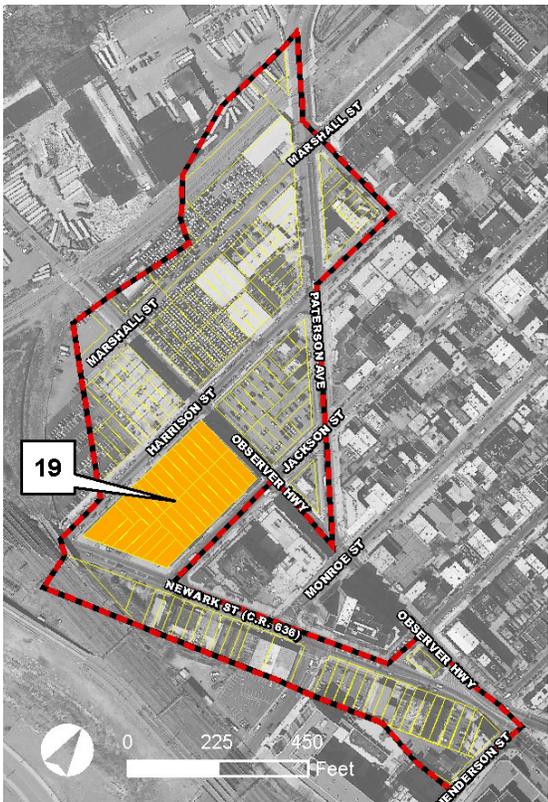
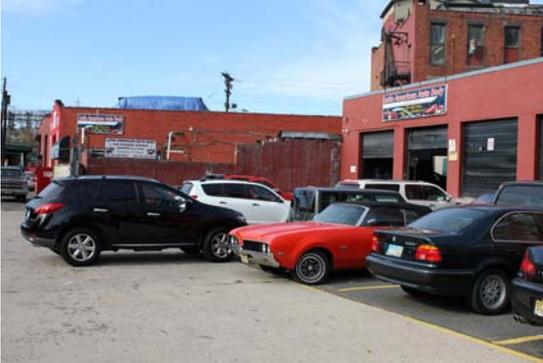
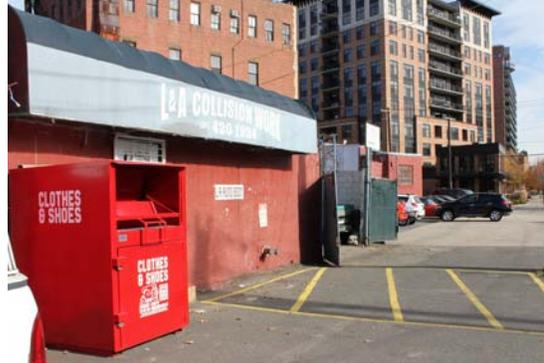
PROPERTY 19

Fronting on Newark Street at the southwestern gateway from Jersey City, this is a series of one-story buildings that are physically connected to the other buildings on the block and owned by the same entity (the building on Lot 5 extends into Lots 9 and 10). The structures are occupied by auto repair contracting, building contractor management and metal working businesses, which are permitted in the I-2 district. Although unattractive, the structures are in fair to good condition, structurally. These are active businesses with parking, loading and access directly from Newark Street. The building configurations and locations appear to be consistent with many of the industrial buildings in the district.

- The Property has an obsolete and faulty design and arrangement that is potentially detrimental to the health, safety and welfare of the community. The conditions (as manifested in parked cars, equipment, fencing and buildings) are overcrowded. The building's relationship to Newark Street creates a chaotic space where vehicles and pedestrians must jockey with each other. There is no formal parking arrangement. Parking of vehicles encroaches into the right-of-way of Newark Street. Maneuvering of vehicles within Newark Avenue, including backing into the road, is necessary. Access to the garage bays are blocked by vehicles. There is no clear delineation of a public sidewalk at the edge of Paterson Avenue, just a full width, undifferentiated apron. There is no delineated sidewalk on the lot to convey pedestrians safely to the building entrance. These conditions create the potential for conflicts between vehicles and vehicles, both on-site and between the site and Newark Avenue. It also creates potential hazards for pedestrians. These conditions are exacerbated by the traffic volume of over 1,810 vehicles traveling past the property along Newark Street during the AM peak hour and over 1,940 vehicles during the PM peak hour; these figures can be compared to the over 620 vehicles traveling along Jackson between Newark Street and Observer Highway during the AM peak hour and over 980 vehicles during the PM peak hour (*Jersey City / Hoboken Connectivity Study, June 2011*). Additionally, the need to address the vehicle congestion and pedestrian safety in this area is evidenced by proposal to realign the vehicle lanes of this section of Newark Street and the addition of traffic signals at Newark Street's intersections with Jackson Street and Harrison Street.

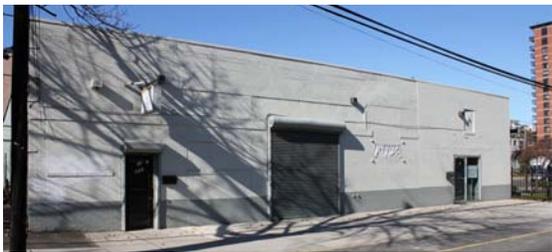
This 0.16 acre property contains a one-story masonry building that is in fair to good shape. A single tenant business office was observed, but the remaining building may be vacant. It appears to have been used as a church and for retail in the past. The uses, with the exception of the church, are permitted in the I-2 zone district.

This property should not be included within an area in need of redevelopment.

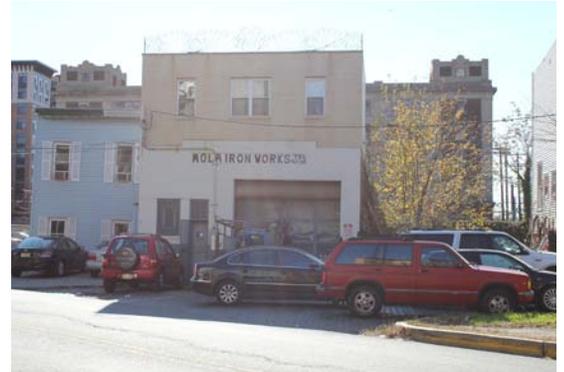
PROPERTY 26

- The Property has an obsolete and faulty design and arrangement that is potentially detrimental to the health, safety and welfare of the community. The conditions (as manifested in parked cars and equipment) are overcrowded. The building's relationship to Paterson Avenue creates a chaotic space where vehicles and pedestrians must jockey with each other. There is no formal parking arrangement. Parking of vehicles encroaches into the right-of-way of Paterson Avenue. Maneuvering of vehicles within Paterson Avenue, including backing into the road, is necessary. Access to the garage bay is blocked by equipment and vehicles. There is no clear delineation of a public sidewalk at the edge of Paterson Avenue, just a full width, undifferentiated apron. There is no delineated sidewalk on the lot to convey pedestrians safely to the building entrance. These conditions create the potential for conflicts between vehicles and vehicles, both on-site and between the site and Paterson Avenue. It also creates potential hazards for pedestrians. These conditions are exacerbated by the traffic volume along Paterson Avenue which is nearly 650 vehicles in the AM peak hour and nearly 800 vehicles in the PM peak hour (*Jersey City / Hoboken Connectivity Study, June 2011*). The need to address traffic congestion and pedestrian safety concerns is evidenced by the proposal to convert this section of Paterson Avenue to one-way (*Jersey City / Hoboken Connectivity Study, June 2011*).

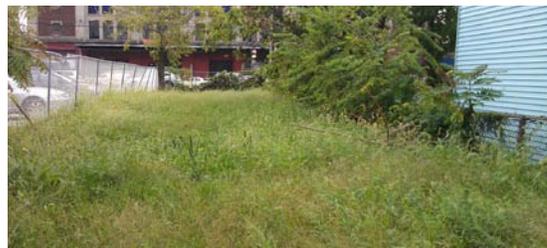
This 0.08 acre property is vacant with no improvements. It has frontage on Paterson Avenue. It is owned by the same entity as the adjacent parking lot but has not been incorporated, presumably, since it would require a revised parking layout.

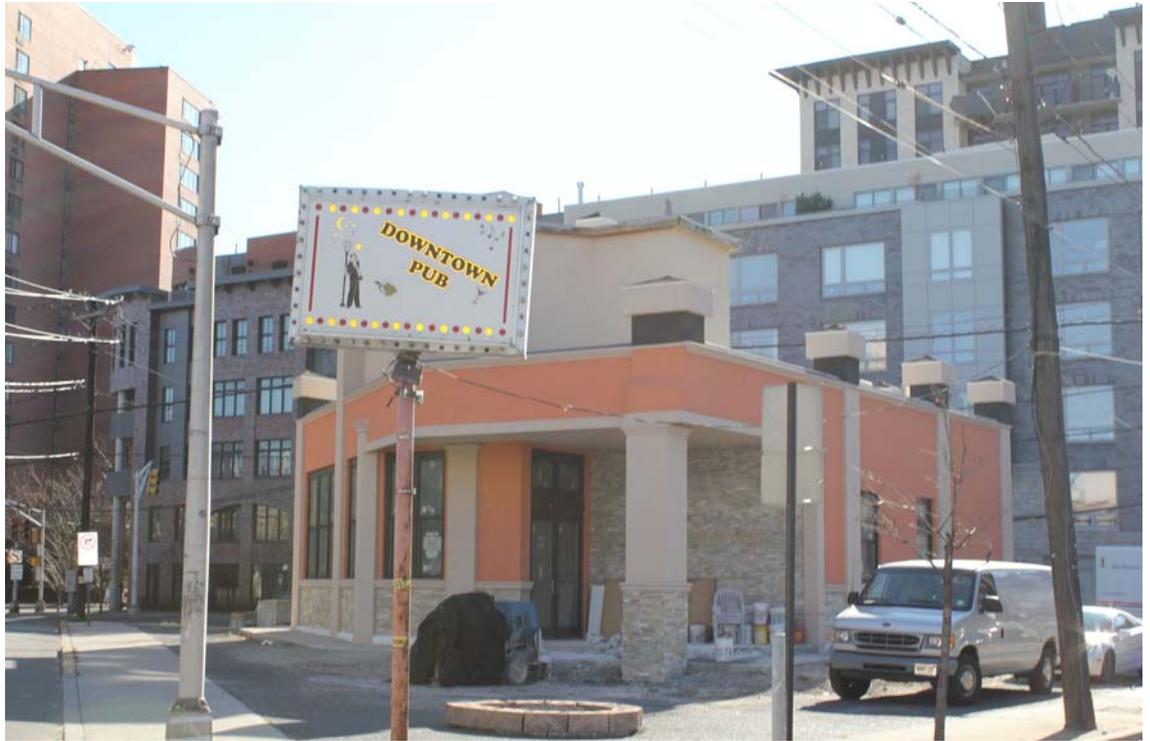
PROPERTY 30

This 0.08 acre property is an awkward, triangular lot at the intersection of three major streets. The Downtown Pub, a refurbished restaurant/bar sits on the site. Although it may represent an under-utilization of urban space and its layout is somewhat unthoughtful, the property does not satisfy the criteria for a determination that it is an area in need of redevelopment.

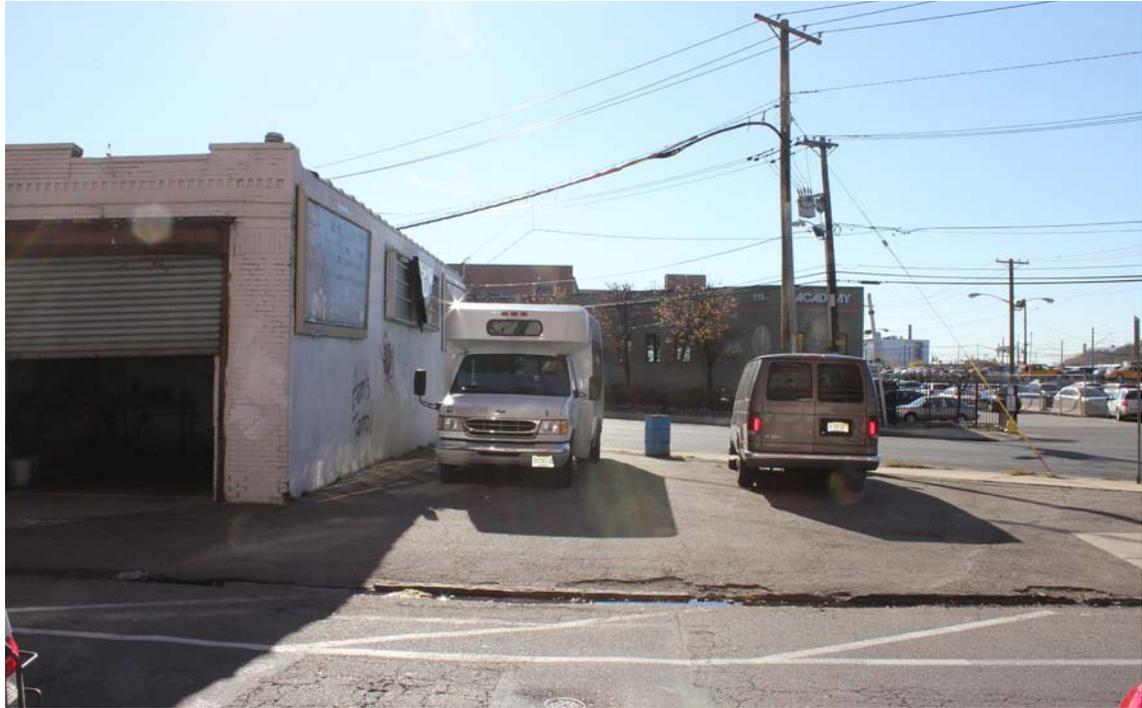
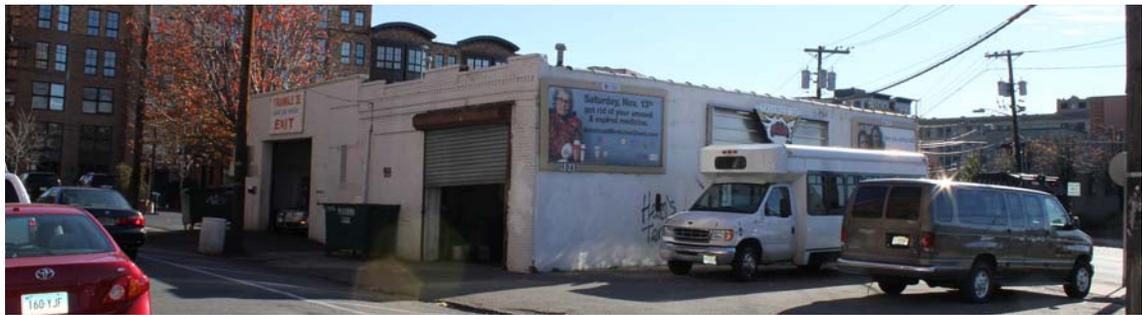
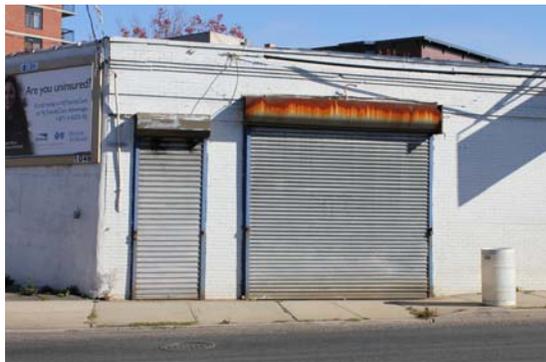
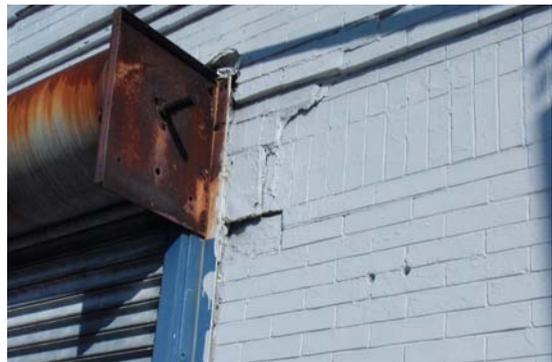
PROPERTY 33

- The building is dilapidated. The exterior walls are in poor condition, displaying cracking and bowing which is indicative of structural movement. The buildings are in poor condition, with graffiti on the exterior and rust evident on the exterior doors. Since the building has not been maintained, it has the potential to jeopardize public health and safety. The building is located along a busy street that is a main access to Hoboken. The dilapidation of this prominent building will continue to have a negative effect on the well being of the community.
