SOUTHWEST AREA REDEVELOPMENT STUDY

January 5, 2012

**Preliminary Investigation for a Determination of
Area in Need of Redevelopment and Area in Need
of Rehabilitation Designations for the
Southwest Area of the City of Hoboken**

In Accordance with the Local Redevelopment & Housing Law
(N.J.S.A. 40A:12A-1 et seq.)

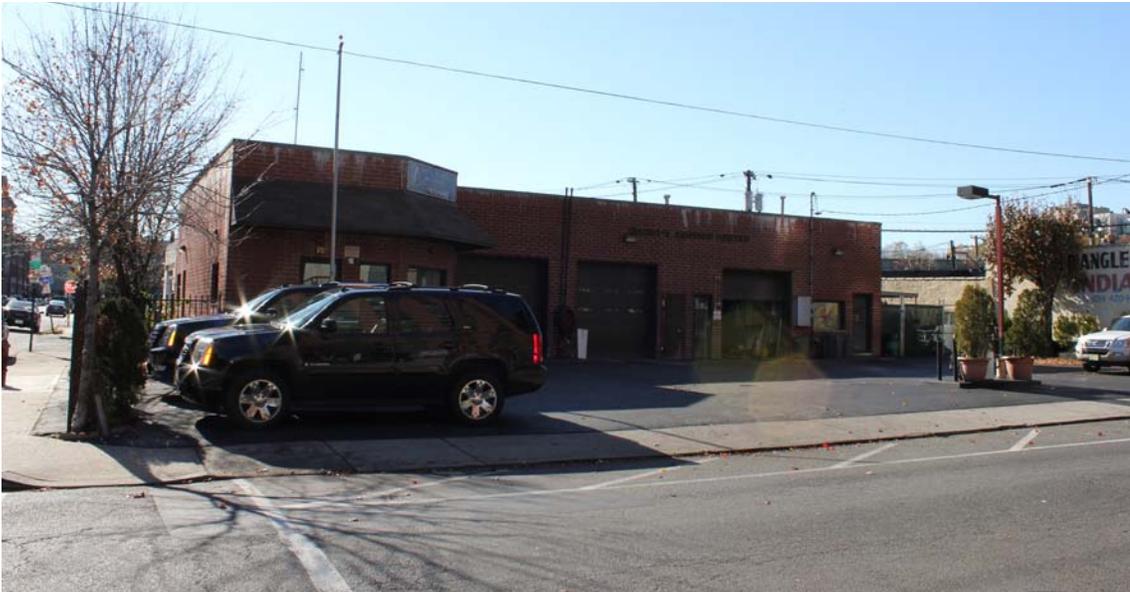
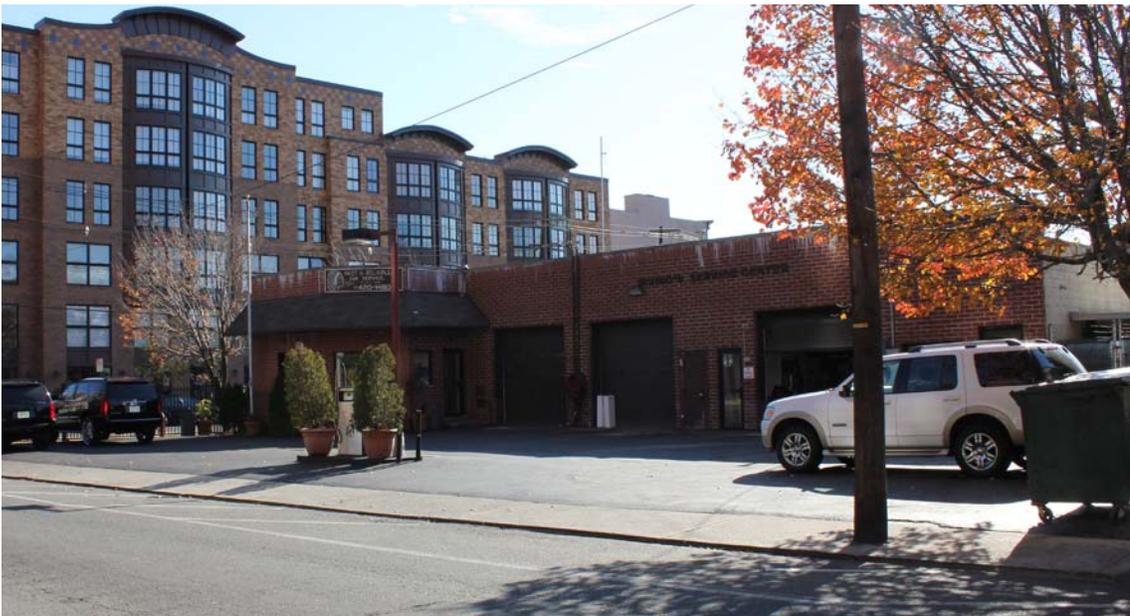
PROPERTY 34

- The property does not meet the redevelopment criteria.

RECOMMENDATION

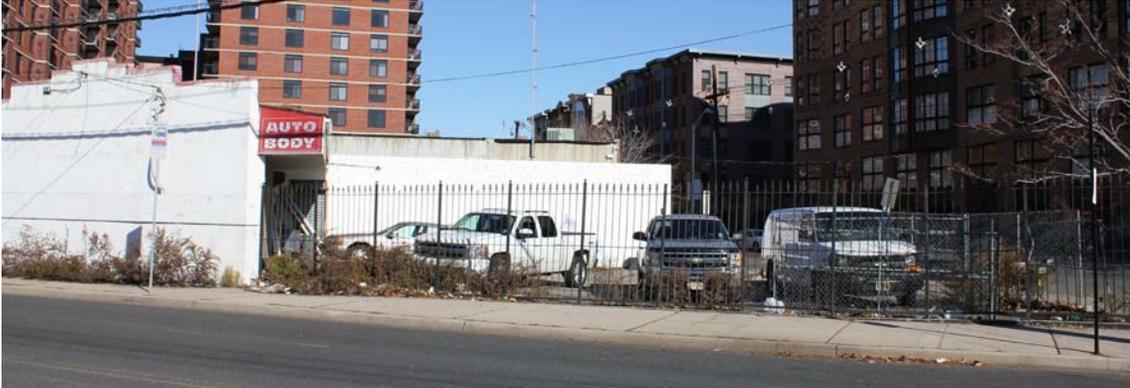
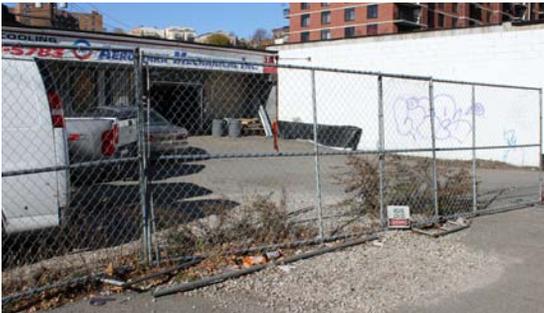
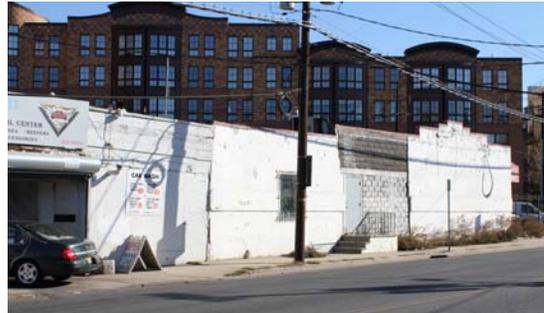
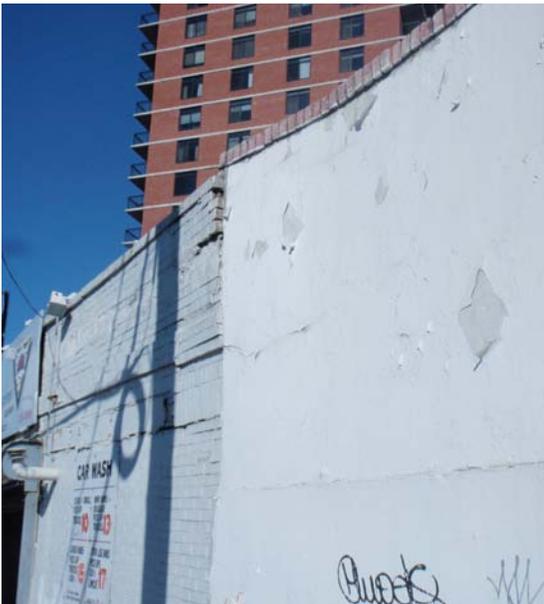
PROPERTY 35

This property is 0.14 acres and sits at the north-west corner of the intersection of Harrison Street and Paterson Avenue. The site is an irregular, triangular shape. The lot contains a group of one story masonry buildings that are used by an HVAC contractor. The condition of the structures range from poor to fair. The building is dilapidated with the exterior walls displaying cracking and bowing which is indicative of structural movement. Graffiti is on the exterior of the building and rust is evident on the exterior doors. Some on-site surface parking is located on this property also. The site is bounded by a combination of permanent metal picket fencing and temporary chain link fencing. Some granular surface is used for pavement rather than asphalt. It is, visually, extremely unkempt. The use is prohibited in the R-3 zone district. Three crimes consisting of larceny/theft, burglary and aggravated assault were reported on this property between January 2006 and May 2008.

- This property is in close proximity to the recent residential buildings and is within the R-3 district. It exhibits dilapidation which creates a negative influence over the public health, safety and welfare of the community, particularly given the property's residential zoning and adjacency to residential development. The building is dilapidated with the exterior walls displaying cracking and bowing which is indicative of structural movement. Graffiti is on the exterior of the building and rust is evident on the exterior doors. Criminal reports for this property reinforce the negative influence that this building and site conditions have manifested. The disrepair of the building and unkempt nature of the lot invite criminal activity, such as but not limited to graffiti. The disrepair of this prominent building will continue to have a negative influence on the residential community adjacent to the property.

RECOMMENDATION

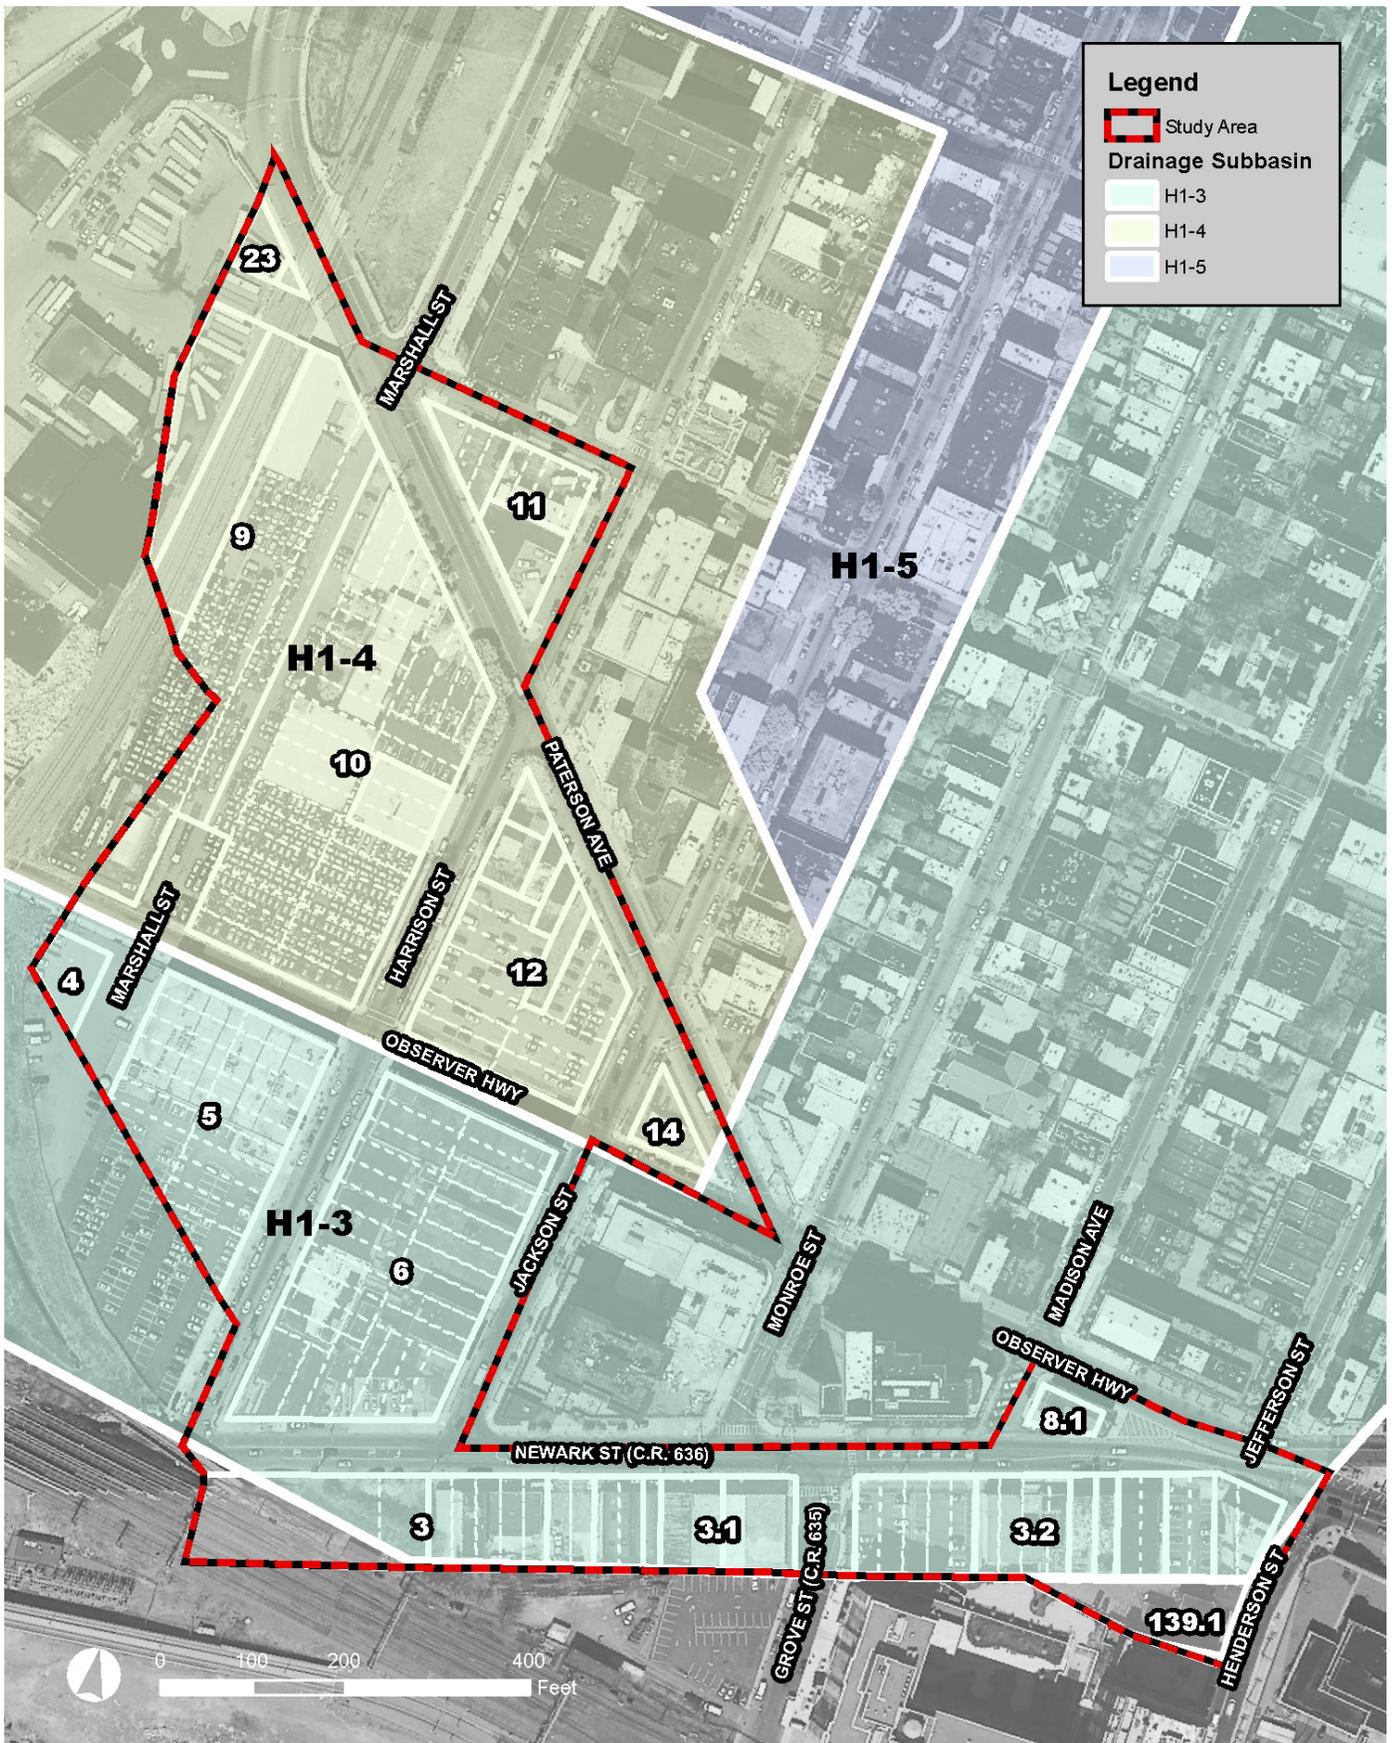
Flood Areas

The flooding in this area occurs because the roadway centerline elevations are below the hydraulic grade lines in the sewer during a 3-year (month) storm event that is coincident with the high tide. For example, the centerline elevations along Marshall Street and Harrison Street between 1st Street and 2nd Street range from 2.0 to 3.4 feet. The model results
