May 31, 2011

**Re: Sovereign at Shipyard – Response to Boswell Underwater Engineering Draft Report
Hoboken, NJ**

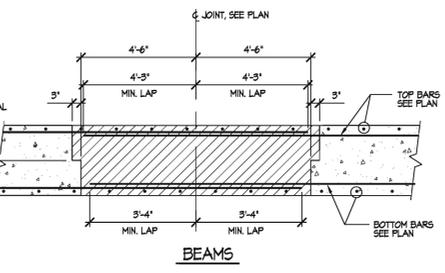
5 TYPICAL FOUR STRIP DETAILS
NT.S.
NOTE: HATCHED AREAS INDICATE CONCRETE TO BE CAST 28 DAYS AFTER LAST ADJACENT SECTION HAS BEEN CAST. ADEQUATE SUPPORTS SHALL BE PROVIDED FOR SLABS AND BEAMS ADJACENT TO THE SHRINKAGE JOINT UNTIL THE WHOLE BAY IS CAST AND ATTAINS 75% OF ITS DESIGN STRENGTH.

Pictures 6.11 through 6.15 in Boswell’s report depict settlement of the fill above the existing platform (below the building structural slab) as well as rigid insulation delaminating from the underside of the slab. The condition revealed in these photographs does not, however, raise any structural concerns. The ground floor slab of the Sovereign building is a reinforced concrete slab which was designed to span between pile caps (reference drawings S-101 and S-301, attached). The insulation served simply as formwork to support the wet concrete when the slab was poured. Structurally this slab behaves just as the upper floor slabs do in as much as the formwork is only required until the concrete has cured sufficiently to reach adequate strength to span between permanent supports.

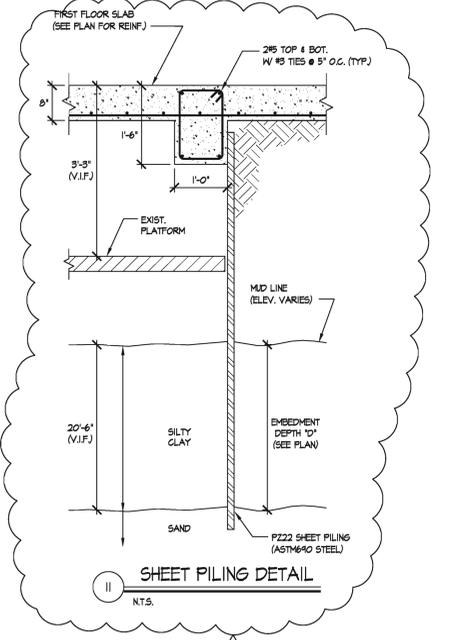
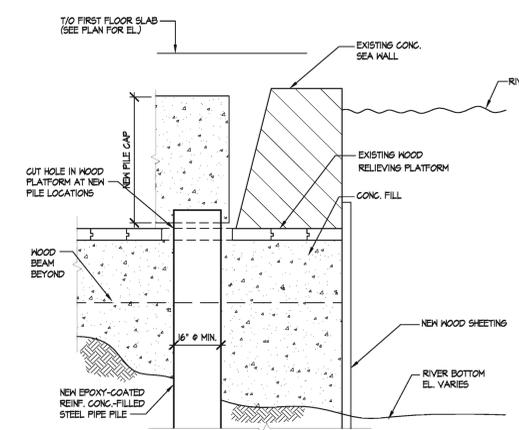
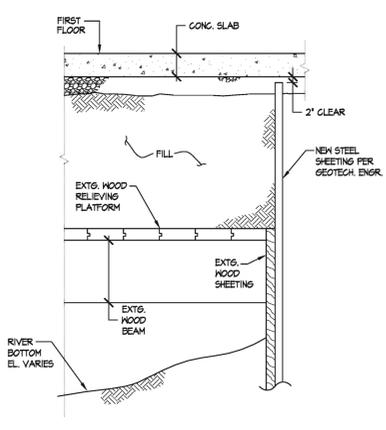
No bulkhead wall was encountered at the north-east corner of the building during the inspection because it is located on the land side of the wood platform supporting the existing sea wall. A new bulkhead wall was installed in the form of corrugated steel sheet piles which were driven inland of the existing wood platform to retain the soil beneath the remainder of the building (reference plans on S-100 and S-300 and details 6, 7A, and 7B on drawing S-100, attached).
