HOBOKEN PRIVATELY-OWNED WATERFRONT STRUCTURES INSPECTION

File No. BUE-1010

BOSWELL UNDERWATER ENGINEERING

June 2011

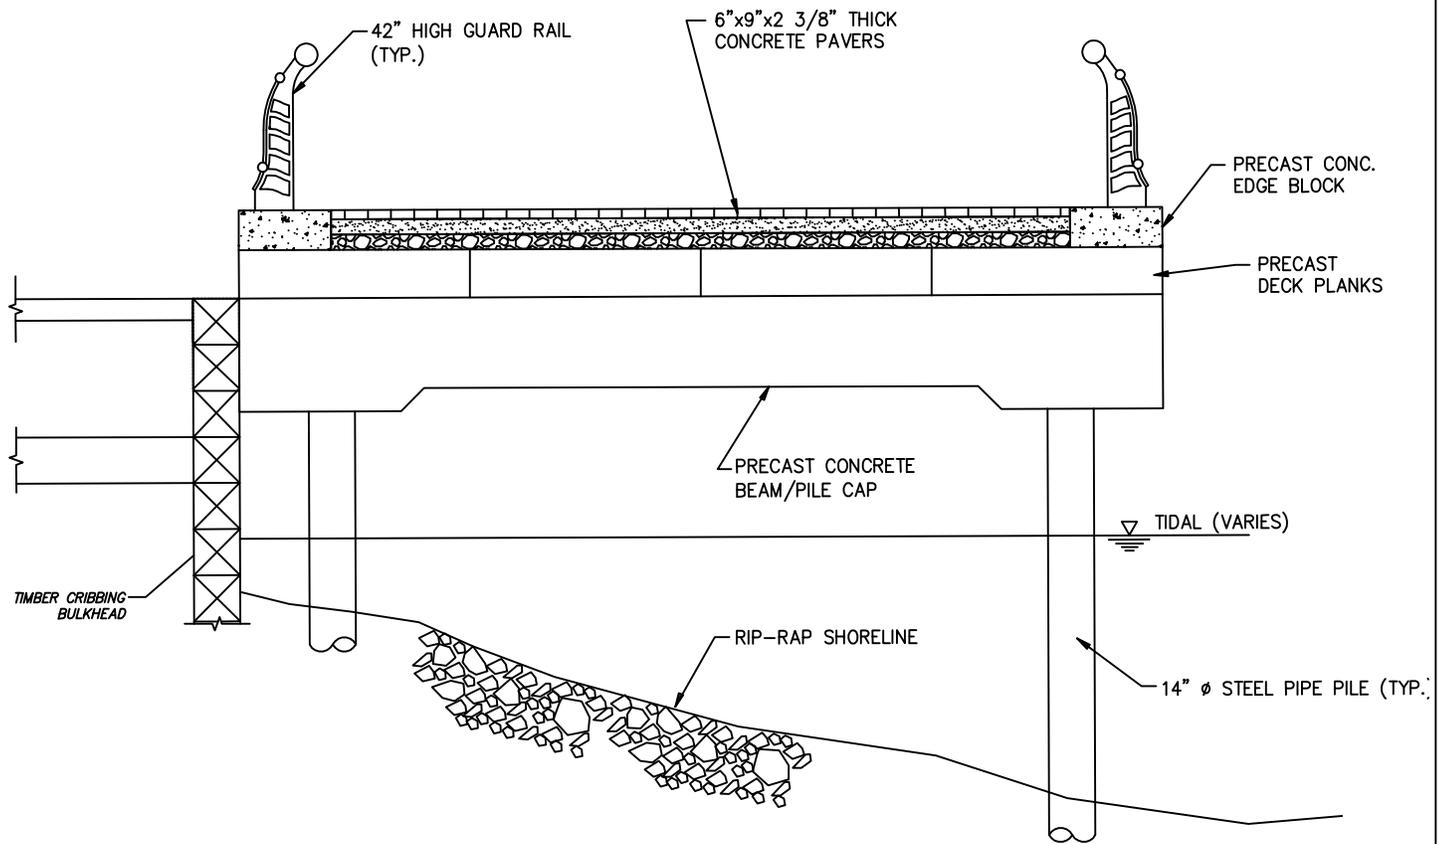
VOIDS BENEATH
CONCRETE CAP

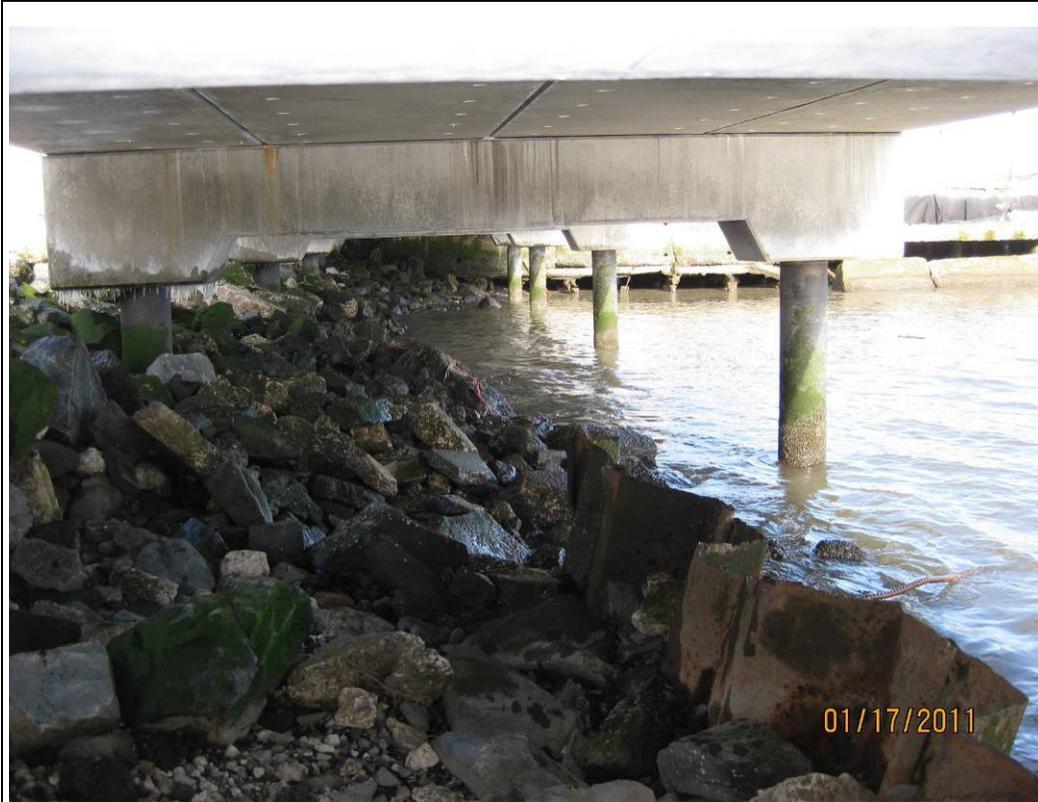
Photo No. 2.5

The general condition of the concrete pile caps is good (Photo No. 2.5). The installation of the deck planks at the south end of the pier was not complete at the time of this inspection. The installed deck planks, however, are in good condition.

General view

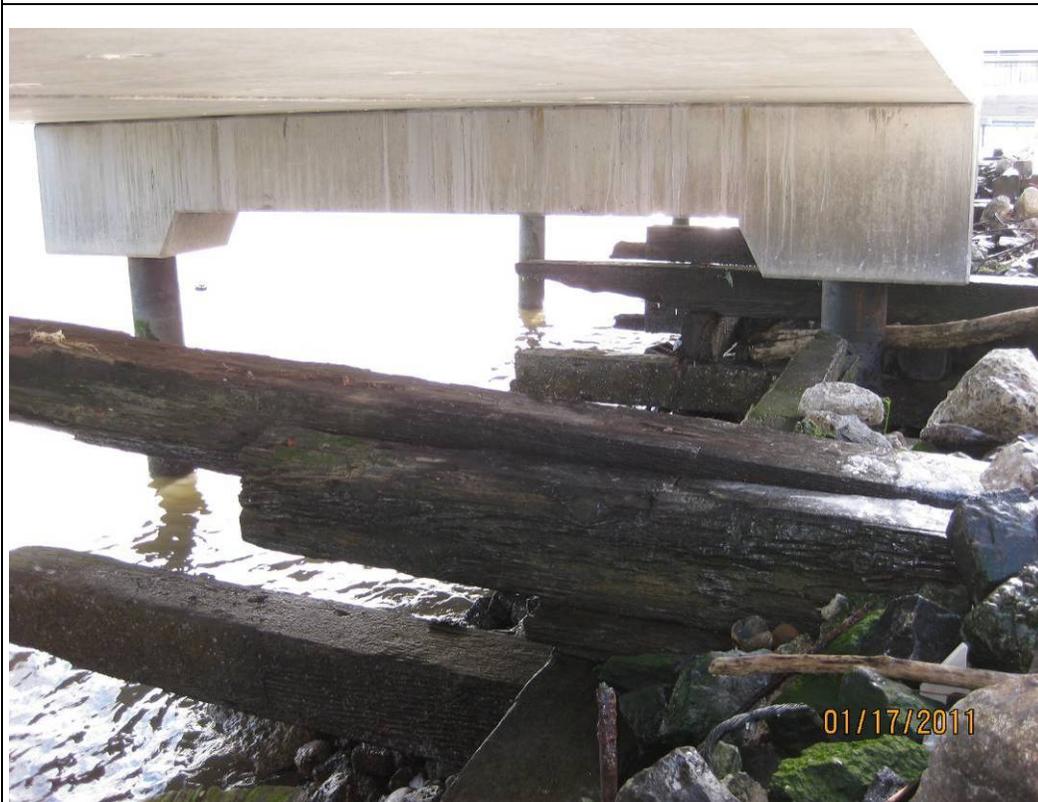
Photo No. 2.6

Timber cribbing partially removed for pile installation

- No access should be permitted to the pier until repairs are made at both the north and south approaches (Castle Point Park and Frank Sinatra Park) and construction of the new pier is complete, inclusive of all deck planks, railings, and safety items.
- Repair/restore the timber cribbing and stabilize the shoreline where cribbing is deteriorated or has been partially demolished for installation of new pier pipe piles.

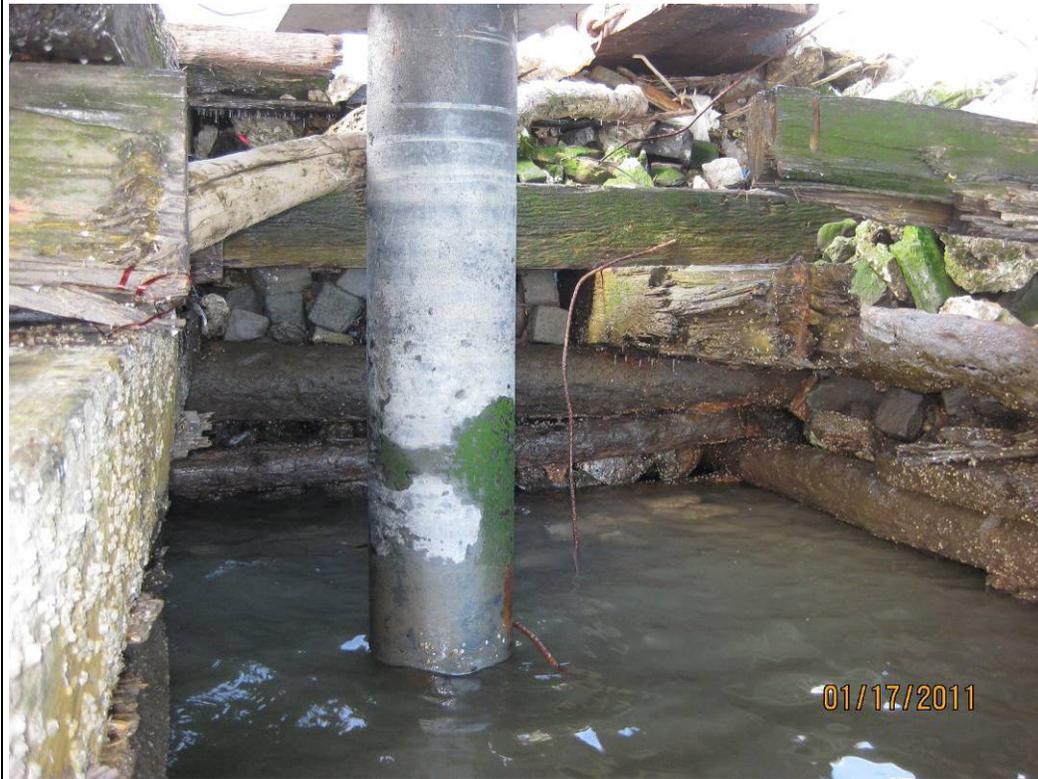
Photo No. 2.7

Gaps in remaining
cribbing, fill visible

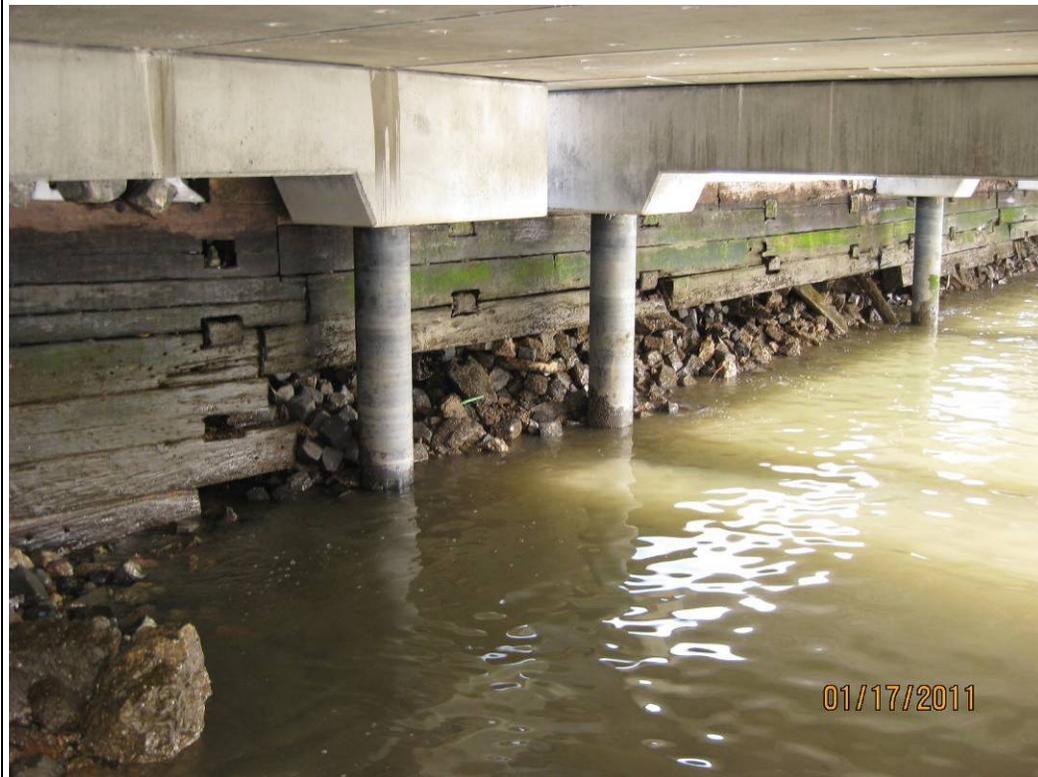
Photo No. 2.8

Additionally, the southern east-west oriented section of pier is directly adjacent to a timber cribbing bulkhead. The bottom of the timber cribbing has several missing timbers with evidence of loose and missing fill within the section of cribbing (Photo No. 2.8).

Deteriorated cribbing,
voids and loose fill
visible

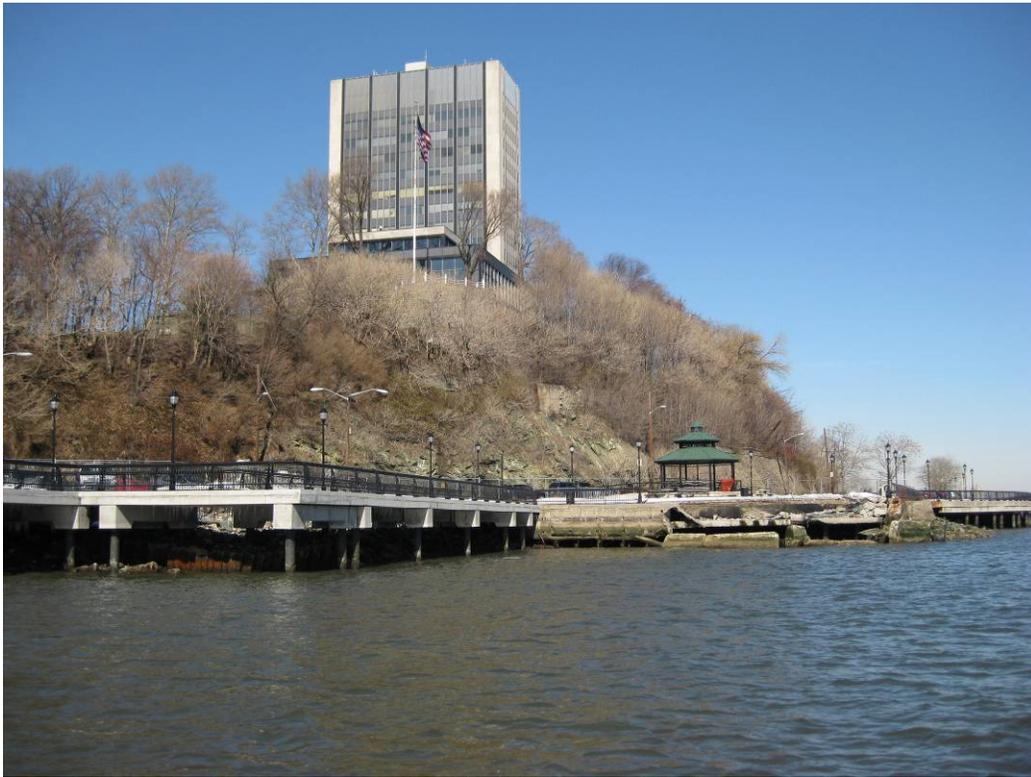
Photo No. 2.9

Partially collapsed

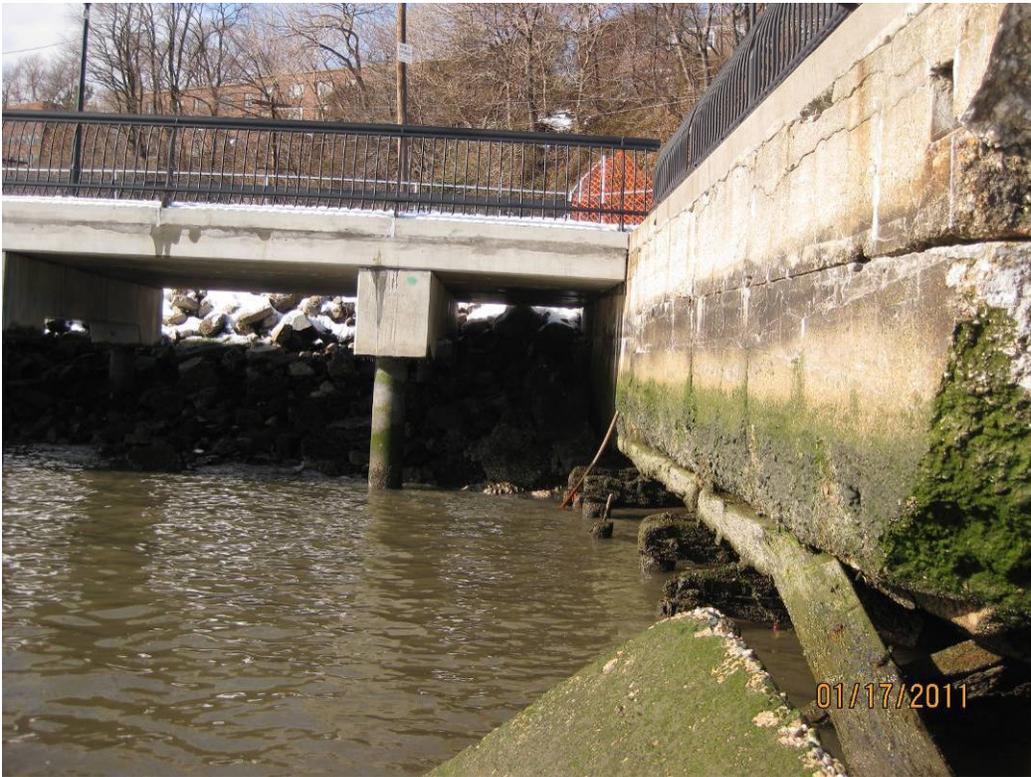
Photo No. 2.10

North deck plank
cantilever abuts Castle
Point seawall

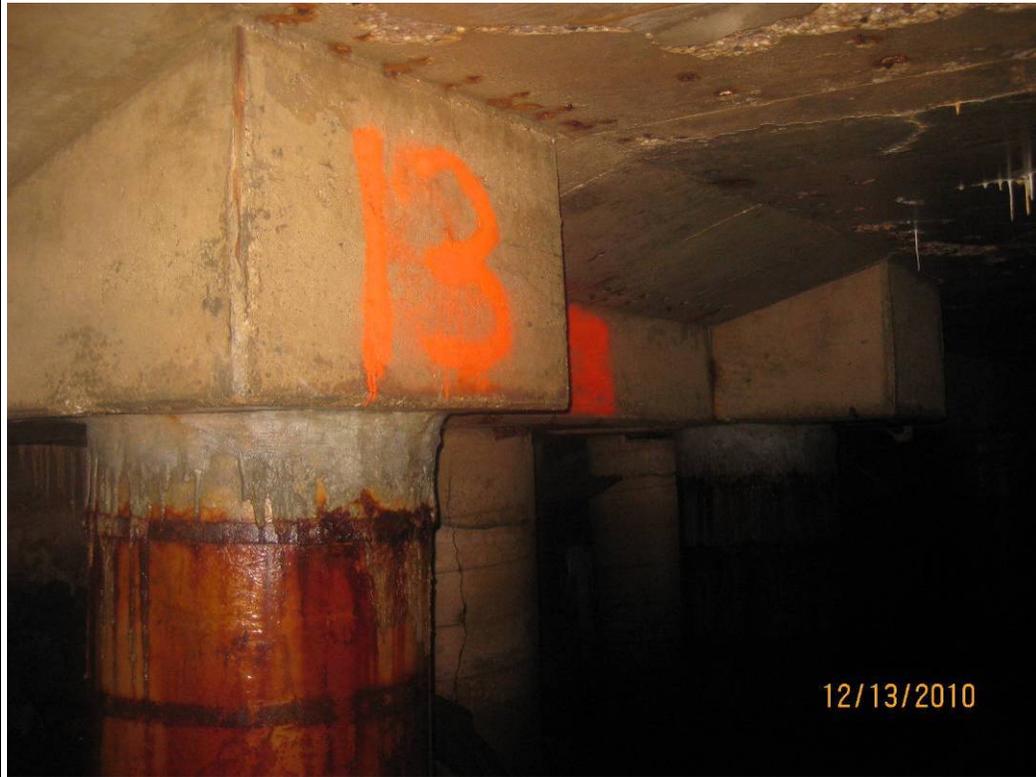
Photo No. 3.5

The condition of the concrete-encased steel H-piles that have been re-encased is generally good. At most locations, the fiberglass form used to construct the encasement repair has been left in place (Photo No. 3.5). There are three piles that show minor deterioration in the concrete jacket in the form of erosion of the concrete, exposing reinforcing steel, and at one location, Pile 14.2-C, the encased steel H-pile is exposed for a height of 0.5 ft near the mudline. However, there was no notable deterioration of the exposed length of pile. Additionally, minor voids in the concrete at the tops of some repairs were observed, but the voids were not deep enough to expose the steel H-pile (Photo No. 3.8).

Typical re-encased pile, fiberglass form left in place

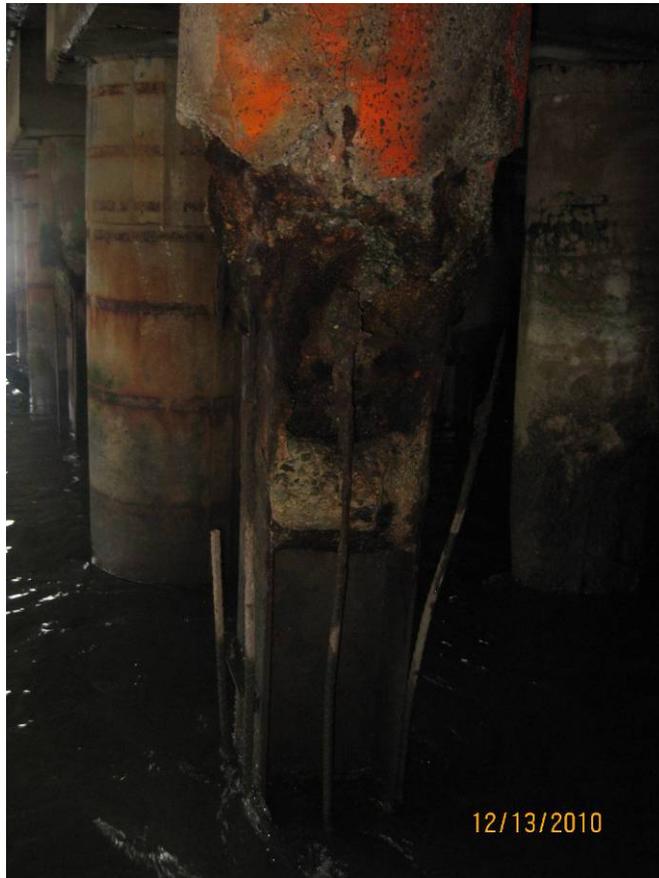
Photo No. 3.6

The piles that were not re-encased have been abandoned in place and are not required to support the structure for its current loading conditions. The abandoned piles typically have wide cracks of the existing concrete-encasement, heavy concrete erosion, and moderate to severe corrosion of the reinforcing steel within the encasement, where visible (Photo No. 3.7). At locations where the underlying steel H-pile is exposed at the abandoned piles, the steel typically shows minor to moderate corrosion (Photo No. 3.6). As the abandoned piles are no longer structurally significant, ultrasonic thickness measurements were not taken where exposed steel H-pile was observed.

Typical abandoned pile, severely deteriorated encasement, steel H-pile exposed

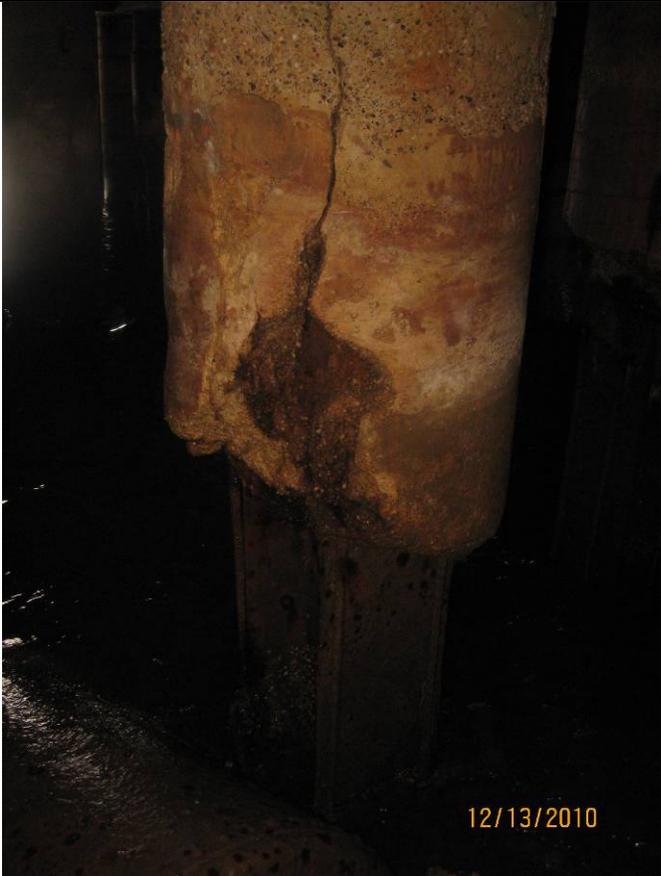
<p>12/13/2010</p>		<p>Photo No. 3.7</p> <p>Location: West Pier</p> <p>Description: Typical abandoned pile, wide crack in existing encasement</p>

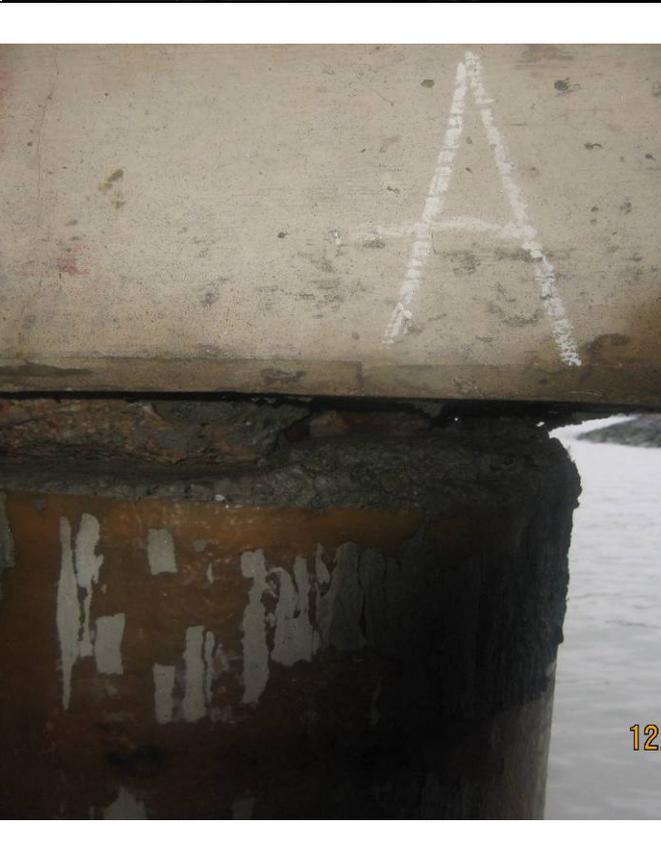
<p>12/13/2010</p>		<p>Photo No. 3.8</p> <p>Location: West Pier Pile 20A</p> <p>Description: Void at top of re-encasement</p>

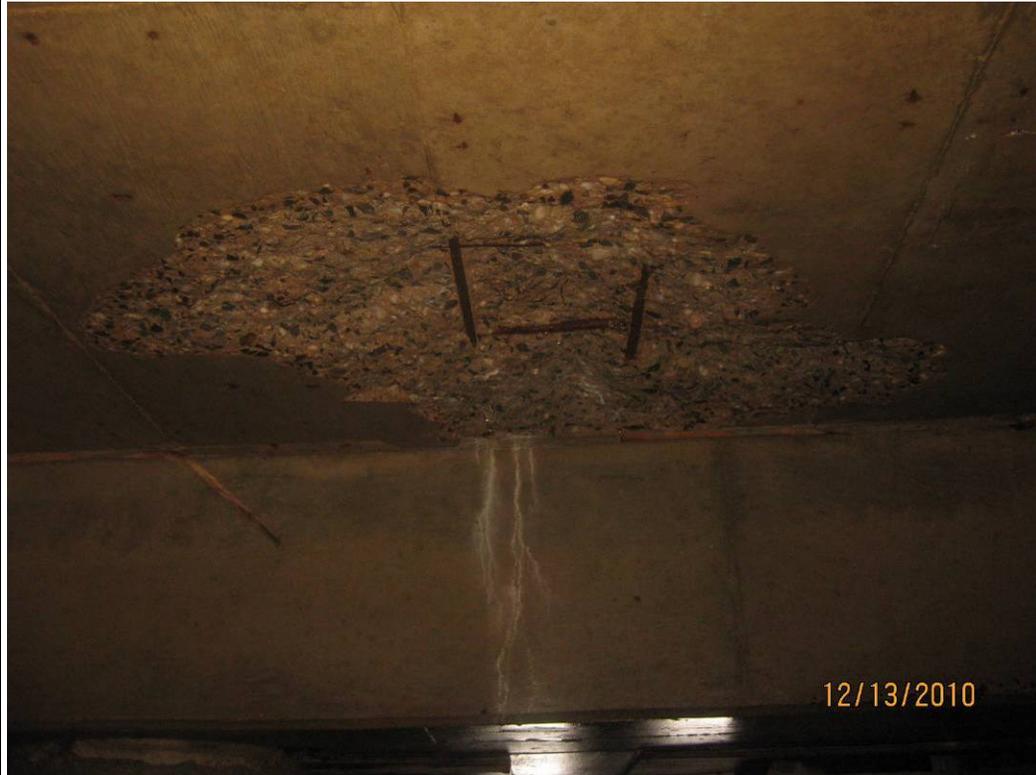
Photo No. 3.9

The condition of the concrete pile caps and underdeck is generally satisfactory, with fifteen (15) isolated areas of spalling found, totaling approximately 145 sf (Photo Nos. 3.9 and 3.10). Where the spalling was observed, the exposed reinforcement has minor to severe of corrosion. Additionally, there was one area found where partial timber formwork was left in place at the underdeck with spalling evident behind the formwork (Photo No. 3.11). The extent of the spalling at this location could not be determined as it was concealed by the remaining formwork.

Spall in underdeck,
exposed moderately
corroded reinforcing
steel

- West Pier – repair approximately 30 lf of exposed steel sheet pile bulkhead at the north end of the pier on a routine basis.
- West Pier – repair underdeck and pile cap spalls on a routine basis.

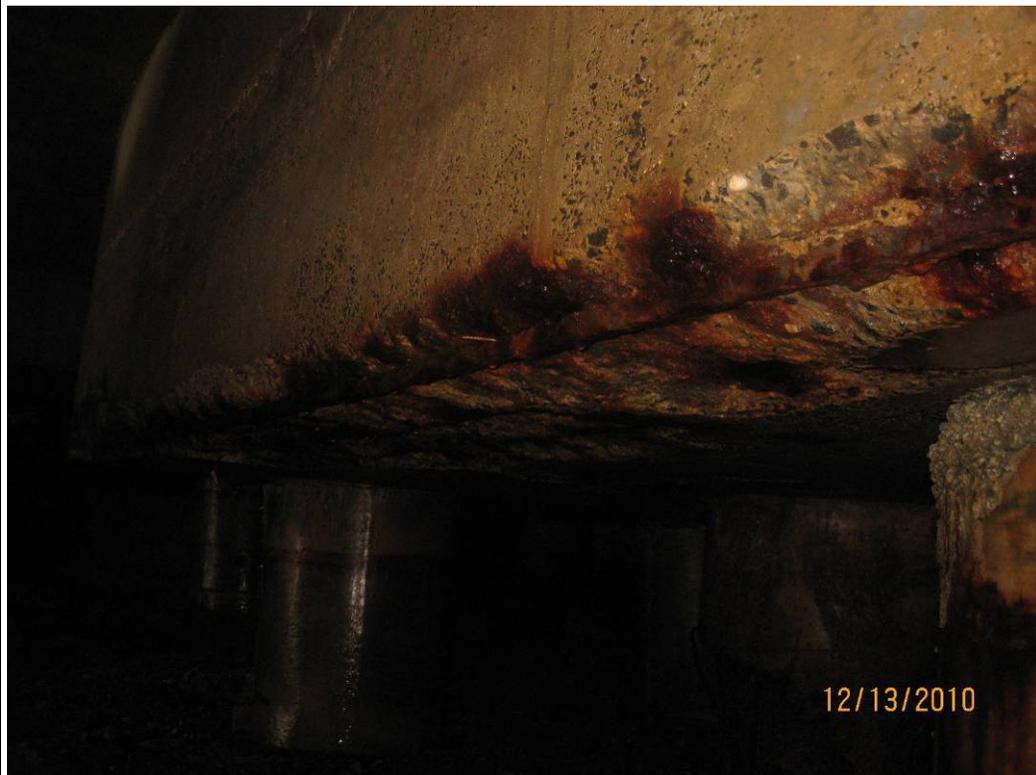
Photo No. 3.10

Spall at bottom of
beam with severely
corroded reinforcing
steel

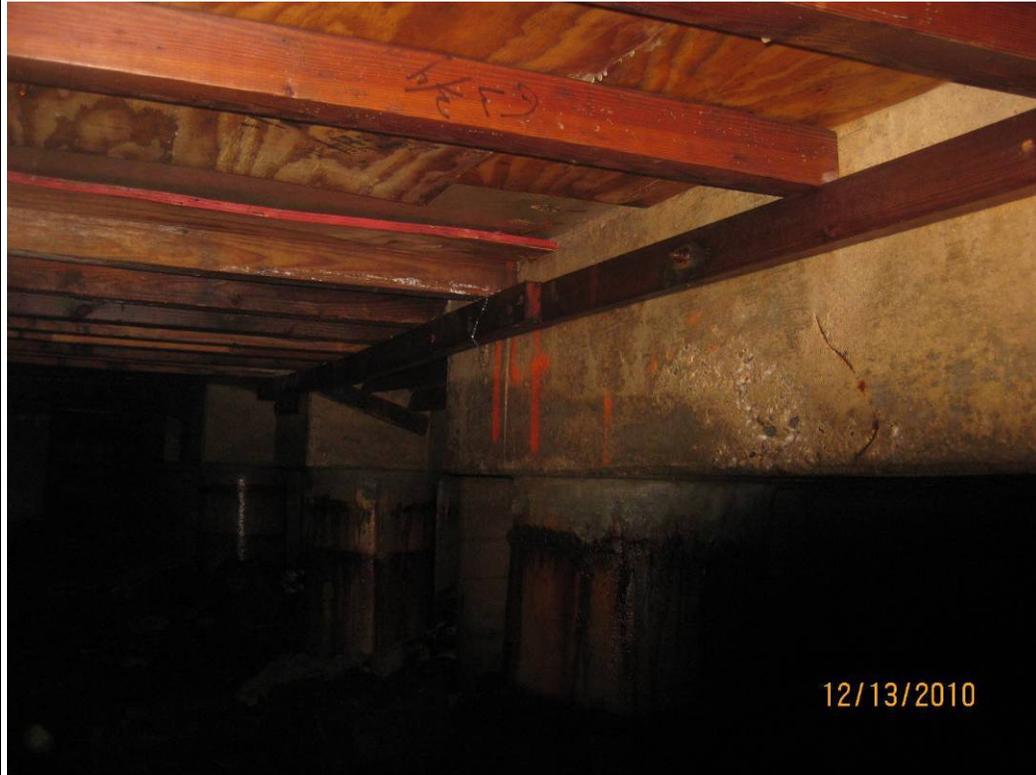
Photo No. 3.11

Underdeck repair
formwork left in place

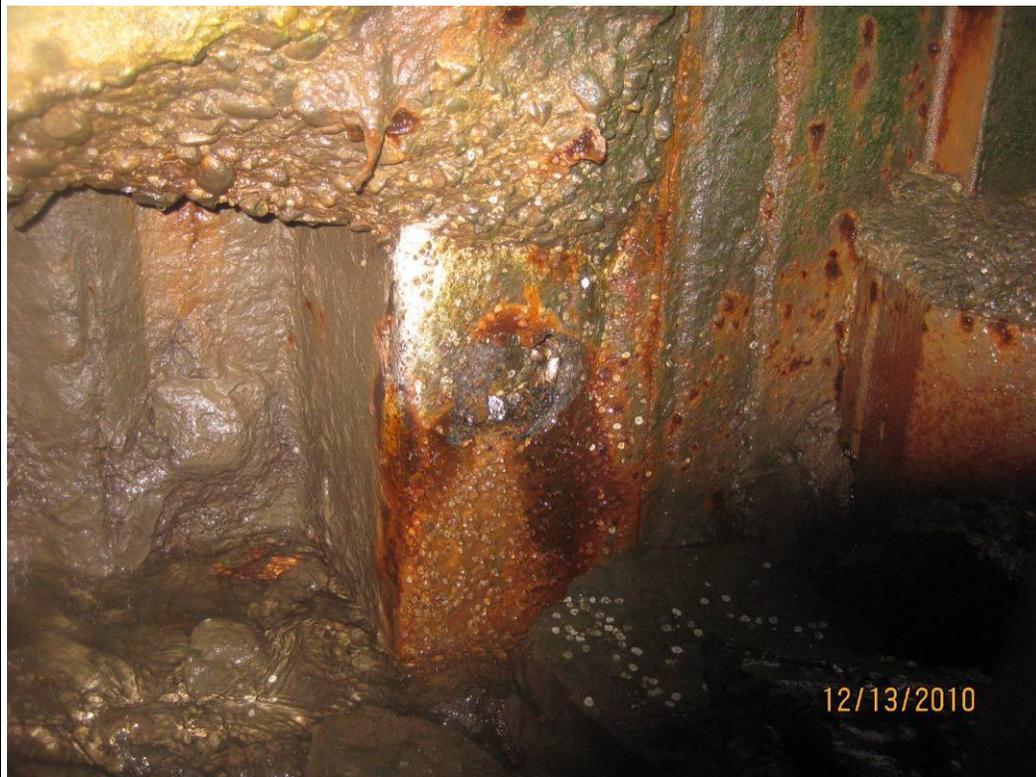
Photo No. 3.12

The concrete bulkhead located at the inland edge of the West Pier is generally in good condition. At the north end of the pier, a steel sheet pile bulkhead is exposed below the concrete bulkhead for a distance of roughly 30 ft and a maximum height of approximately 2 ft. A portion of the steel bulkhead is hidden by a horizontal timber, so that the entire steel bulkhead could not be inspected. The condition of the visible steel bulkhead is poor, showing severe corrosion and at least one through hole approximately 3 in. in diameter (Photo No. 3.12). Further deterioration of the bulkhead could allow the upland fill retained by the bulkhead to escape.

Steel sheeting below
concrete bulkhead,
hole in sheeting

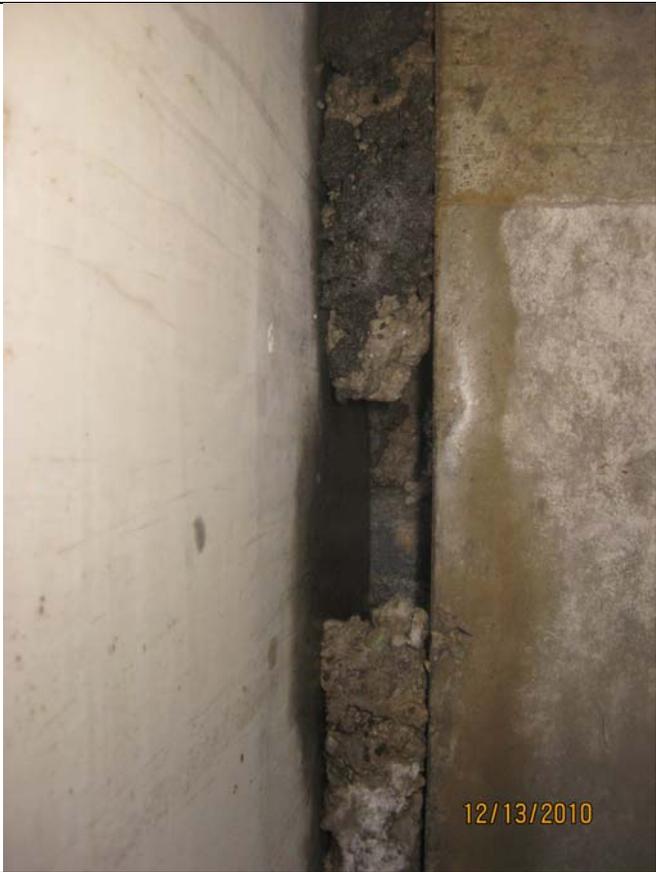
The overall condition of the North Pier is good with only minor deterioration noted. The concrete piles are generally in good condition with a few shallow spalls at isolated locations noted, typically less than 1 in. deep. One void was found at the pile cap grout socket at Pile 6B, measuring 12 in. wide and 6 in. deep (Photo No. 3.13). The condition of the pre-cast deck planks is good. A total of four spalls were found in the bottom of the deck planks, none of which contained exposed reinforcing steel (Photo No. 3.14). The steel sheet pile bulkhead at the inboard side of the North Pier also is in good condition.

<p>Photo No. 3.13</p> <p>Location: North Pier, Pile 6B</p> <p>Description: Void at top of pile</p>

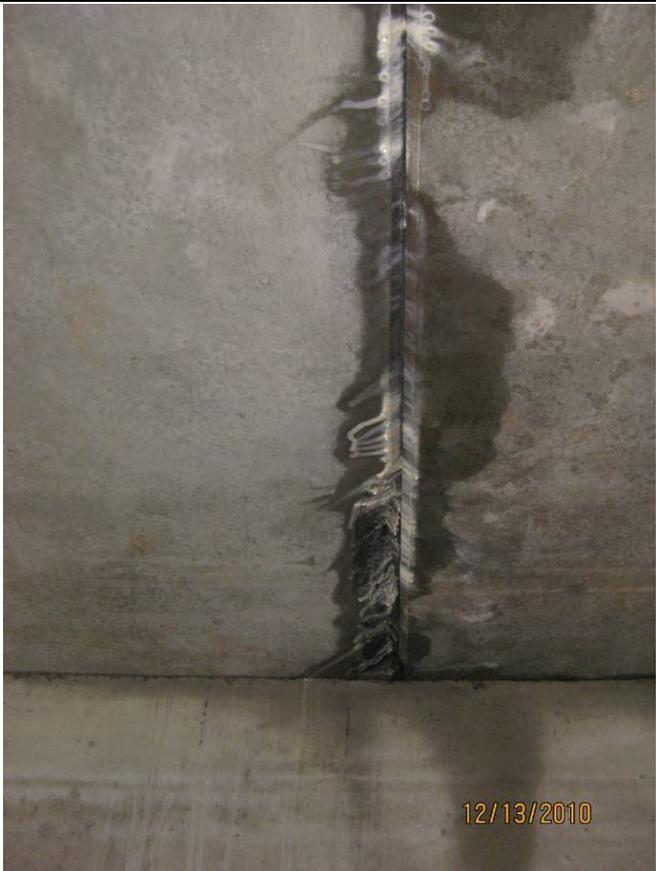
<p>Photo No. 3.14</p> <p>Location: North Pier</p> <p>Description: Underdeck between Bents 19 and 20, spall in deck plank</p>

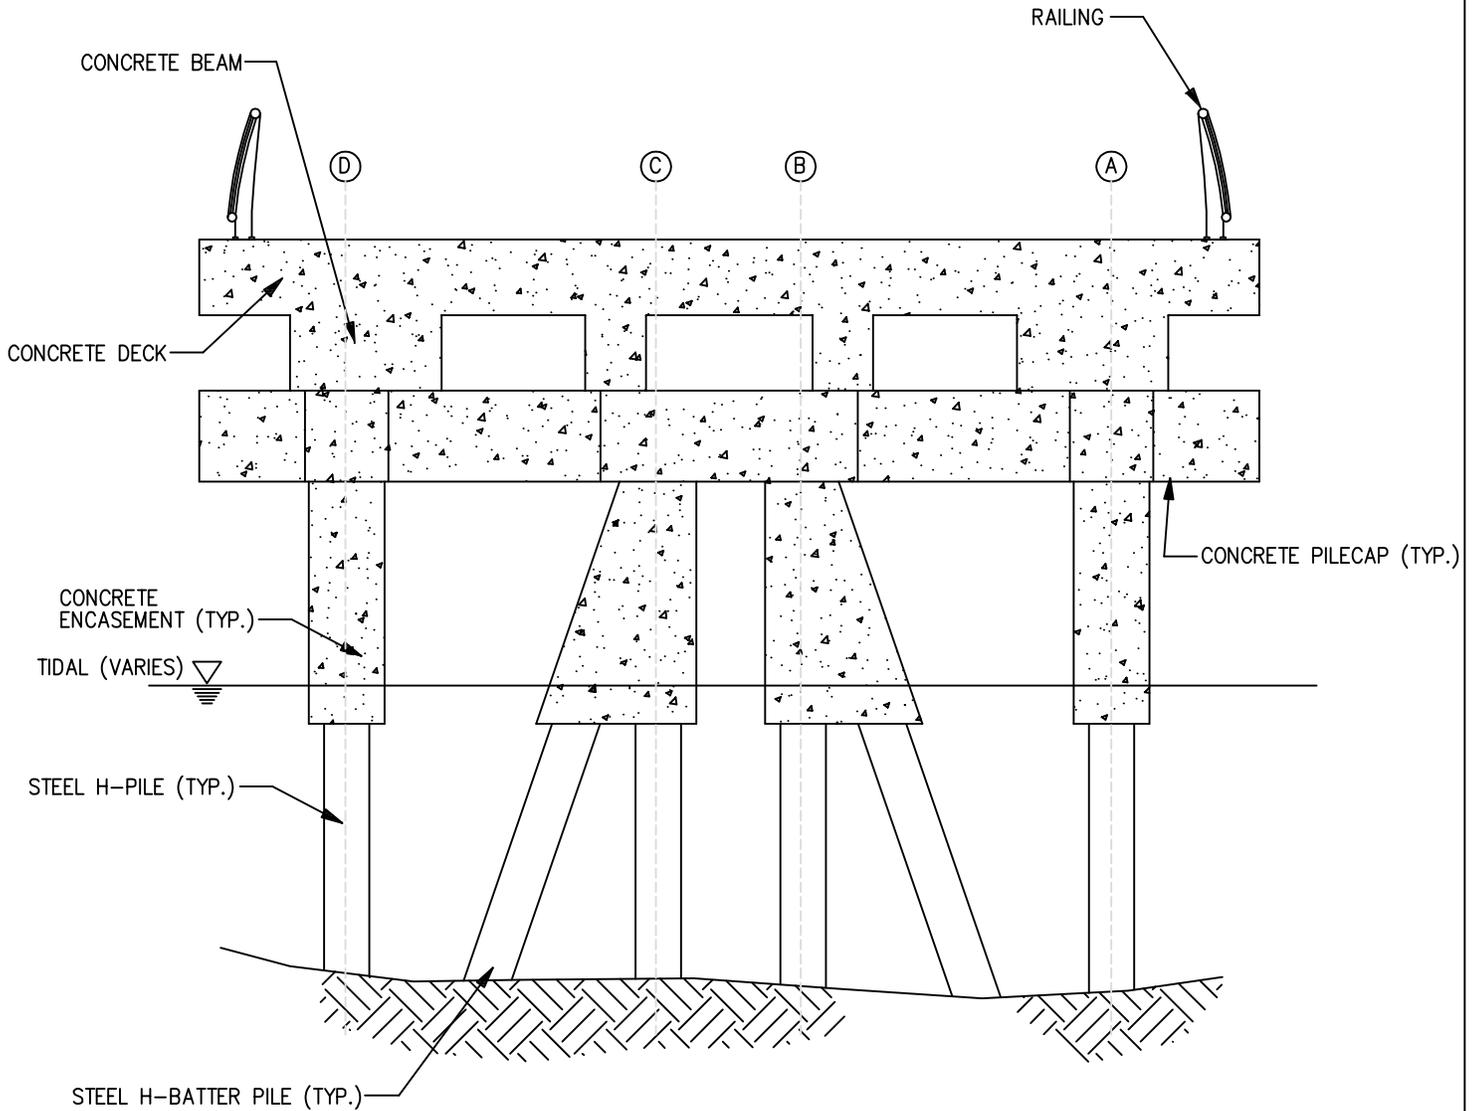
PIER A TYPICAL SECTION
VIEW LOOKING WEST

Pier A has a concrete deck, concrete beams and pile caps, and is founded on 360 steel H-piles that have been concrete-encased (Photo No. 4.1). The pier is roughly 782 ft long and 35 ft wide. The pier has 34 bent rows spaced at approximately 22 ft-on-center. Each row typically contains ten piles, two each near the north and south end of the bent, and a center cluster containing six piles, two of which are battered. The pier is currently utilized as an access pier to a marina, and has a lawn area at the east end of the pier. The marina is comprised of floating docks located between Piers A and B. The marina floating docks and piles were not included in this scope of work. North and south of the inland portion of Pier A, the pier is flanked by high-level steel H-pile supported platforms.

The overall condition of the concrete-encased steel H-piles is poor, with one localized, isolated location where the pile conditions are critical as described above. A total of 277 of the 361 piles that support the pier have steel H-piles exposed below the concrete repair jackets, while 84 have full length encasements. The full length encasements were generally found in the eastern half of the pier, with five piles in each bent having full length encasement. All of the piles with steel exposed below the encasement, with the exception of two piles, have section loss classified as severe as evidenced by knife-edging of the flange edges and hour glassing of the width of the flange. At 20 locations, the corrosion is severe enough to have caused through holes in the webs of the H-pile. A summary of steel H-pile conditions is presented in Table 4.1 below.

The overall condition of the concrete pile caps is satisfactory. There is moderate scaling at the bottom edges of the caps; typically the scaling is not severe enough to expose reinforcing steel. Spalling of the north end of the pile caps with exposed, corroded reinforcing steel was found at six locations (Photo No. 4.9). The general condition of the concrete beams and underdeck is fair. There is spalling throughout the structure with exposed reinforcing steel, which varies from moderate to severe corrosion. The deterioration is generally concentrated at the bottom of the north and south longitudinal beams and along the outboard edge of the underdeck (Photo Nos. 4.7 to 4.9). The two interior longitudinal beams typically have cracking 1/4 to 1/2 in. wide or incipient spalls

along their bottom edges (Photo Nos. 4.10 to 4.12). These defects are a sign that the underlying reinforcing steel is corroding.

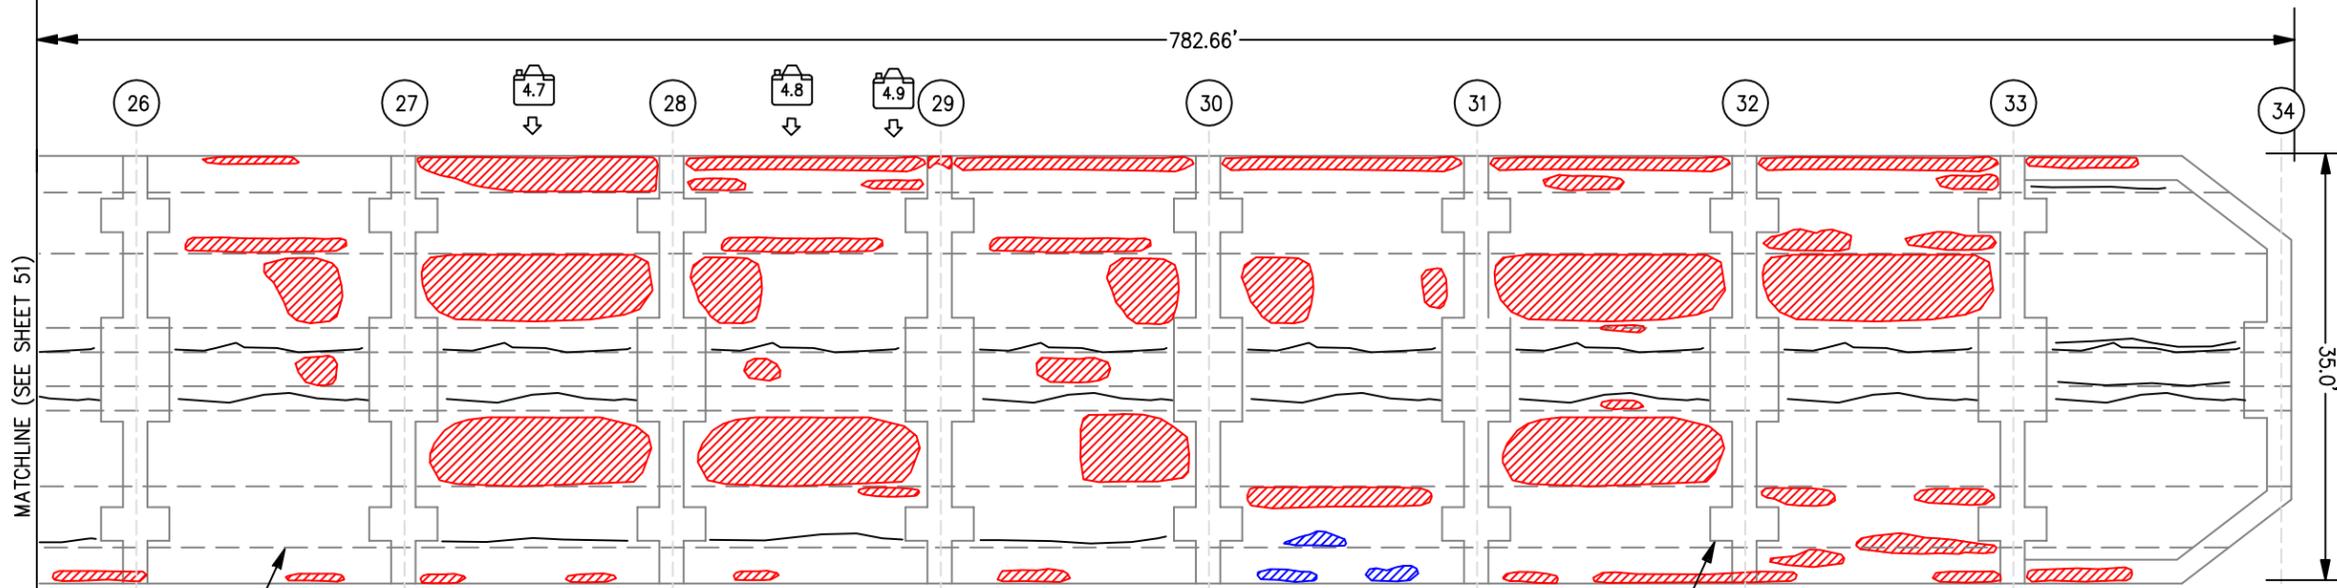
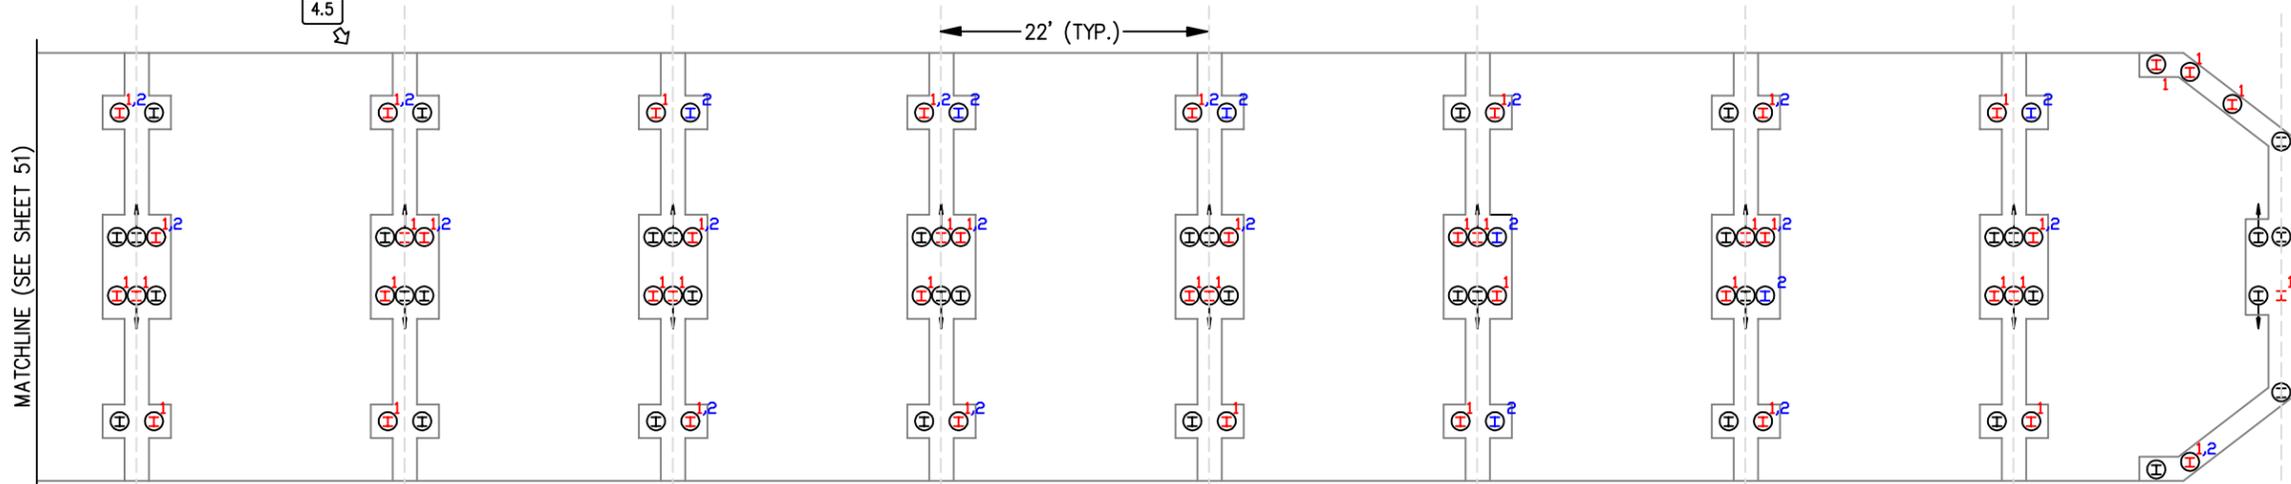
SHIPYARD ASSOCIATES LP
 PIER A PLAN VIEW 4 OF 4

At the easternmost row of piles, Bent-2, eight of ten piles are in critical condition. The eight steel H-piles do not have concrete repair jackets and all have 100% loss of section near the mudline, effectively leaving all but the north end of the pile cap completely unsupported. The bent row supports a concrete walkway adjacent to and east of Frank Sinatra Drive. Repair design plans prepared by Birdsell Services Group dated March 10, 2011 show this portion of platform being rebuilt with new concrete encased steel H-piles and a new concrete deck, see Appendix B.

At 124 locations, voids were found at the tops of the concrete encasements deep enough to expose the underlying steel H-piles (Photo Nos. 4.4 to 4.6). The condition of H-piles within the voids was typically satisfactory, with little or no section loss observed. However, the voids do expose the steel H-piles in the atmospheric zone, which is generally an area highly susceptible to corrosion.

The Shipyards Promenade Stabilization Plans dated March 2011 include design of repairs or replacement of the westernmost bent at Pier A, the timber cribbing bulkhead and the low-level timber relieving platform.
