HOBOKEN PRIVATELY-OWNED WATERFRONT STRUCTURES INSPECTION

File No. BUE-1010

BOSWELL UNDERWATER ENGINEERING

June 2011

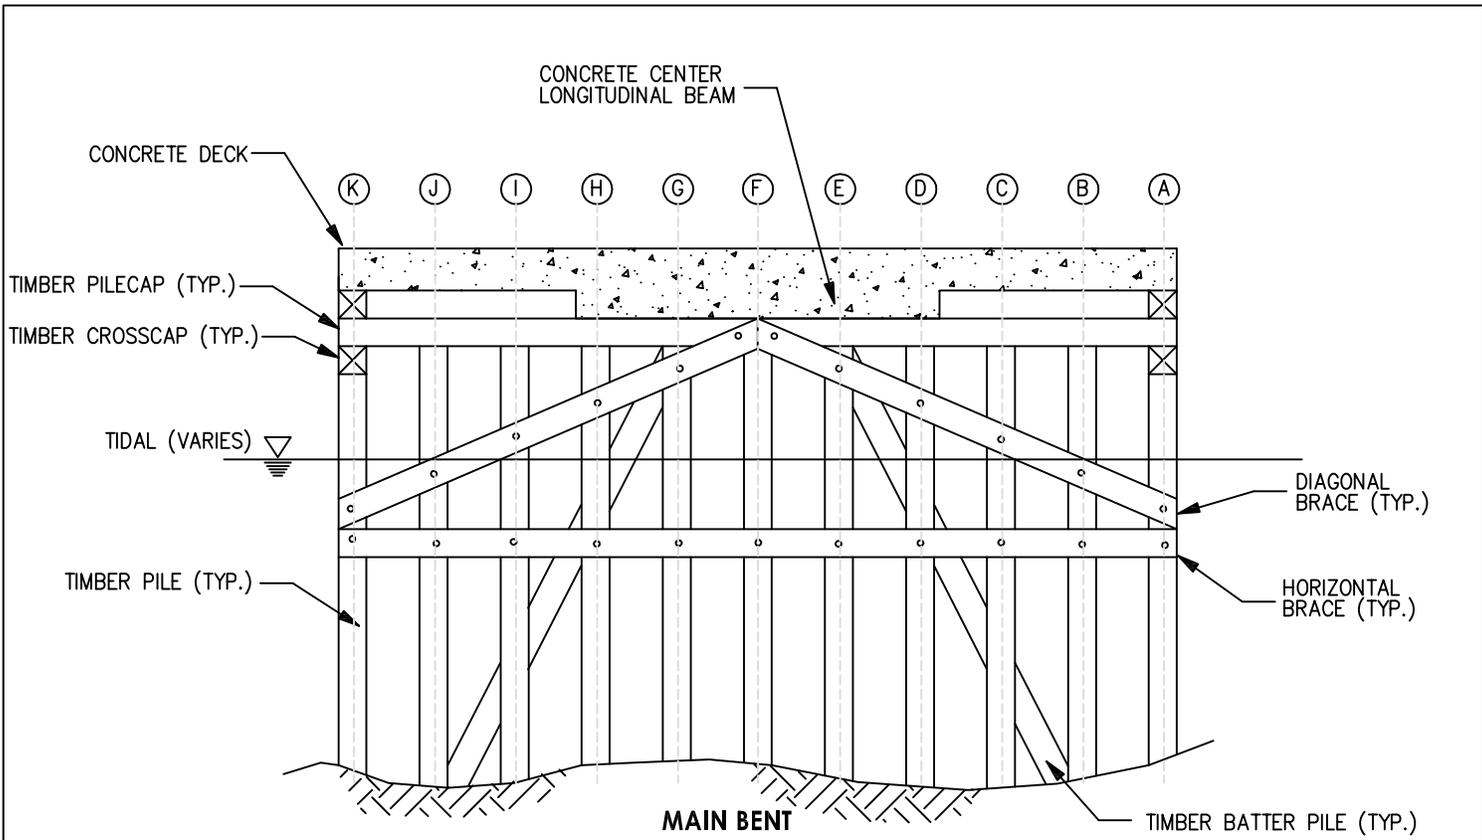
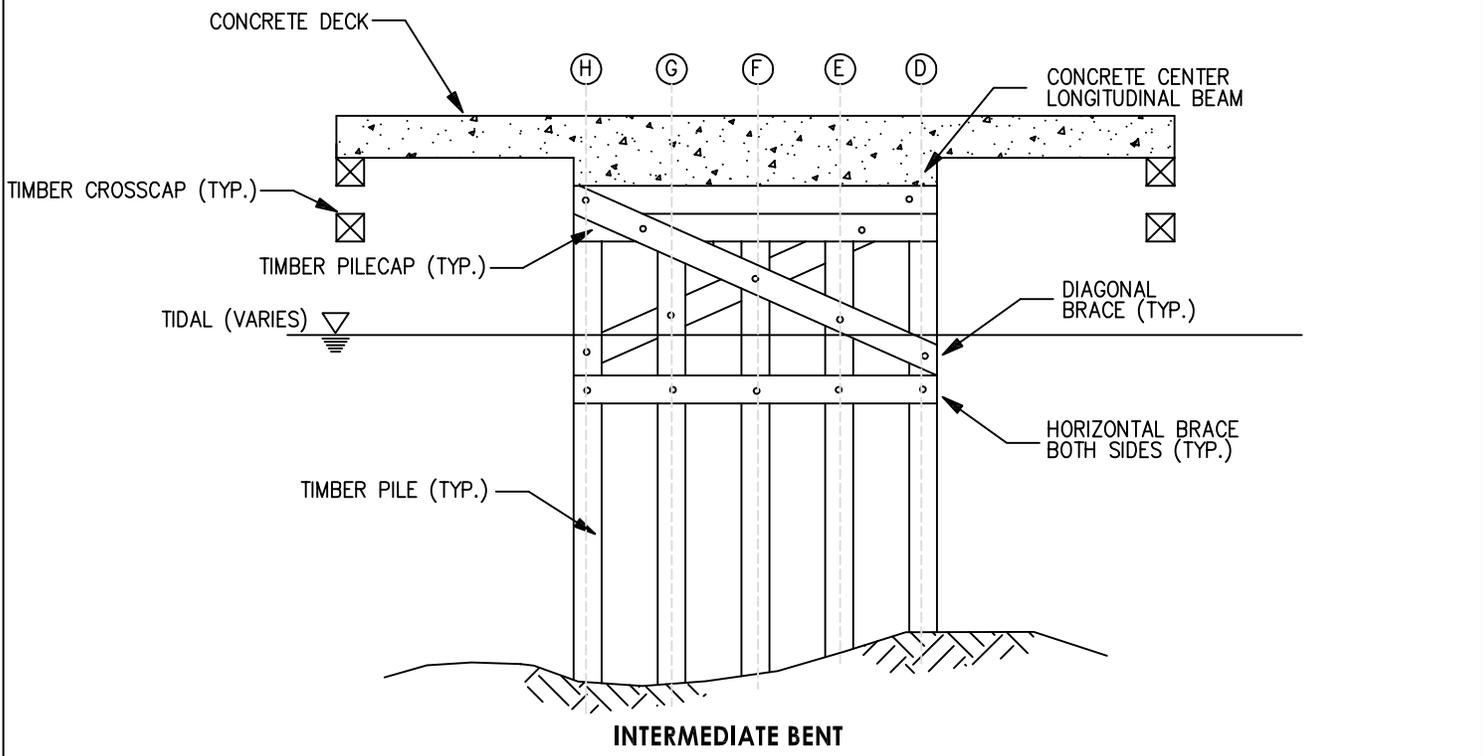
PIER B TYPICAL SECTION

The eastern 45 ft (Bents 65 to 68) of Pier B is in critical condition due to 36 missing, broken or split timber piles, severe spalling of the concrete pier deck and six locations where the transverse concrete beams are broken or missing (Photo Nos. 4.15 to 4.19). The eastern 11 ft of concrete deck is completely unsupported because all of the piles in the eastern two bents are missing, and the north half of the pier for the easternmost five rows have missing piles and broken concrete beams. No load should be permitted within this area and a permanent barrier should be installed to restrict access as soon as possible.

With the exception of the eastern portion of the pier, which is severely deteriorated, the remainder of the timber piles are in fair condition. There are 150 locations (inclusive of the 36 severe piles at the east end of the pier) where piles have section loss greater than 49 percent, severe splits, or missing connection hardware and are rated severe (Photo Nos. 4.19 to 4.21). The majority of these piles are located at the north or south end of a row and many appear to have been affected by impact damage and hollowing of the interior of the top of the pile. A total of 70 piles are rated moderate due to section loss less than 49%, splits, loss of bearing or corroded connection hardware. The remainder of the timber piles are typically in satisfactory condition with only minor deterioration noted. Marine borer intrusion in the form of Teredos was observed at 67 piles. The severity of the infestation is light, and the resultant section loss is generally less than 10 percent. However, Teredo infestation can be difficult to detect solely from a visual inspection as they attack the interior of the wood. Additionally, deterioration due to marine borer attack can progress rapidly, so the extent of marine borer intrusion should be monitored closely during future inspections.

The timber pile caps are typically in satisfactory condition with isolated areas of section loss and hollowing found at ends of some caps due to rot (Photo No. 4.21). Four pile caps are rated severe and two pile caps are rated moderate due to hollowing observed at the ends of the pile caps.

The condition of the timber horizontal bracing and cross bracing is poor. The majority of the braces are loose, split or have section loss due to soft rot (Photo 4.24). At several locations the braces are missing altogether. Additionally, at the lower hardware connections, those within the tidal zone, the hardware is typically severely corroded or missing (Photo No. 4.25).

The condition of the concrete pier deck and beams from Bent 64 to the east end is critical as described above. The overall condition of the concrete underdeck and beams is poor from Bent 1 to Bent 64. There is widespread delaminations and spalling with exposed and moderately to severely corroded reinforcing steel throughout the entire structure. The entire surface of the underdeck is spalled from Bent 59 to the east end of the structure. The lower course of reinforcing steel is severely corroded with some locations where the reinforcing steel is completely corroded through. At one location, Bent 62 to 63, cracks were observed in the remaining concrete that extended to the top of the deck (Photo No. 4.27). The remainder of the concrete beams and deck also have cracks, delaminations and spalling (Photo Nos. 4.28 to 4.30).

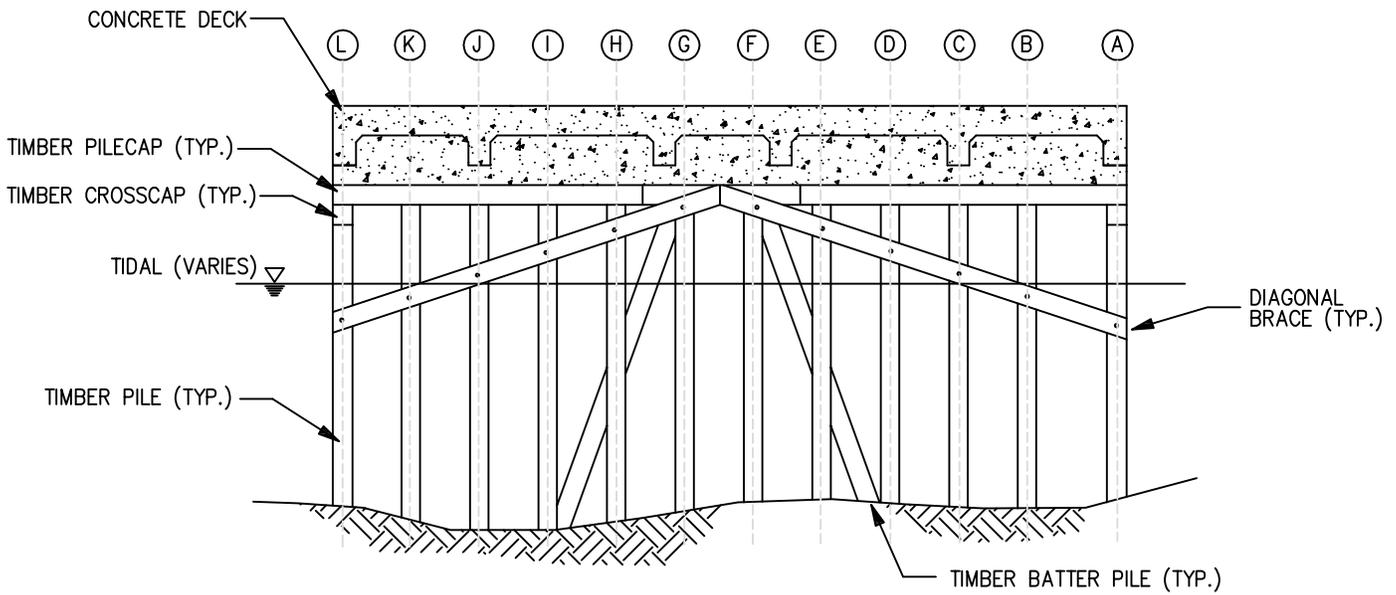
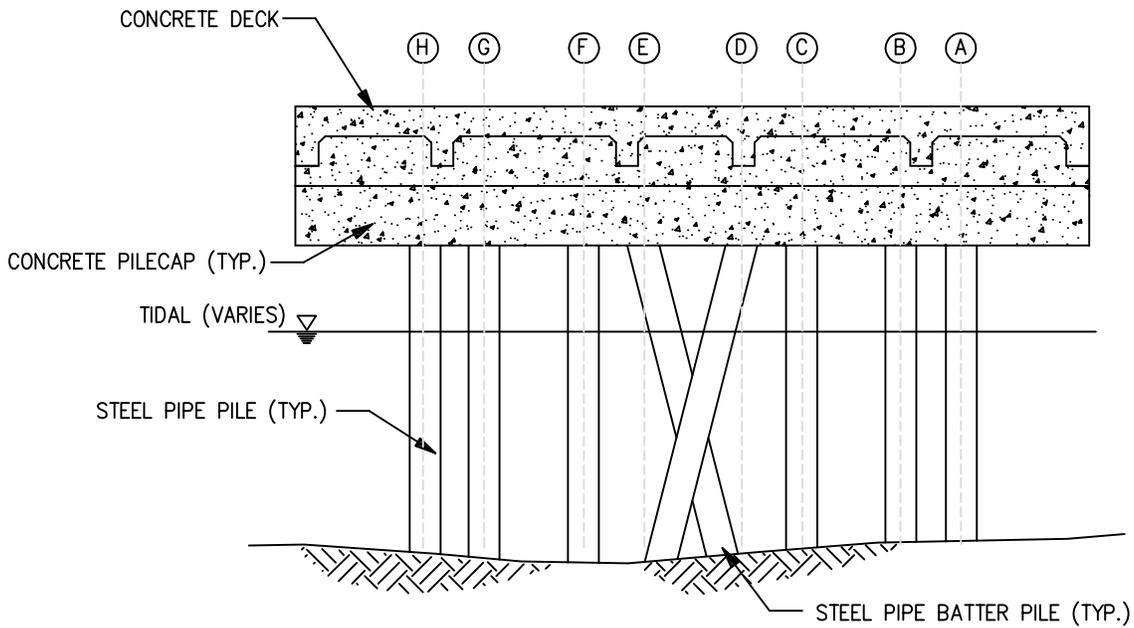
PIER C TYPICAL SECTION

Pier C is roughly 739 ft long and 40 ft wide. The pier is comprised of two different construction types, the inboard 310 ft is of similar construction type of Pier B, with 32 main timber pile bents spaced roughly 10 ft on-center. Each main bent contains 12 plumb piles and two batter piles. Centered between each main bent is an intermediate bent containing ten plumb piles. Each timber bent supports a concrete pile cap, longitudinal concrete deck beams and a concrete pier deck. The outboard 429 ft of the pier is founded on 14 in. diameter pipe piles configured in 26 rows spaced approximately 17 ft on-center. Each row contains 6 plumb piles and two batter piles supporting a concrete cap. The pile caps support longitudinal concrete beams and a concrete pier deck. At the time of inspection, two boats were berthed at the pier.

The overall condition of the timber piles at Pier C is fair. Of the 737 inspected timber piles, 89 are rated severe due to section loss greater than 50%, a loss of bearing greater than 50%, splits or batter piles with missing or severely corroded hardware. A total of 238 piles are rated moderate due to section loss between 10% and 49%, loss of bearing between 10% and 49%, splits or corrosion of connecting hardware. Many piles are less than 100% bearing due to deterioration of the top of the piles from rot and/or hollowing, deterioration of the timber pile cap it supports or a combination of the two (Photo No. 4.33).

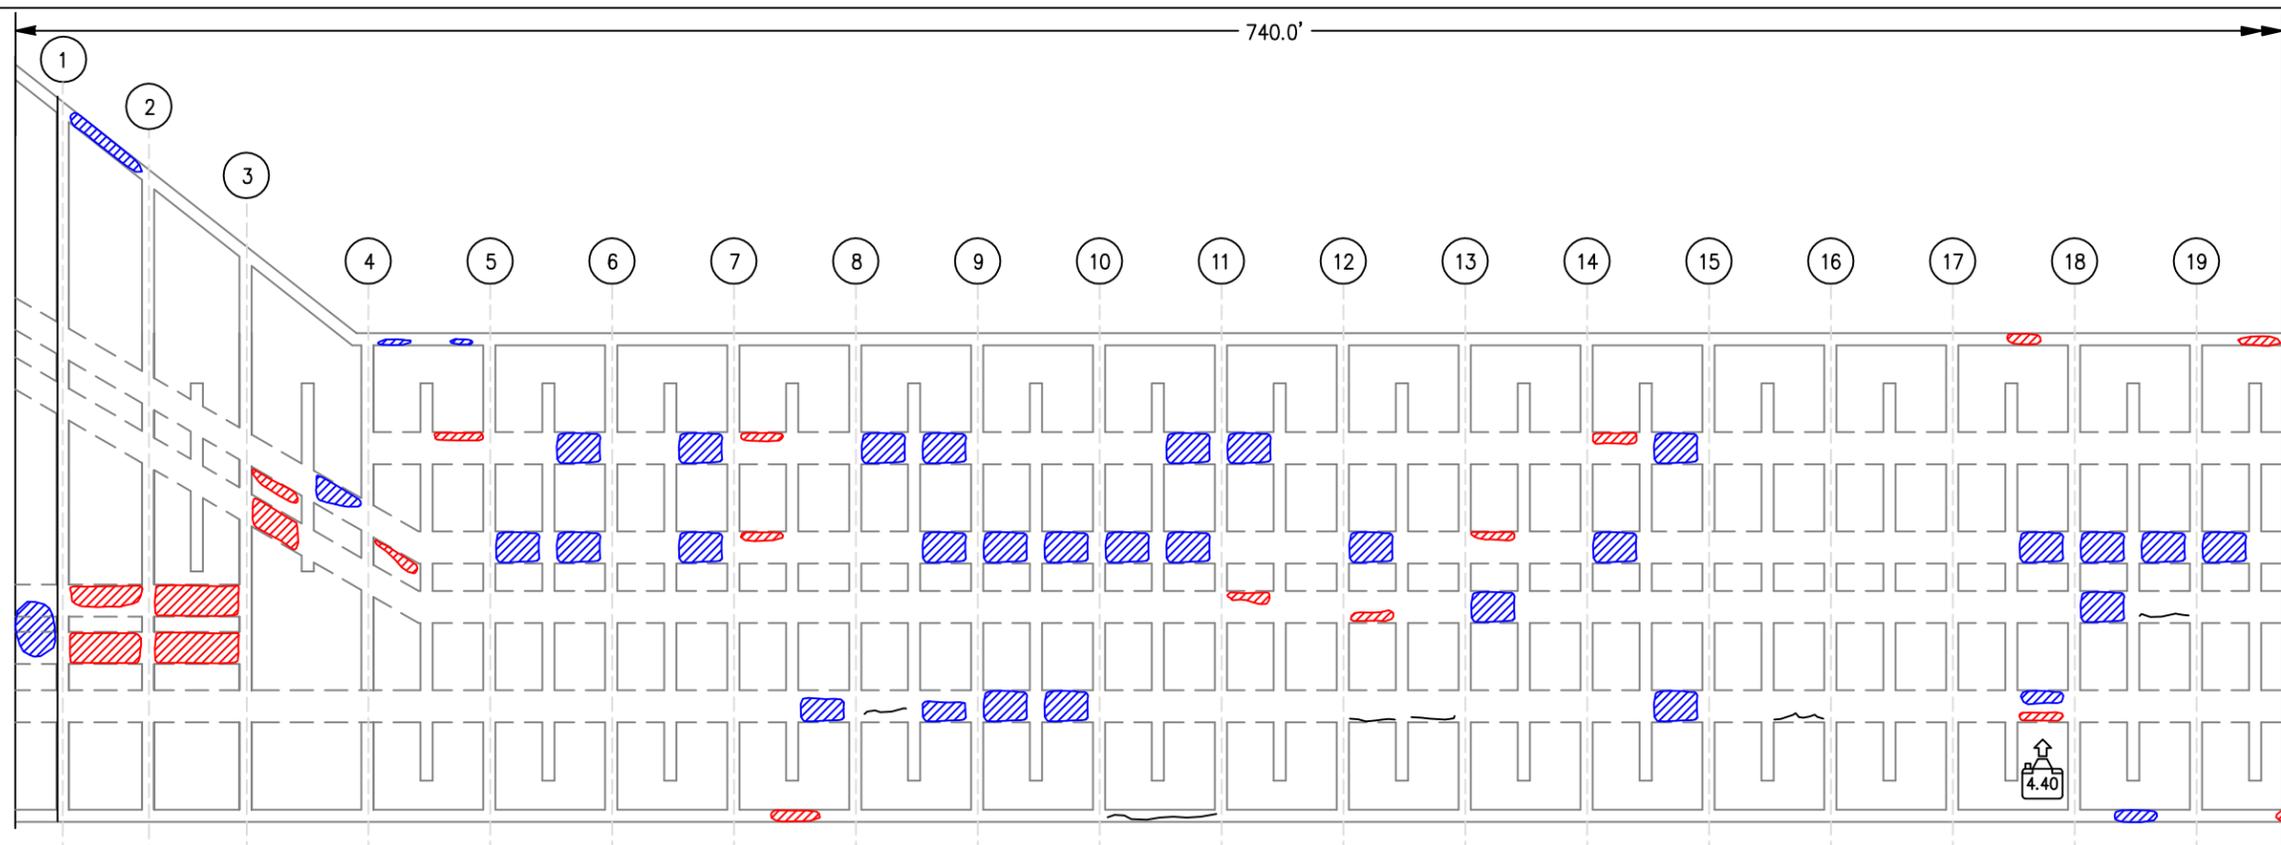
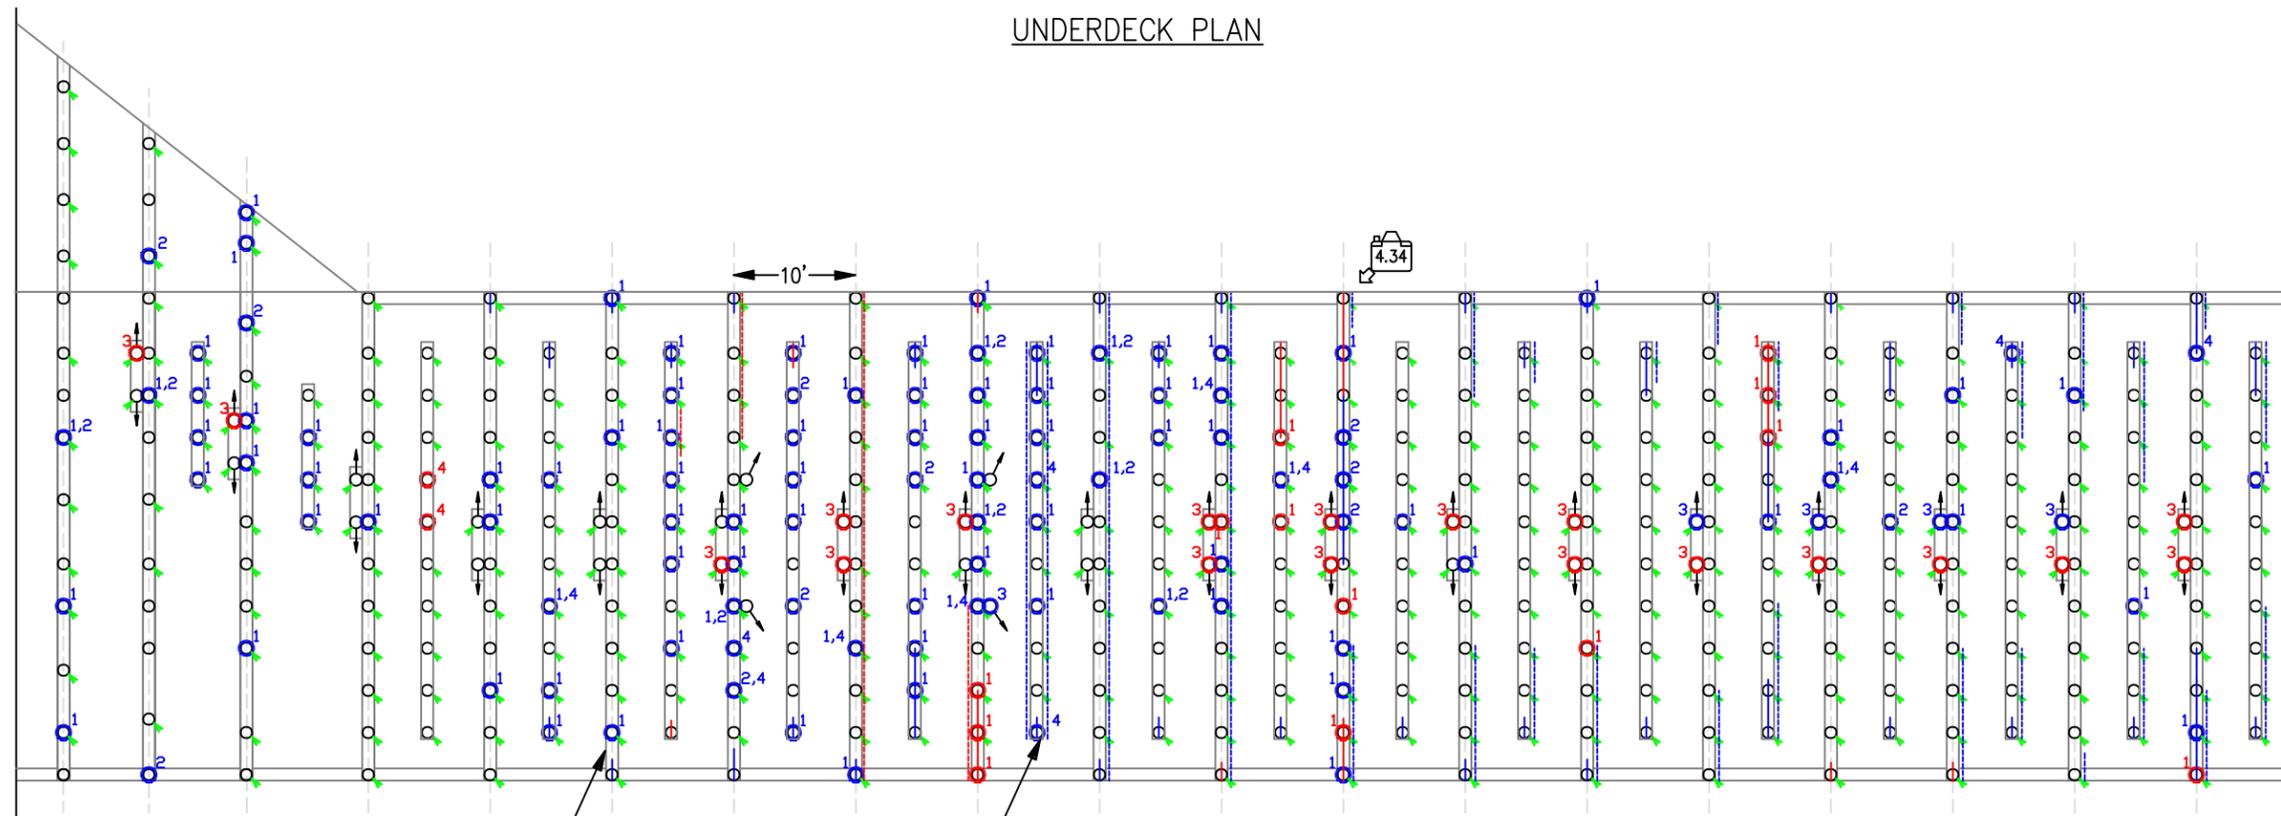
Visual signs of marine borer infestation were detected at 95 percent of the timber piles inspected. While marine borer intrusion is widespread throughout the structure, the level of intrusion is typically light with little or no observed section loss. However, the rate of deterioration due to marine borer intrusion can be very rapid, and should be closely monitored during future inspections.

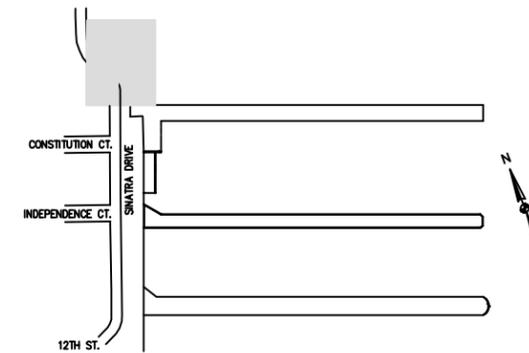
SEAWALL REMOVED AS PART OF EMERGENCY
REPAIRS IN RESPONSE TO ROADWAY COLLAPSE
IN OCTOBER, 2010. TEMPORARY H-PILES AND
STEEL PLATES IN PLACE AT TIME OF INSPECTION.

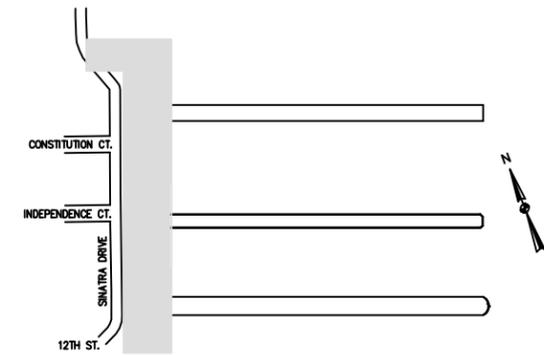
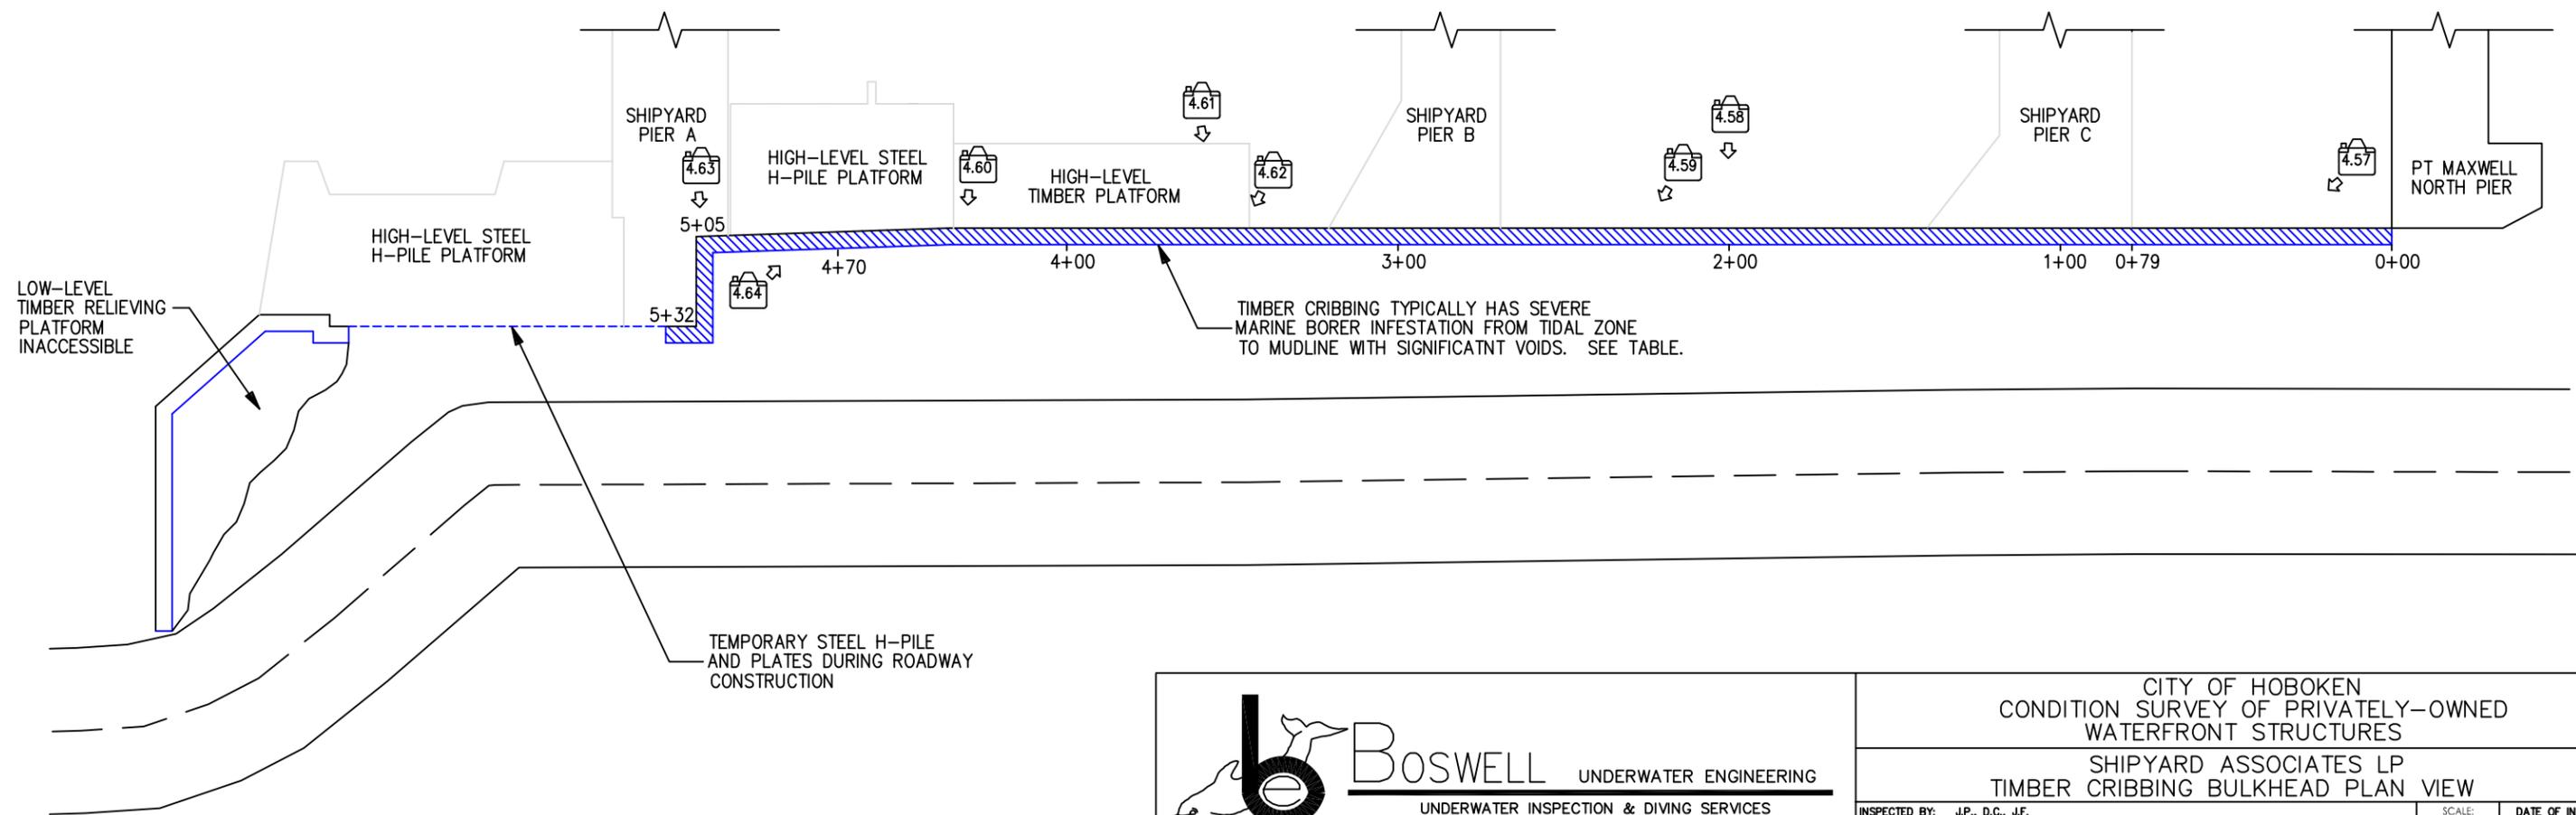
CITY OF HOBOKEN CONDITION SURVEY OF PRIVATELY-OWNED WATERFRONT STRUCTURES		
SHIPYARD ASSOCIATES LP TIMBER CRIBBING BULKHEAD PLAN VIEW		
INSPECTED BY: J.P., D.C., J.F. DRAWN BY: J.G.	SCALE: 1" = 15'	DATE OF INSPECTION: FEBRUARY, 2011
JOB NO. BUE-1010	DRAWING NO. 4.18	SHEET 65

Voids in Timber Cribbing			
Sta.	Description	Sta.	Description
0+06	5'L x 0.5'H x 4'D	2+15	12'L x 2.5'H x 3'D
0+50	1.5'L x 1'H x 2.5'D	2+25	5'L x 2.5'H x 3'D
0+54	1'L x 1'H x 3.5'D	2+48	2'L x 1'H x 2'D
0+65	1.5'L x 0.5'H x 1.5'D	2+63	3.5'L x 2'H x 2'D
0+68	1'L x 0.5'H x 1'D	2+75	2.5'L x 0.5'H x 2'D
1+10	2.5'L x 1'H x 2'D	2+85	3'L x 0.5'H x 1.5'D
1+22	4'L x 1'H x 2'D	2+87	2'L x 1'H x 2.5'D
1+30	3.5'L x 2'H x 2'D	2+90	3'L x 1'H x 2.5'D
1+35	4'L x 2'H x 2'D	3+04	2'L x 1'H x 1.5'D
1+41	3.5'L x 2'H x 3'D	3+10	4'L x 1'H x 1.5'D
1+46	1'L x 1'H x 1.5'D	3+15	2.5'L x 1'H x 2'D
1+51	9'L x 2.5'H x 2.5'D	3+20	1'L x 1'H x 1.5'D
1+60	4'L x 1.5'H x 1.5'D	3+45	1'L x 1'H x 2.5'D
1+65	3'L x 1'H x 2'D	3+69	4'L x 1'H x 2.5'D
1+90	1.5'L x 1.5'H x 5'D	3+87	3'L x 1'H x 2'D
1+95	6'L x 1.5'H x 2'D	4+15	2'L x 1'H x 2.5'D
2+15	12'L x 2.5'H x 3'D	4+35	2'L x 1'H x 1.5'D

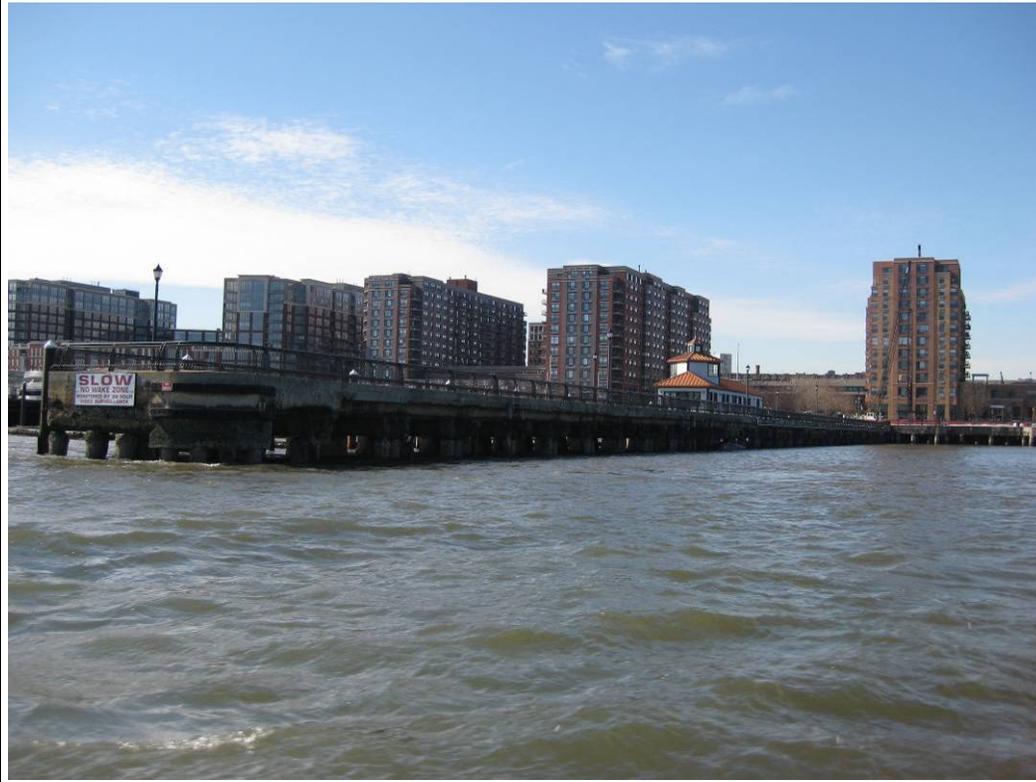
Photo No. 4.1

Pier A has a concrete deck, concrete beams and pile caps, and is founded on 360 steel H-piles that have been concrete-encased (Photo No. 4.1). The pier is roughly 782 ft long and 35 ft wide. The pier has 34 bent rows spaced at approximately 22 ft-on-center. Each row typically contains ten piles, two each near the north and south end of the bent, and a center cluster containing six piles, two of which are battered. The pier is currently utilized as an access pier to a marina, and has a lawn area at the east end of the pier. The marina is comprised of floating docks located between Piers A and B. The marina floating docks and piles were not included in this scope of work. North and south of the inland portion of Pier A, the pier is flanked by high-level steel H-pile supported platforms.

General view looking west

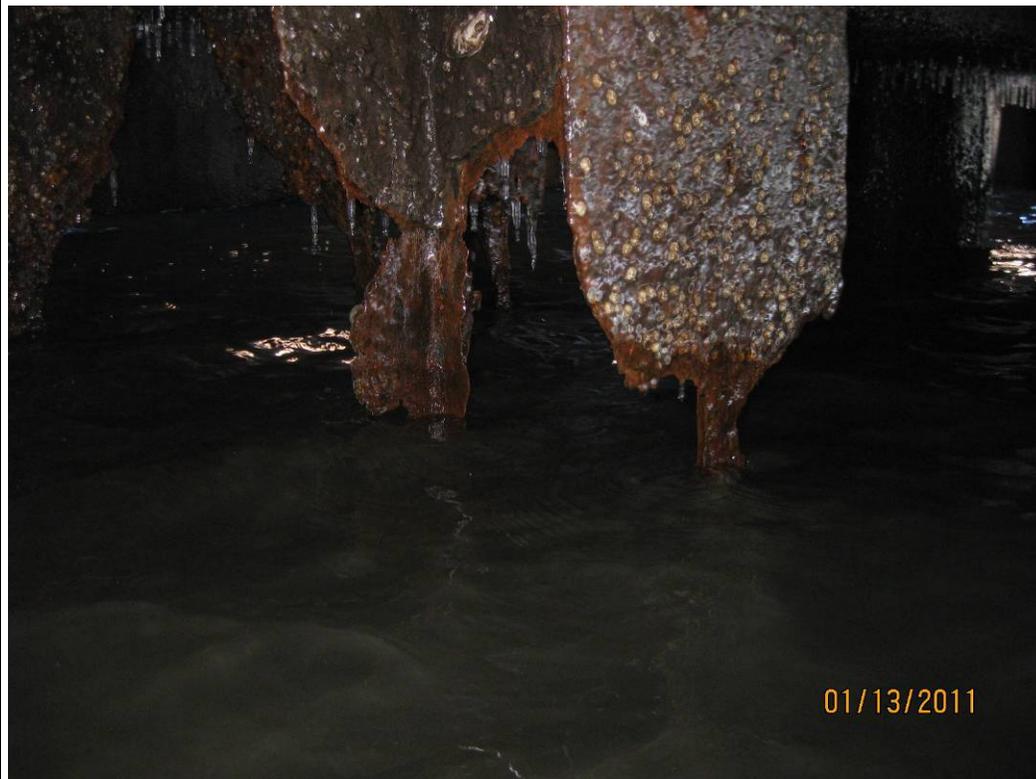
Photo No. 4.2

Severely corroded steel H-pile

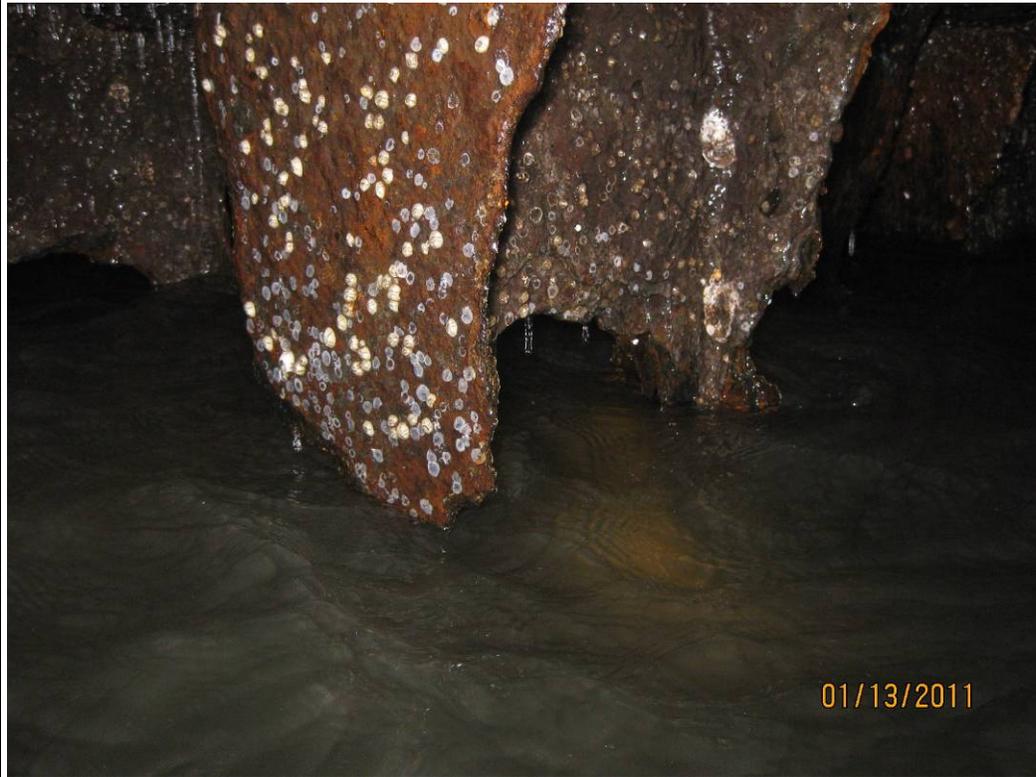
Photo No. 4.3

Severely corroded
steel H-pile

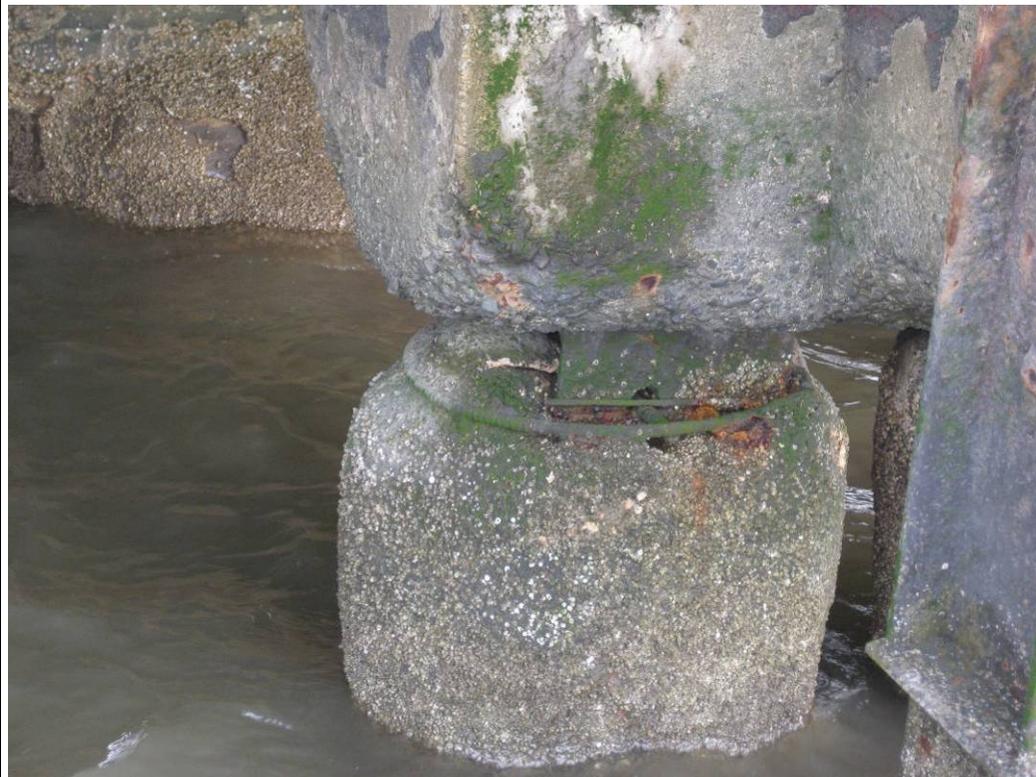
Photo No. 4.4

Void at top of
H-pile concrete
encasement

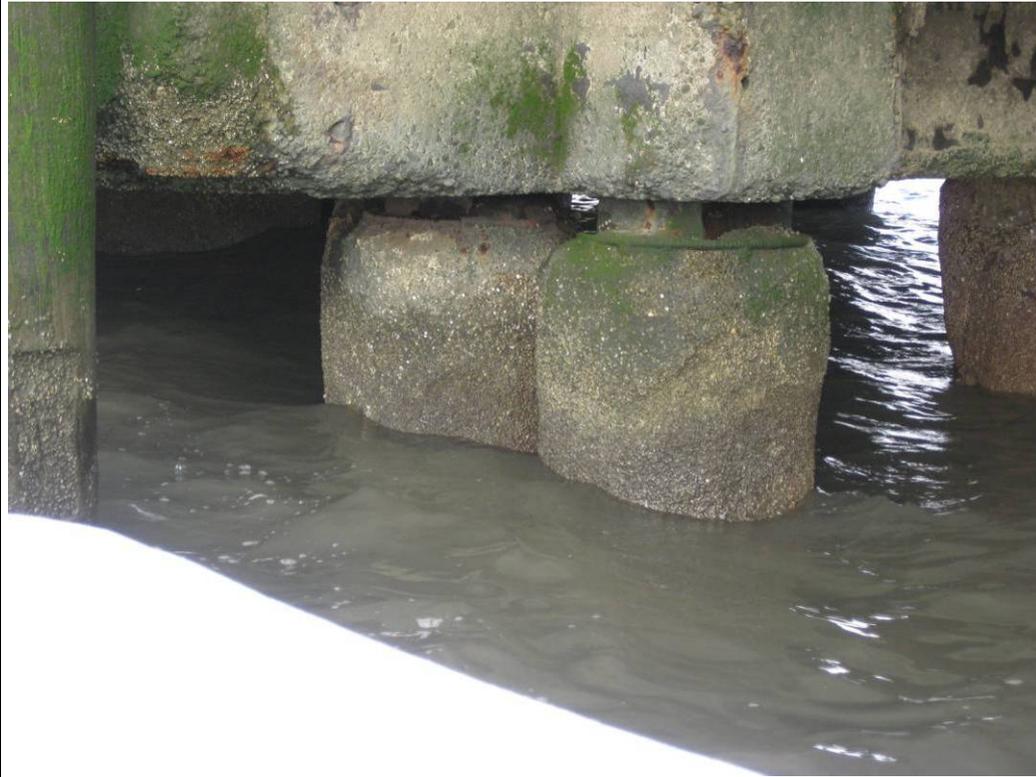
Photo No. 4.5

Void at top of 2
H-pile concrete
encasements

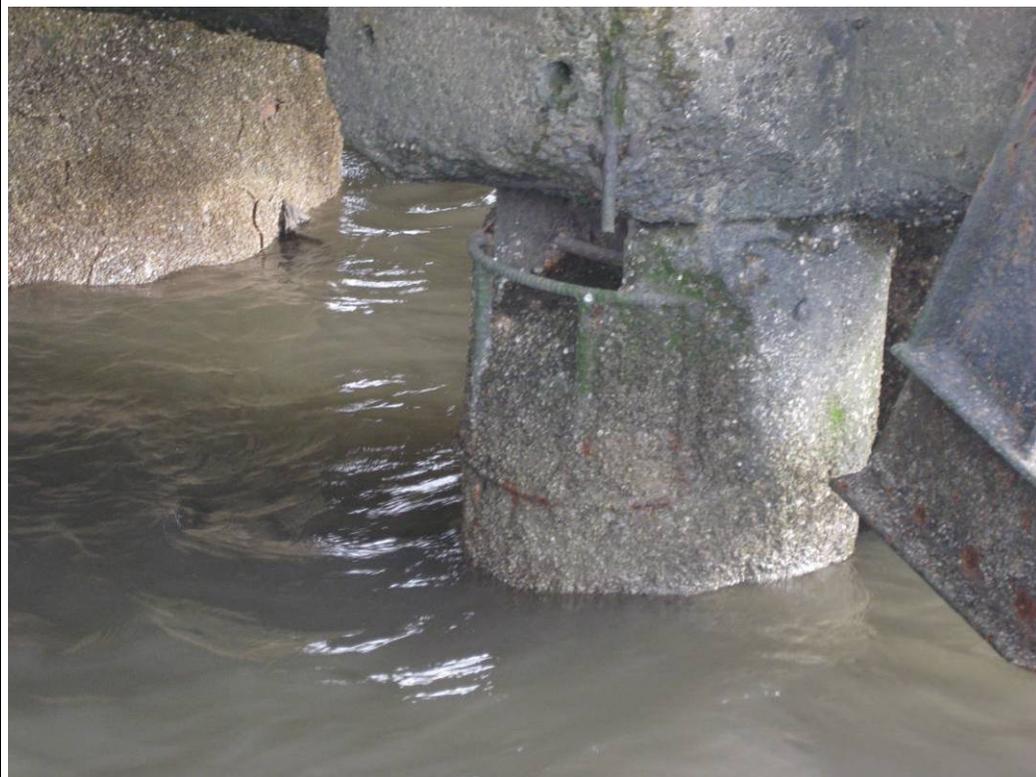
Photo No. 4.6

Void at top of H-pile
concrete encasement
showing exposed steel
reinforcement

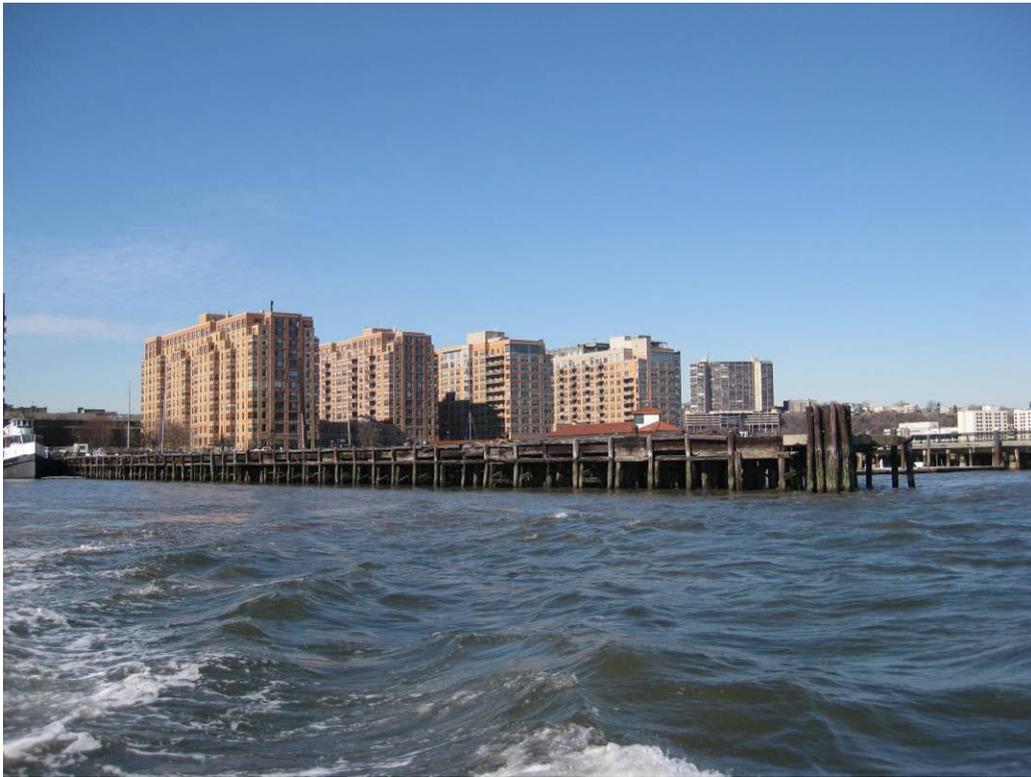
Photo No. 4.13

Pier B consists of timber piles and pile caps supporting concrete pile caps, deck beams and pier deck (Photo No. 4.13). The pier is approximately 738 ft long and 30 ft wide and is comprised of 68 main bent rows, of eight to 11 plumb piles each, with two batter piles on the west side in each row (Photo No. 4.14). Between each main pile bent is an intermediate bent of four to five piles that are centered within the pier. The pier currently has a dog park at the west end and two boats were berthed at the south face of the pier at the time of inspection.

General view looking northwest

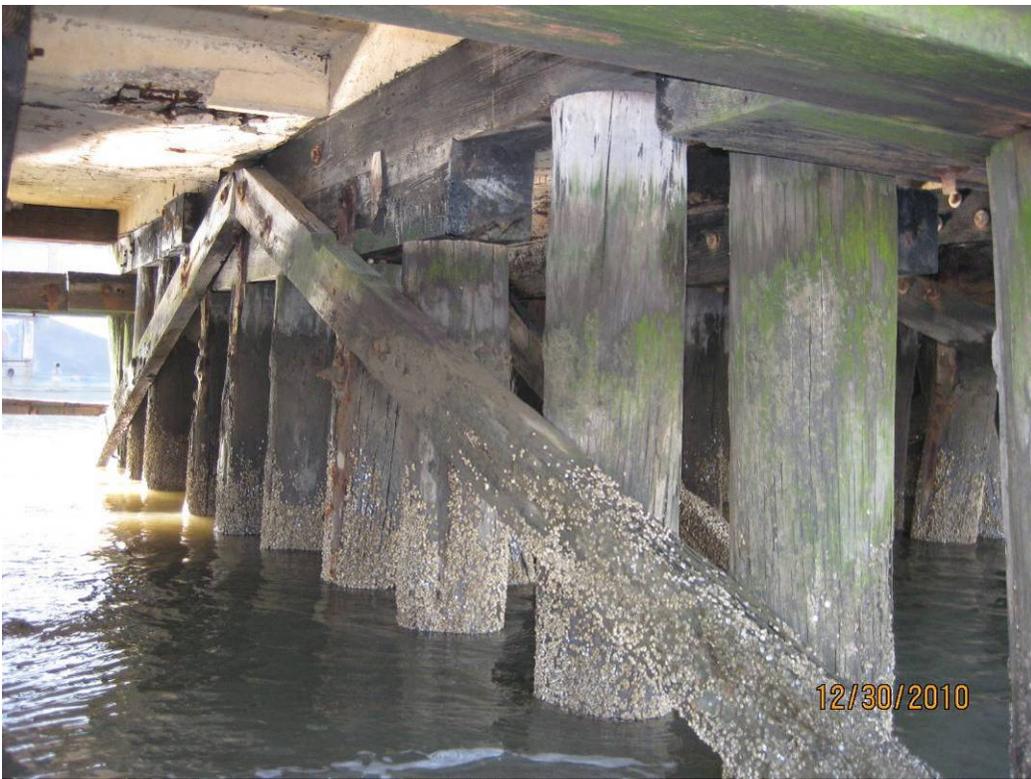
Photo No. 4.14

General view, typical bent row

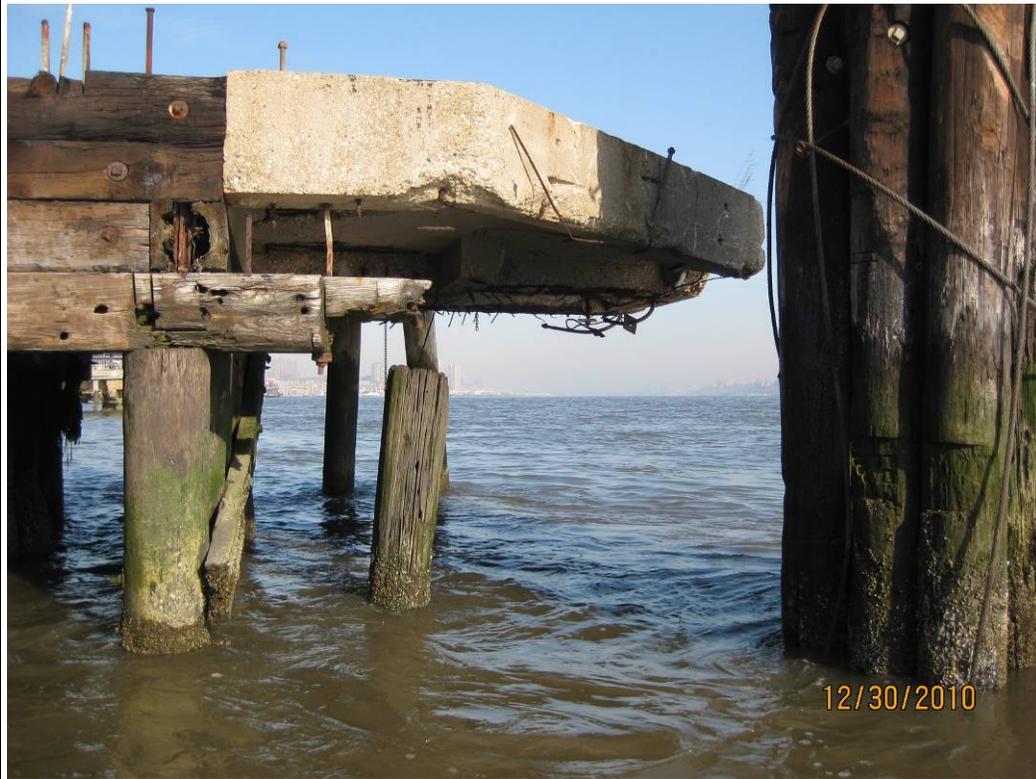
Photo No. 4.15

East end of pier unsupported

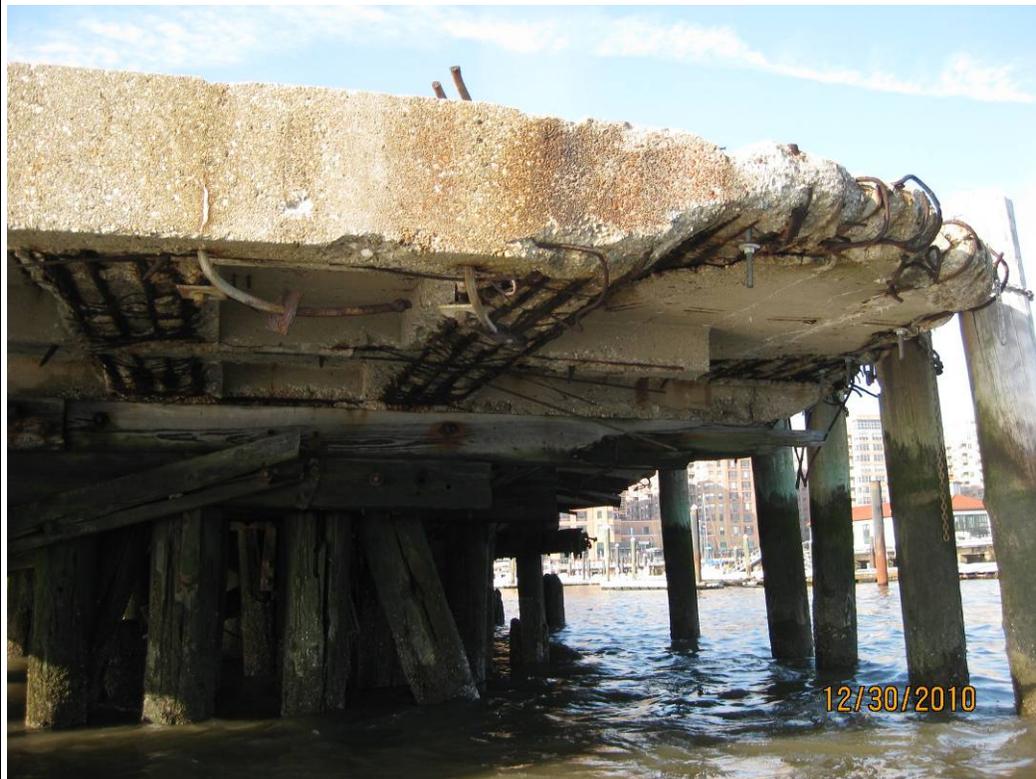
Photo No. 4.16

East end of pier unsupported

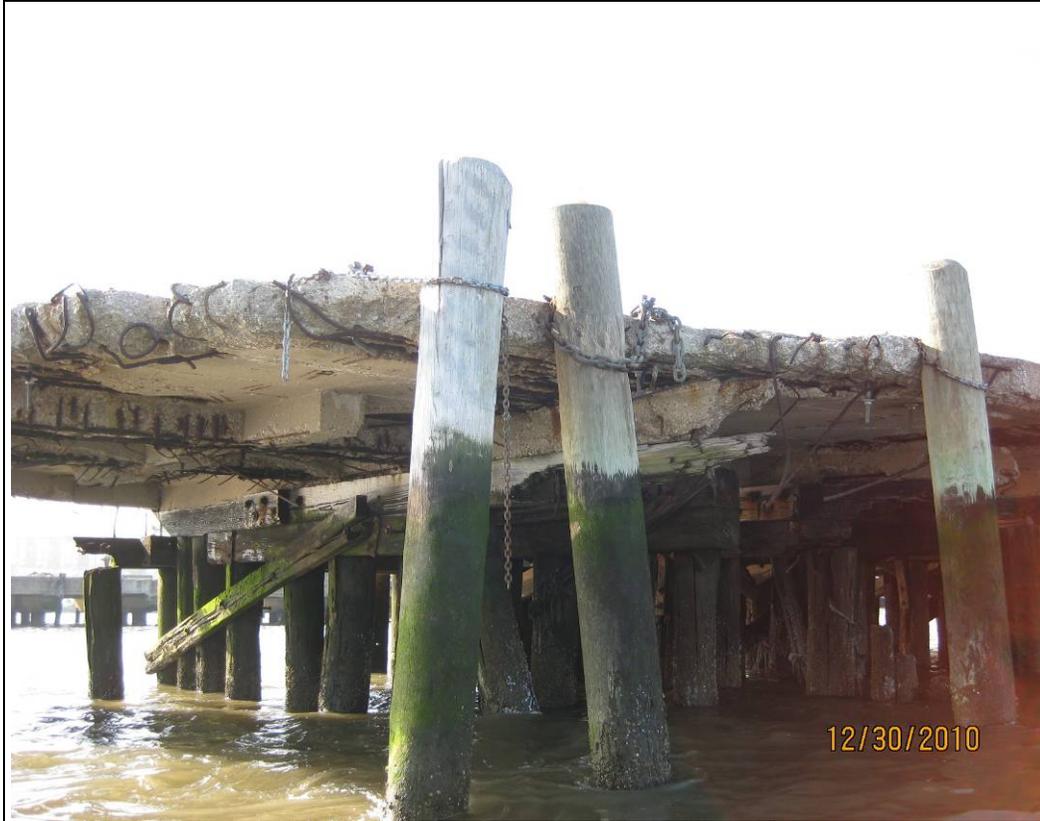
Photo No. 4.17

East end of pier unsupported

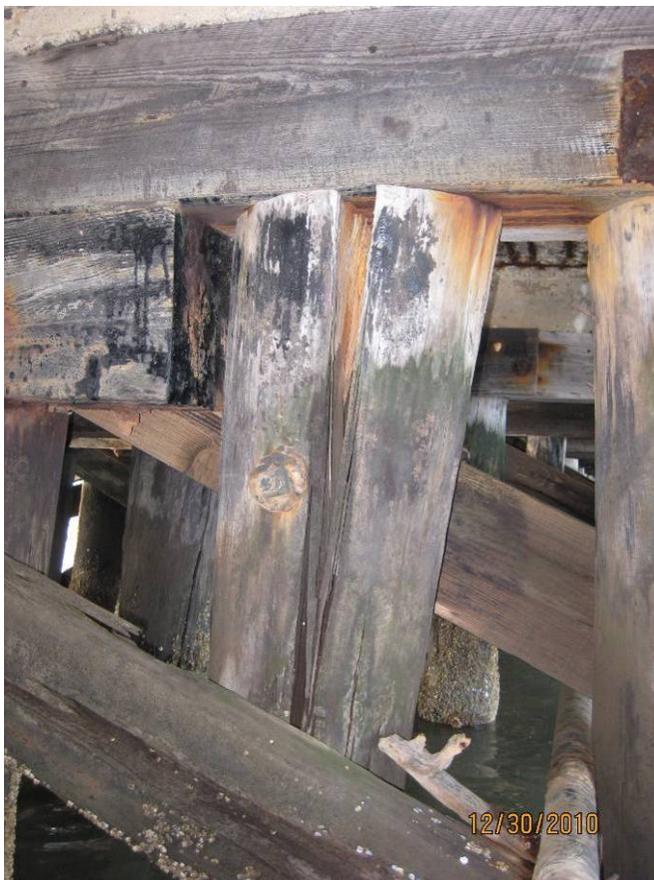
Photo No. 4.20

Wide split at top of pile

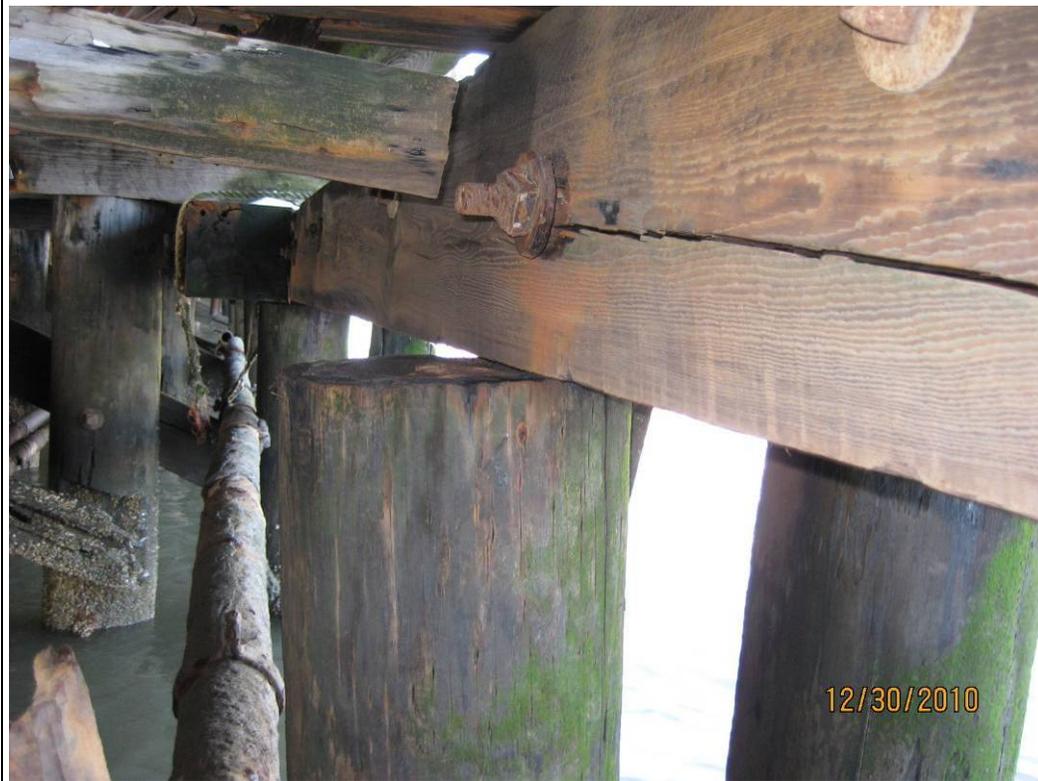
Photo No. 4.21

Severely corroded
attachment hardware
