HOBOKEN PRIVATELY-OWNED WATERFRONT STRUCTURES INSPECTION

File No. BUE-1010

BOSWELL UNDERWATER ENGINEERING

June 2011

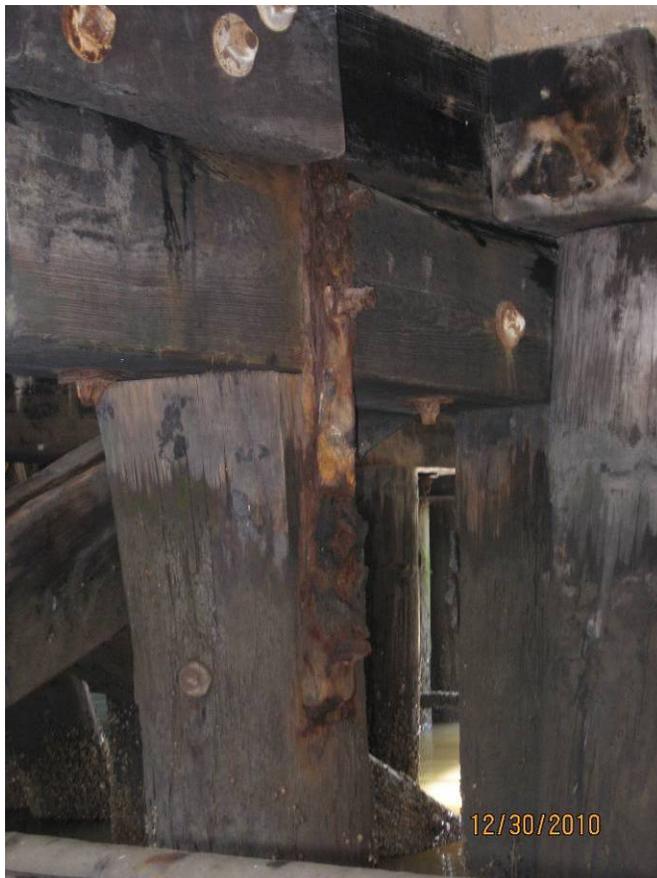
Photo No. 4.22

Severely corroded
attachment hardware

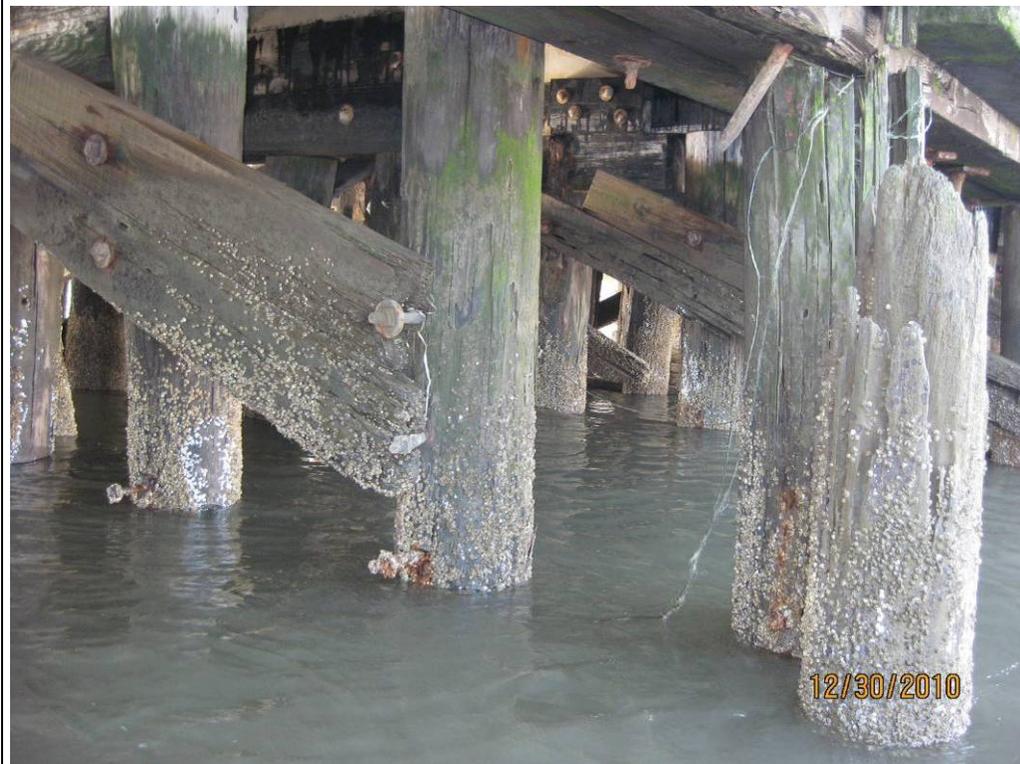
Photo No. 4.24

The condition of the timber horizontal bracing and cross bracing is poor. The majority of the braces are loose, split or have section loss due to soft rot (Photo 4.24). At several locations the braces are missing altogether. Additionally, at the lower hardware connections, those within the tidal zone, the hardware is typically severely corroded or missing (Photo No. 4.25).

Diagonal timber
brace broken

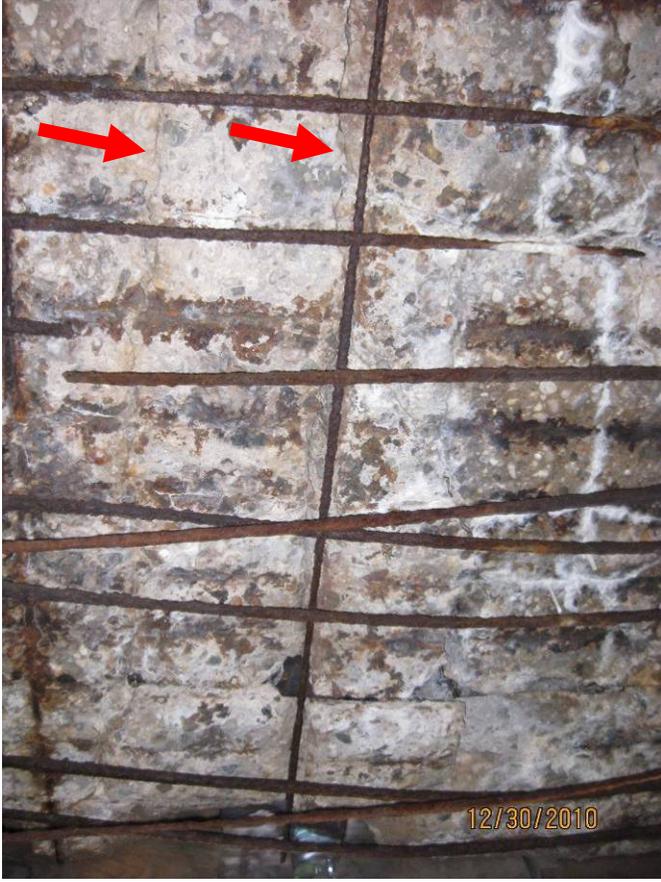
<p>Photo No. 4.27</p> <p>Location: Pier B Bent 54 to 55</p> <p>Description: Spall of concrete underdeck showing severely corroded reinforcing steel and cracks in remaining concrete</p>

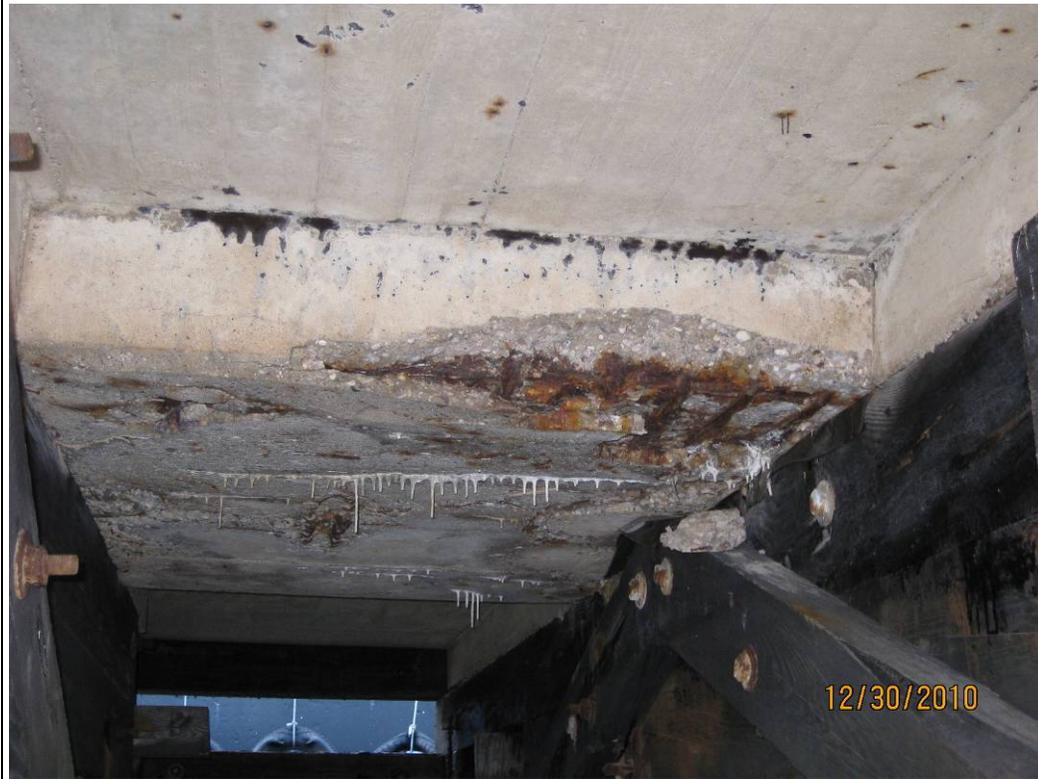
Photo No. 4.29

The condition of the concrete pier deck and beams from Bent 64 to the east end is critical as described above. The overall condition of the concrete underdeck and beams is poor from Bent 1 to Bent 64. There is widespread delaminations and spalling with exposed and moderately to severely corroded reinforcing steel throughout the entire structure. The entire surface of the underdeck is spalled from Bent 59 to the east end of the structure. The lower course of reinforcing steel is severely corroded with some locations where the reinforcing steel is completely corroded through. At one location, Bent 62 to 63, cracks were observed in the remaining concrete that extended to the top of the deck (Photo No. 4.27). The remainder of the concrete beams and deck also have cracks, delaminations and spalling (Photo Nos. 4.28 to 4.30).

Spall at bottom of longitudinal concrete beam

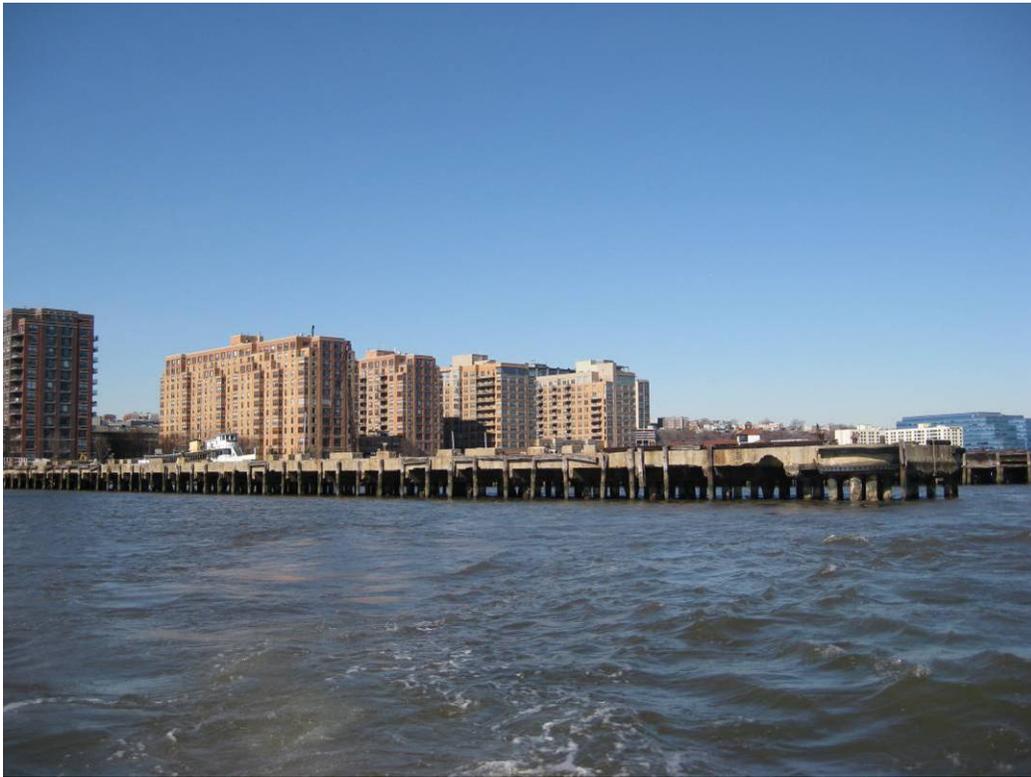
Photo No. 4.31

General view looking northwest

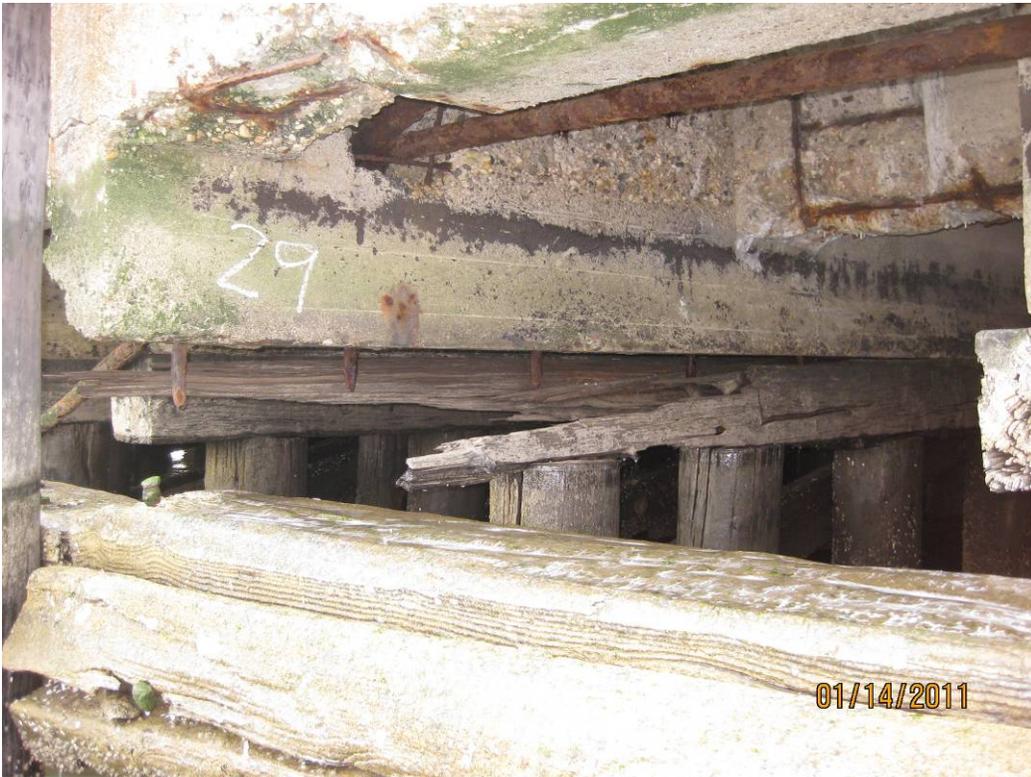
Photo No. 4.32

Severe deterioration of timber pile cap

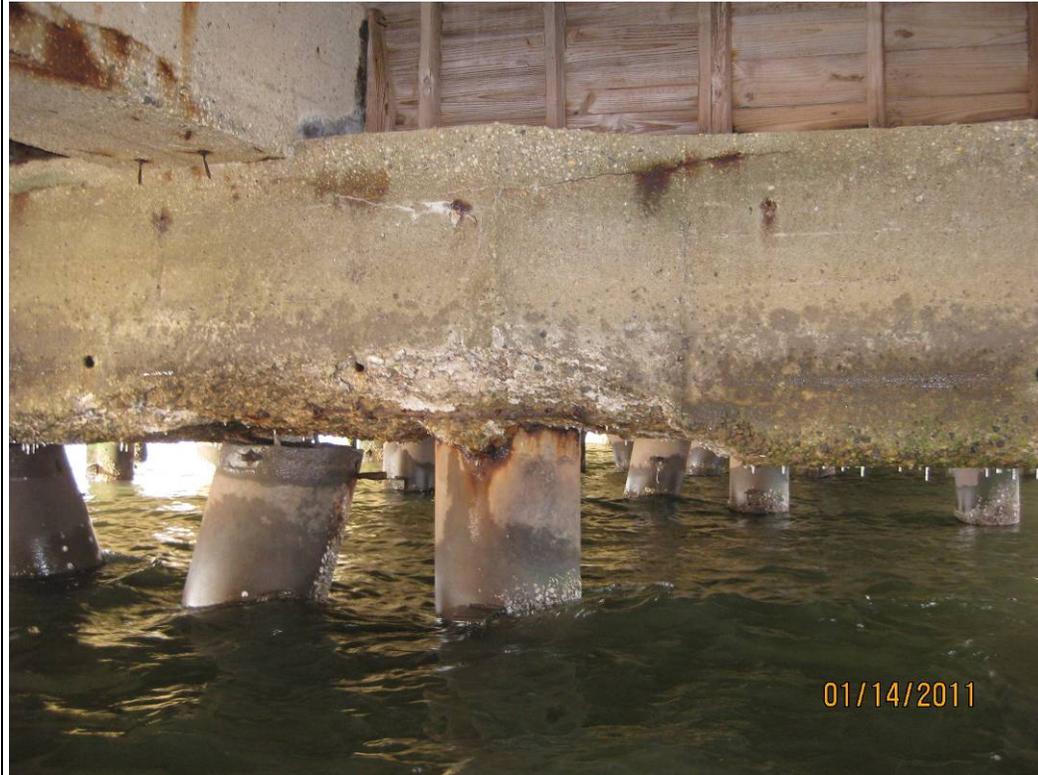
Photo No. 4.35

Steel pipe pile is 0% bearing

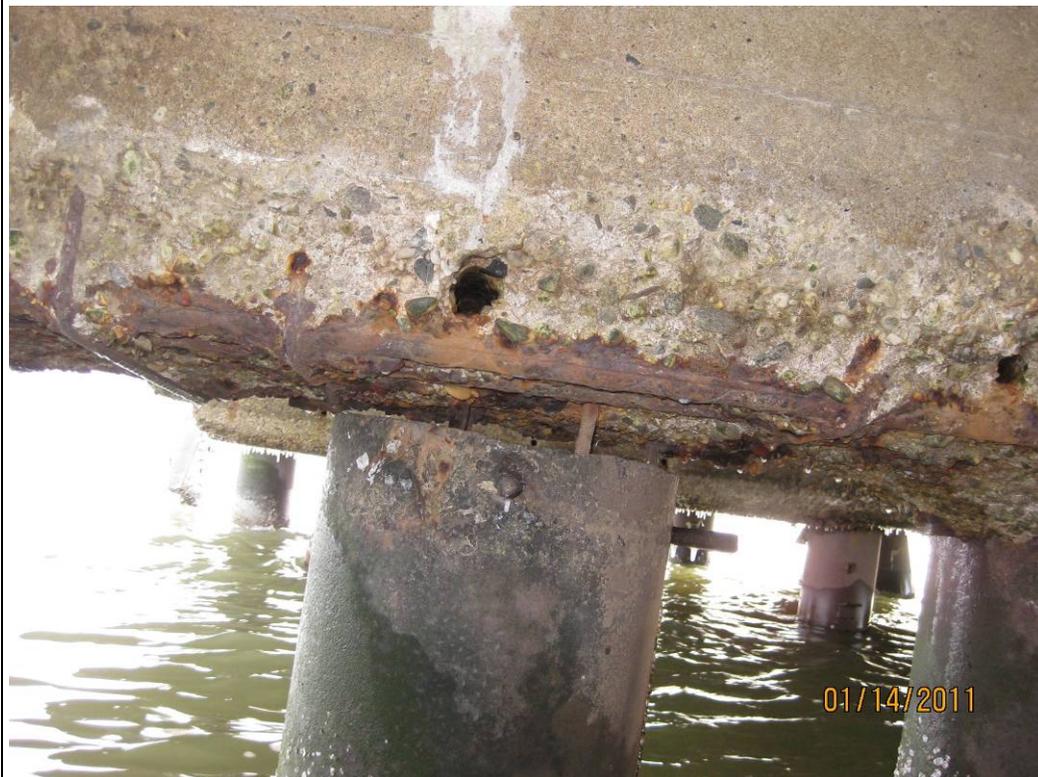
Photo No. 4.36

Steel pipe pile is 0% bearing; spalling of concrete pile cap showing exposed, corroded steel reinforcement

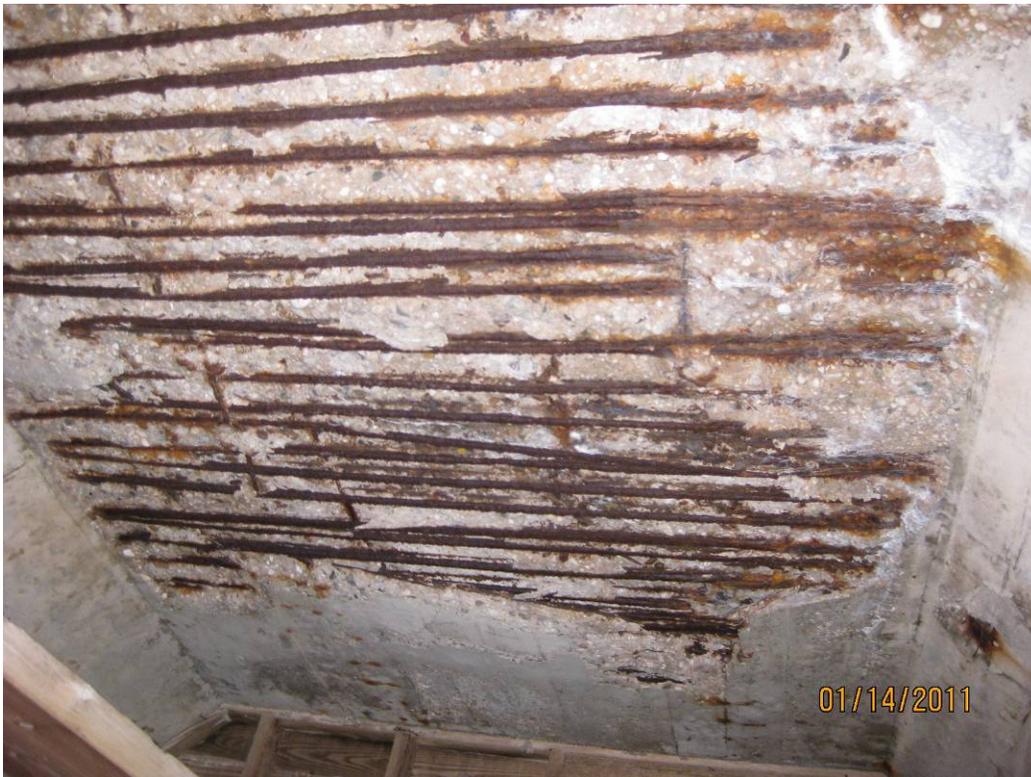
Photo No. 4.38

Spalled concrete underdeck, severely corroded reinforcing steel

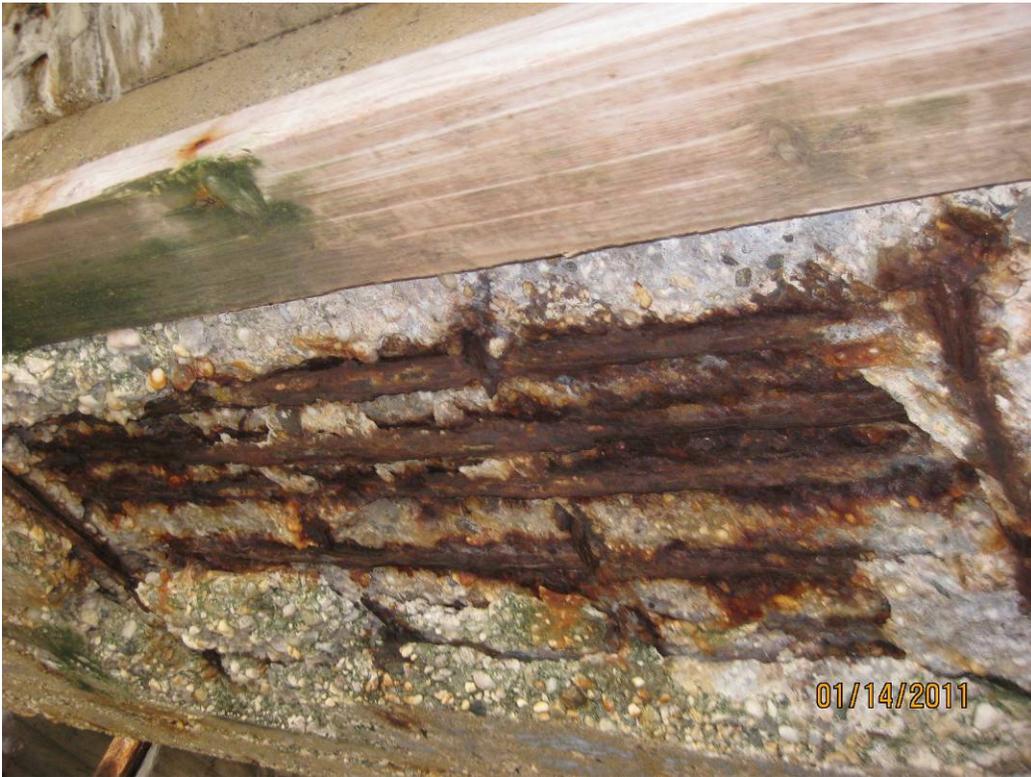
<p>Photo No. 4.39</p> <p>Location: Pier C Bent 51 to 52</p> <p>Description: Southern longitudinal concrete beam spall with severely corroded reinforcing steel</p>

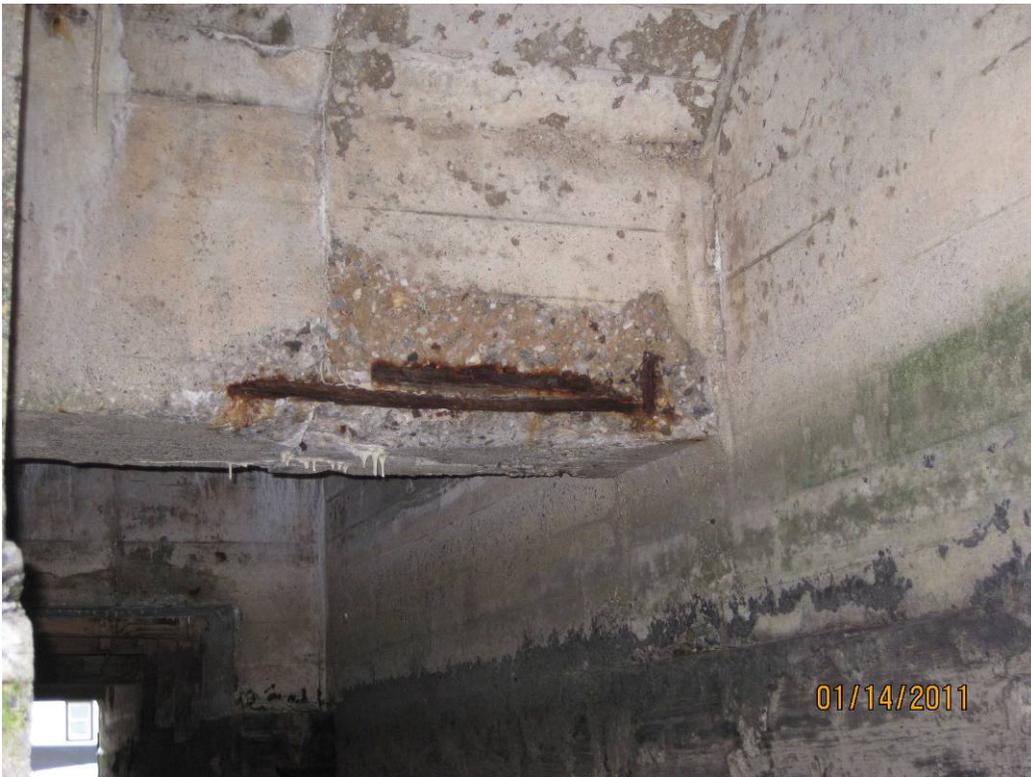
<p>Photo No. 4.40</p> <p>Location: Pier C Bent 17.5 to 18</p> <p>Description: Spall at bottom of interior longitudinal concrete beam</p>

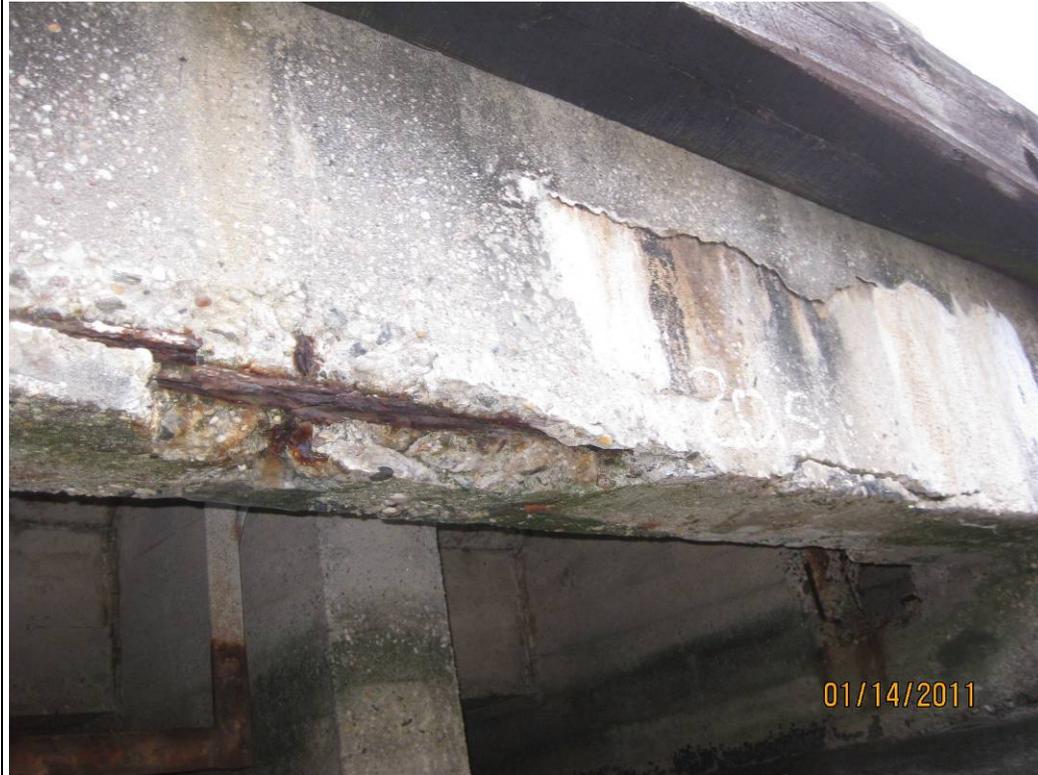
Photo No. 4.41

Concrete spall at
bottom of southern
fascia beam

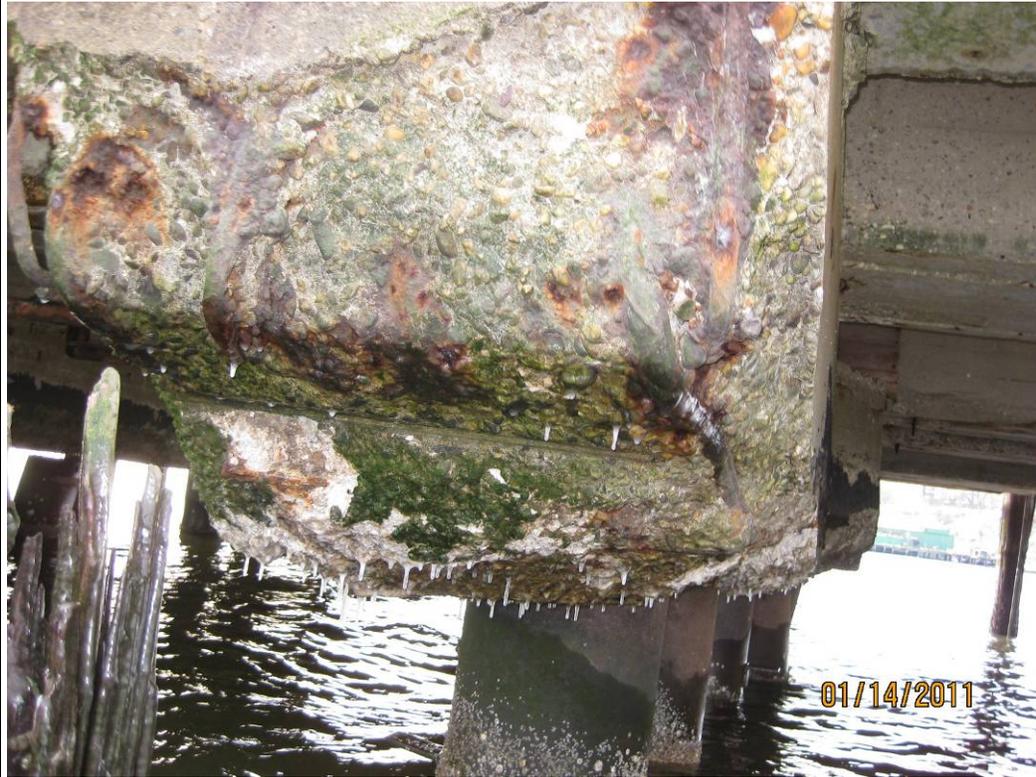
Photo No. 4.43

The overall condition of the concrete beams, pile caps and underdeck is fair with isolated locations in poor condition. There is delamination and spalling with moderate to severely corroded reinforcing steel throughout the structure. The concrete deterioration in the timber Bents 1 to 32 is concentrated on the bottom of the longitudinal beams, typically in the form of concrete delaminations, with isolated areas of spalling (Photo Nos. 4.40 to 4.42). From Bents 33 to 50, the spalling and delaminations occur on the bottom of the longitudinal beams (Photo No. 4.39), the underdeck (Photo Nos. 4.37 and 4.38), and the north and south ends of the pile caps. From Bents 50 to 58, the condition of the underdeck is generally poor. Spalling of the concrete affects roughly 80% of the surface of the underdeck and 50% of the beams. The majority of these spalls have exposed, severely corroded reinforcing steel. Also, in this area the concrete pile caps exhibit spalls with exposed, corroded steel (Photo No. 4.43).

Spall at north end of
concrete pile cap

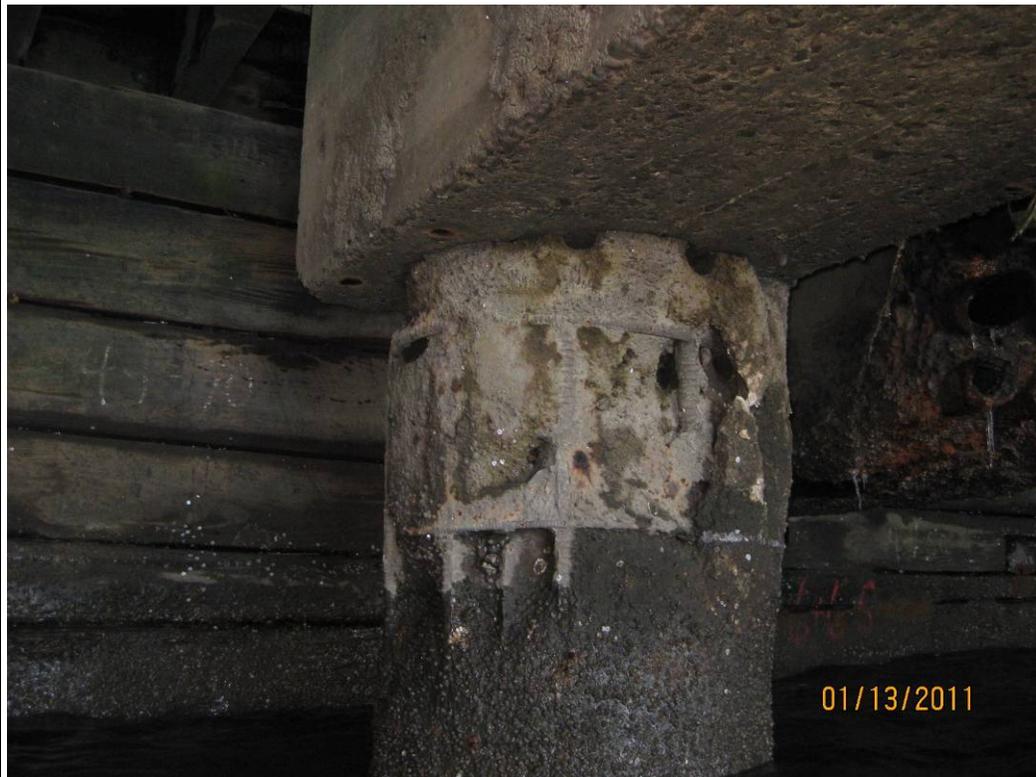
Photo No. 4.46

Void in concrete encasement with exposed steel reinforcement

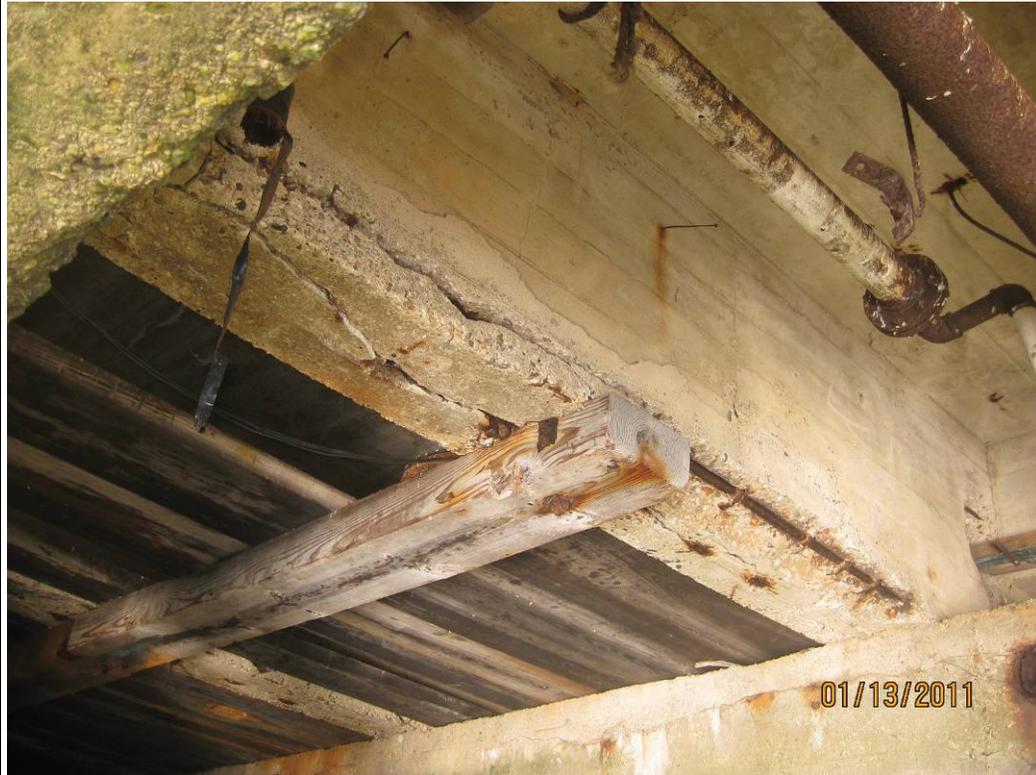
Photo No. 4.47

Erosion of concrete encasement with exposed steel reinforcement

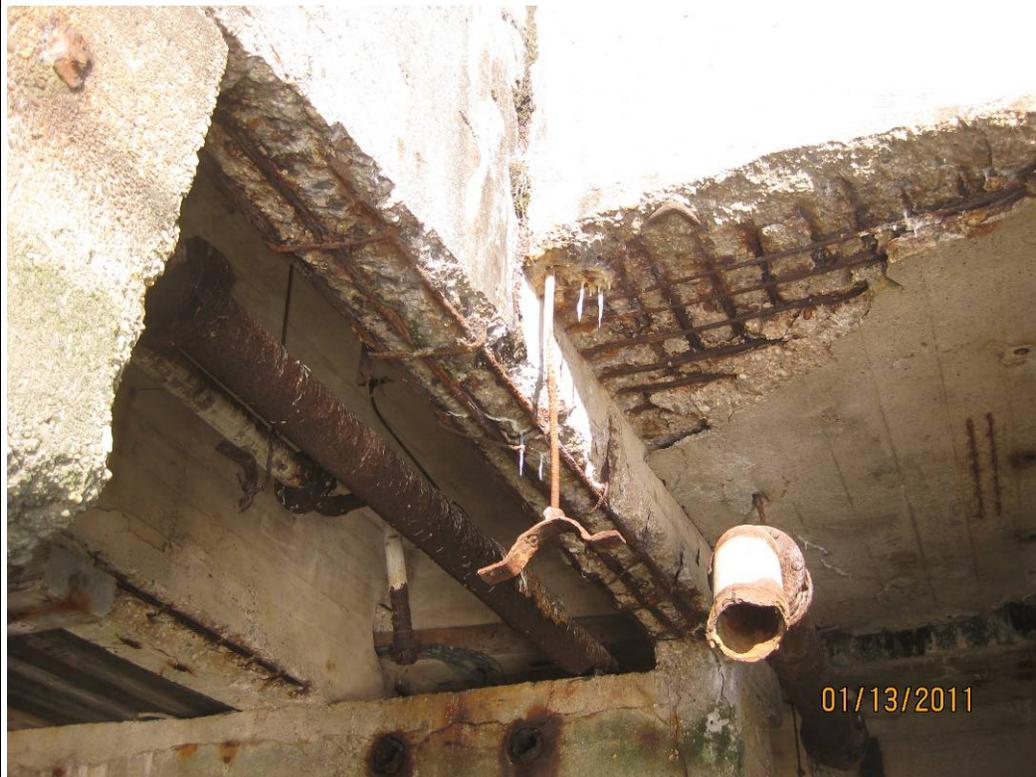
Photo No. 4.48

Spall at bottom of concrete beam exposing corroded steel reinforcement

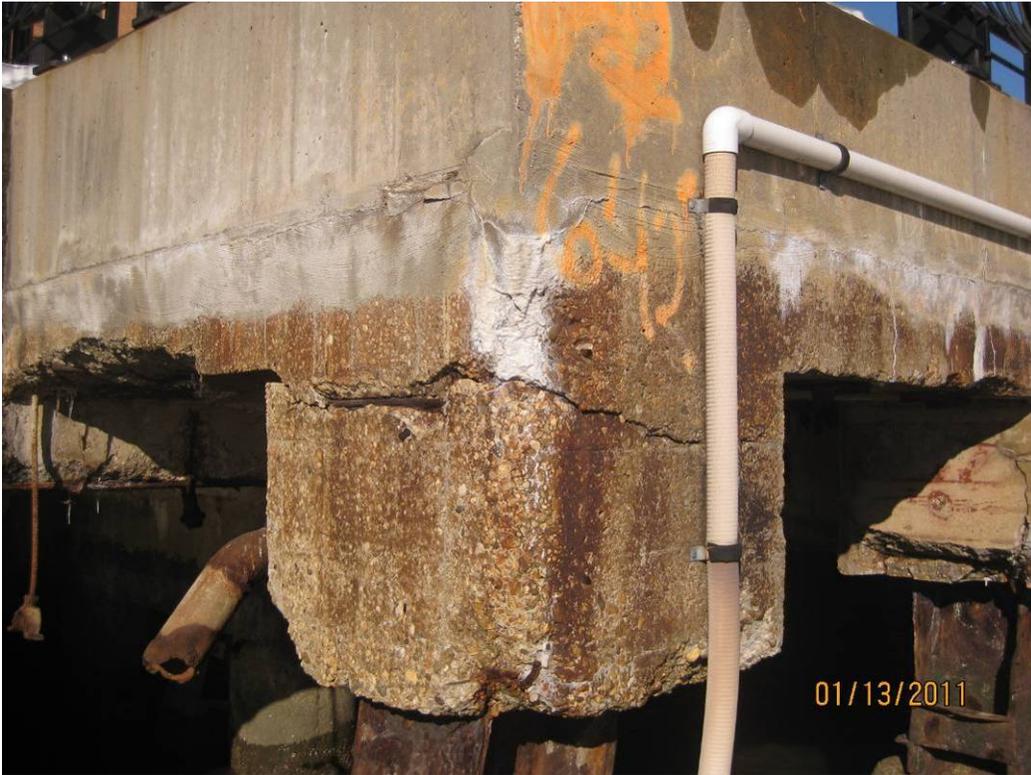
Photo No. 4.49

Spall at bottom of concrete beam, exposing corroded steel reinforcement; underdeck spalled and showing corroded steel rebar

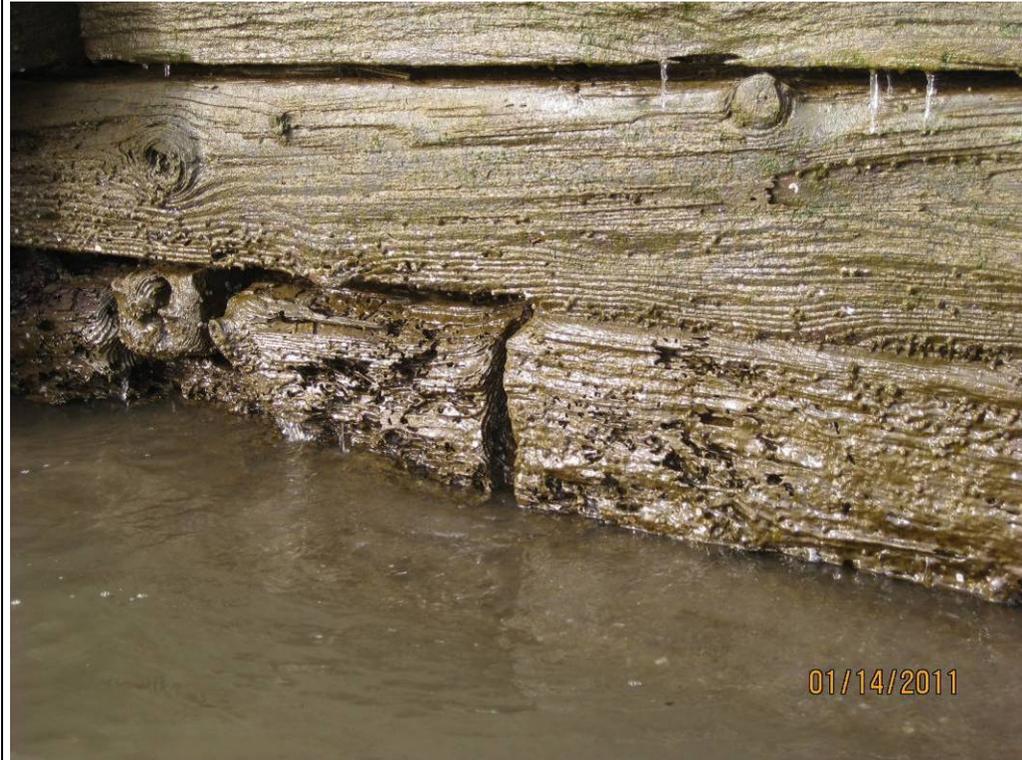
<p>Photo No. 4.59</p> <p>Location: Timber Cribbing, Sta. 2+25</p> <p>Description: Severe marine borer infestation</p>

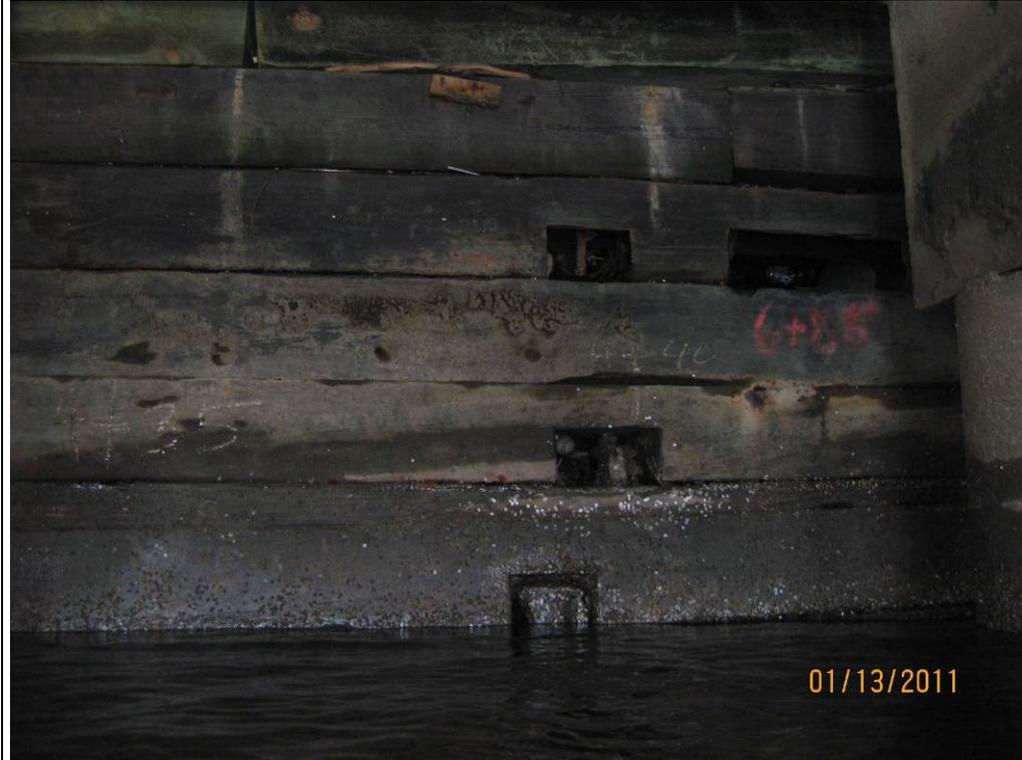
<p>Photo No. 4.60</p> <p>Location: Timber Cribbing Sta. 4+40</p> <p>Description: Severely deteriorated transverse timbers</p>

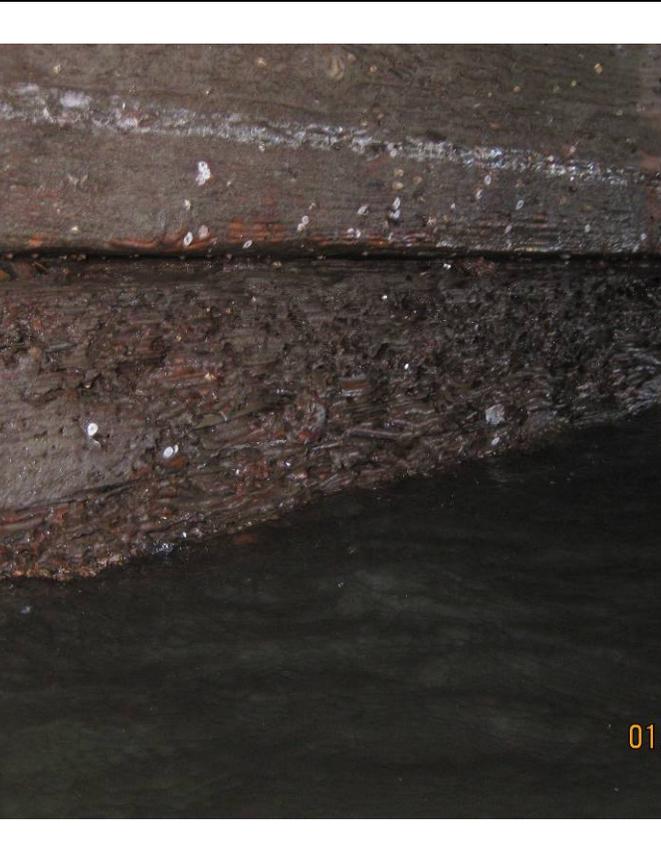
<p>01/13/2011</p>		<p>Photo No. 4.62</p> <p>Location: Timber Cribbing, Sta. 3+90</p> <p>Description: Close-up view of damage caused by marine borer infestation</p>

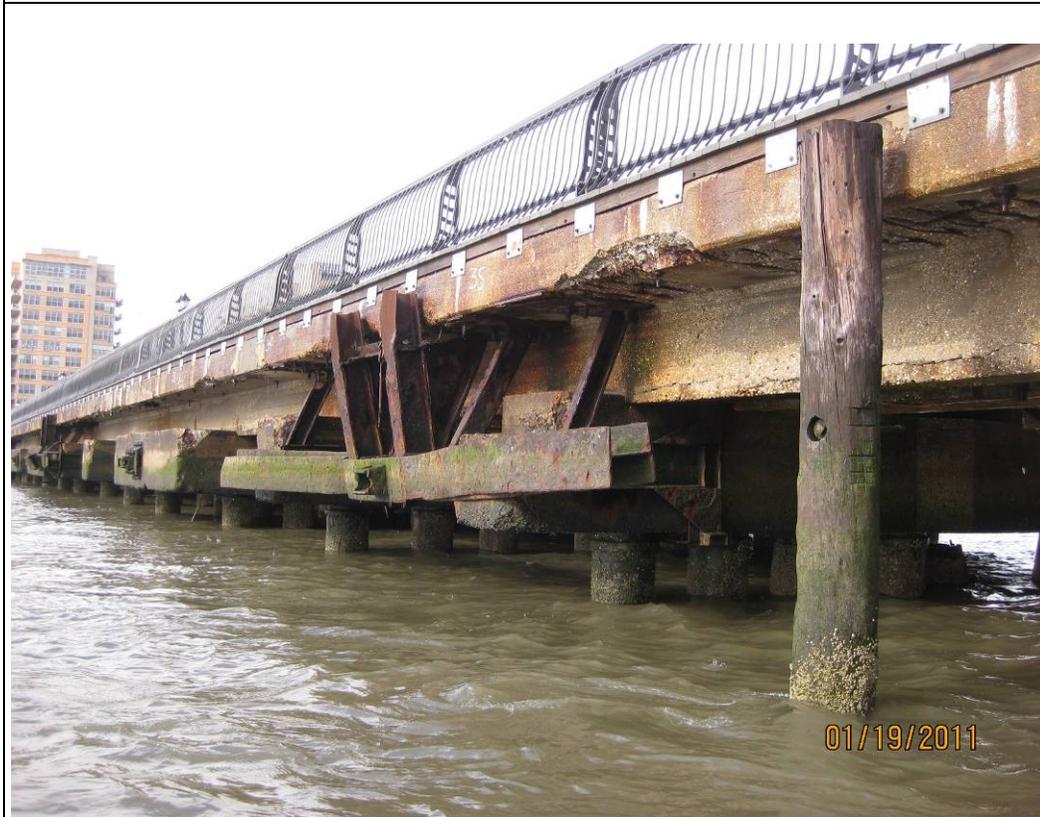
Photo No. 5.5

Abandoned steel
frame attached to
fascia

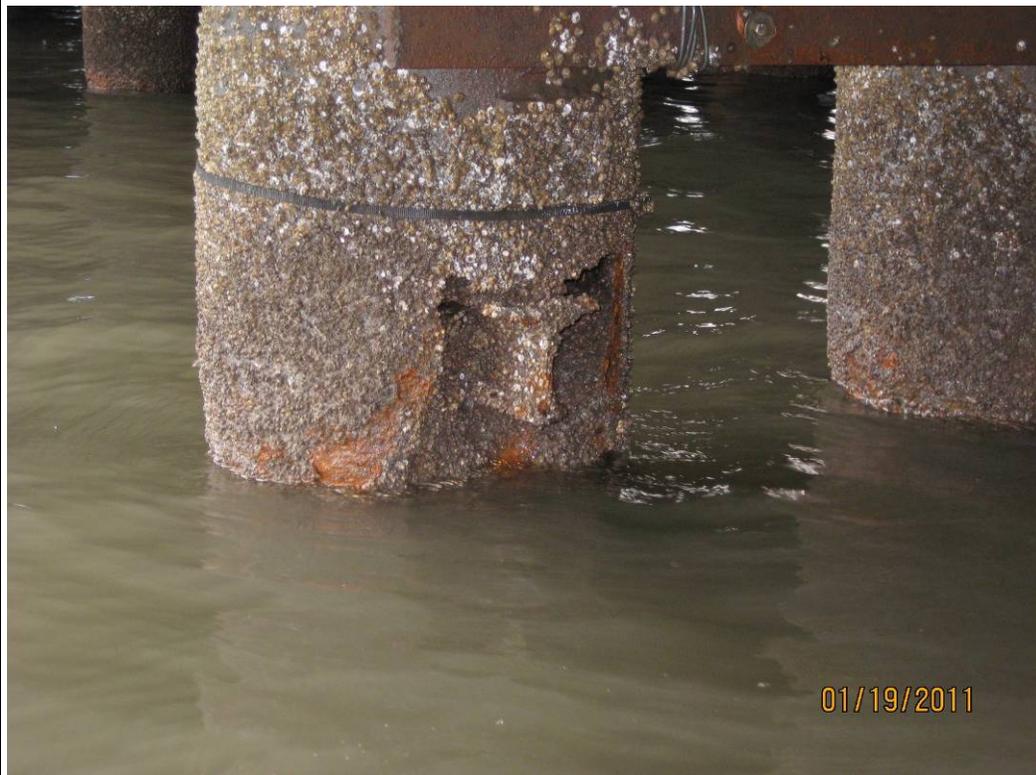
Photo No. 5.8

Steel pile corroded with through hole, void 30”H x 24”W x 8”D

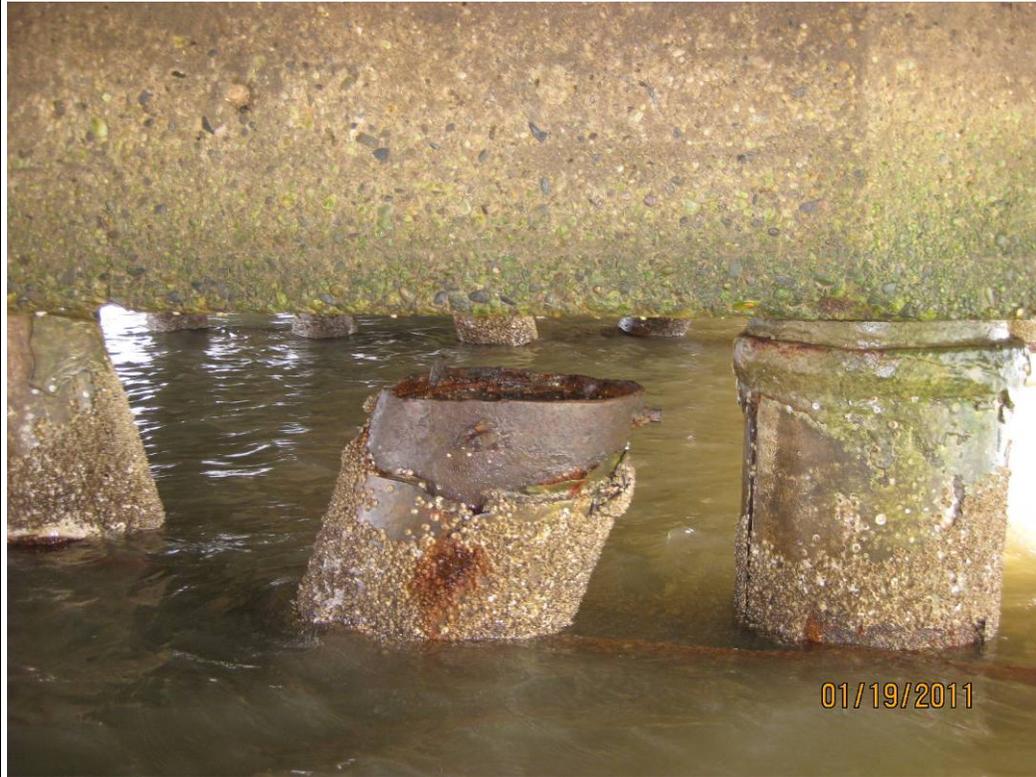
Photo No. 5.9

erosion of the concrete pile cap (Photo No. 5.9). Also contributing to the cause of the non-bearing condition is what appears to be inadequate embedment of the top of the pile into the pile cap as evidenced by a shallow socket in the bottom of the pile cap (Photo No. 5.10). Below the tidal zone, the steel is typically in fair to satisfactory condition to the mudline, showing minor to moderate uniform corrosion and pitting of the surface of the steel.

Steel pile corroded through, void 18”H x 18”W x 4”D with railroad beam cast in concrete

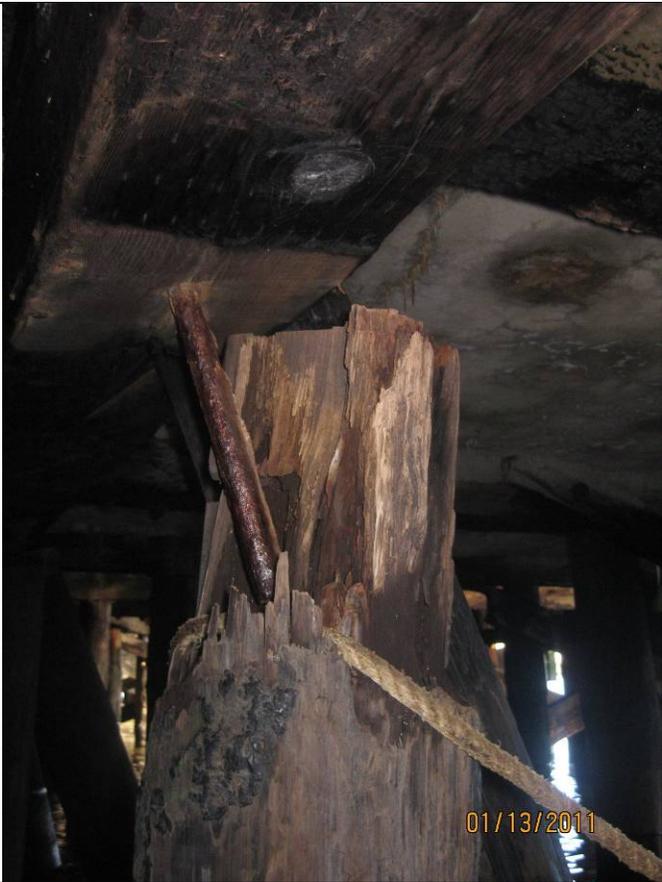
Top 2 ft of timber pile hollow with 0% bearing

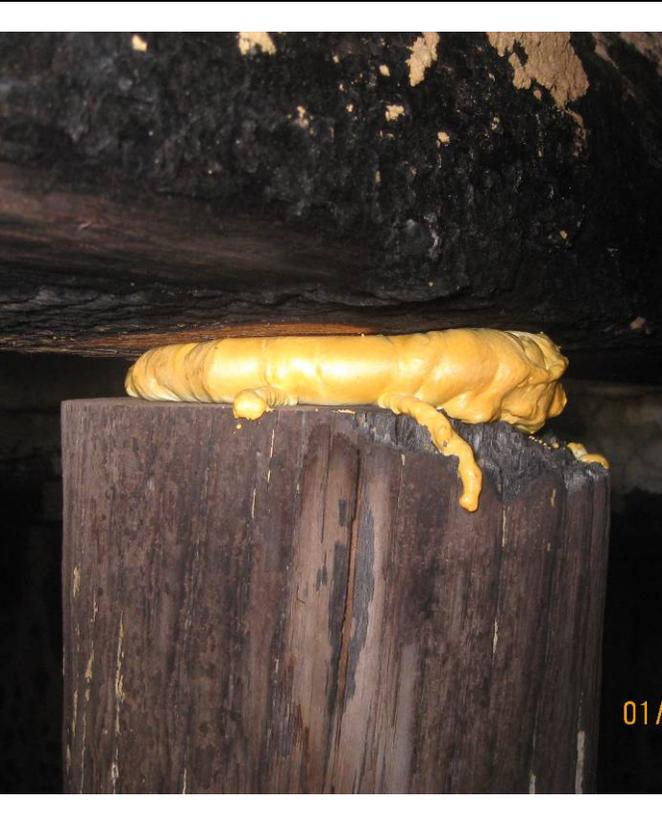
<p>Photo No. 5.23</p> <p>Location: Pile 16G</p> <p>Description: Top 2 ft of timber pile hollowing with 0% bearing</p>

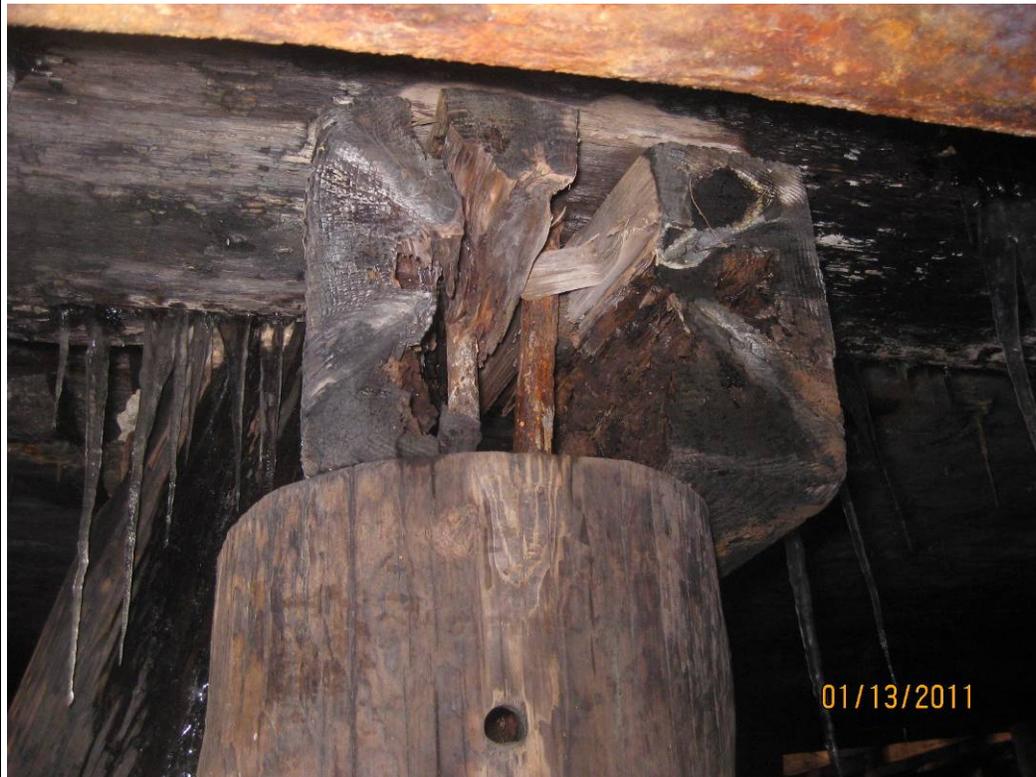
<p>Photo No. 5.24</p> <p>Location: Pile 18I</p> <p>Description: Inadequate repair - foam sprayed to fill separation at pile that is hollow with 0% bearing</p>
