HOBOKEN PRIVATELY-OWNED WATERFRONT STRUCTURES INSPECTION

File No. BUE-1010

BOSWELL UNDERWATER ENGINEERING

June 2011

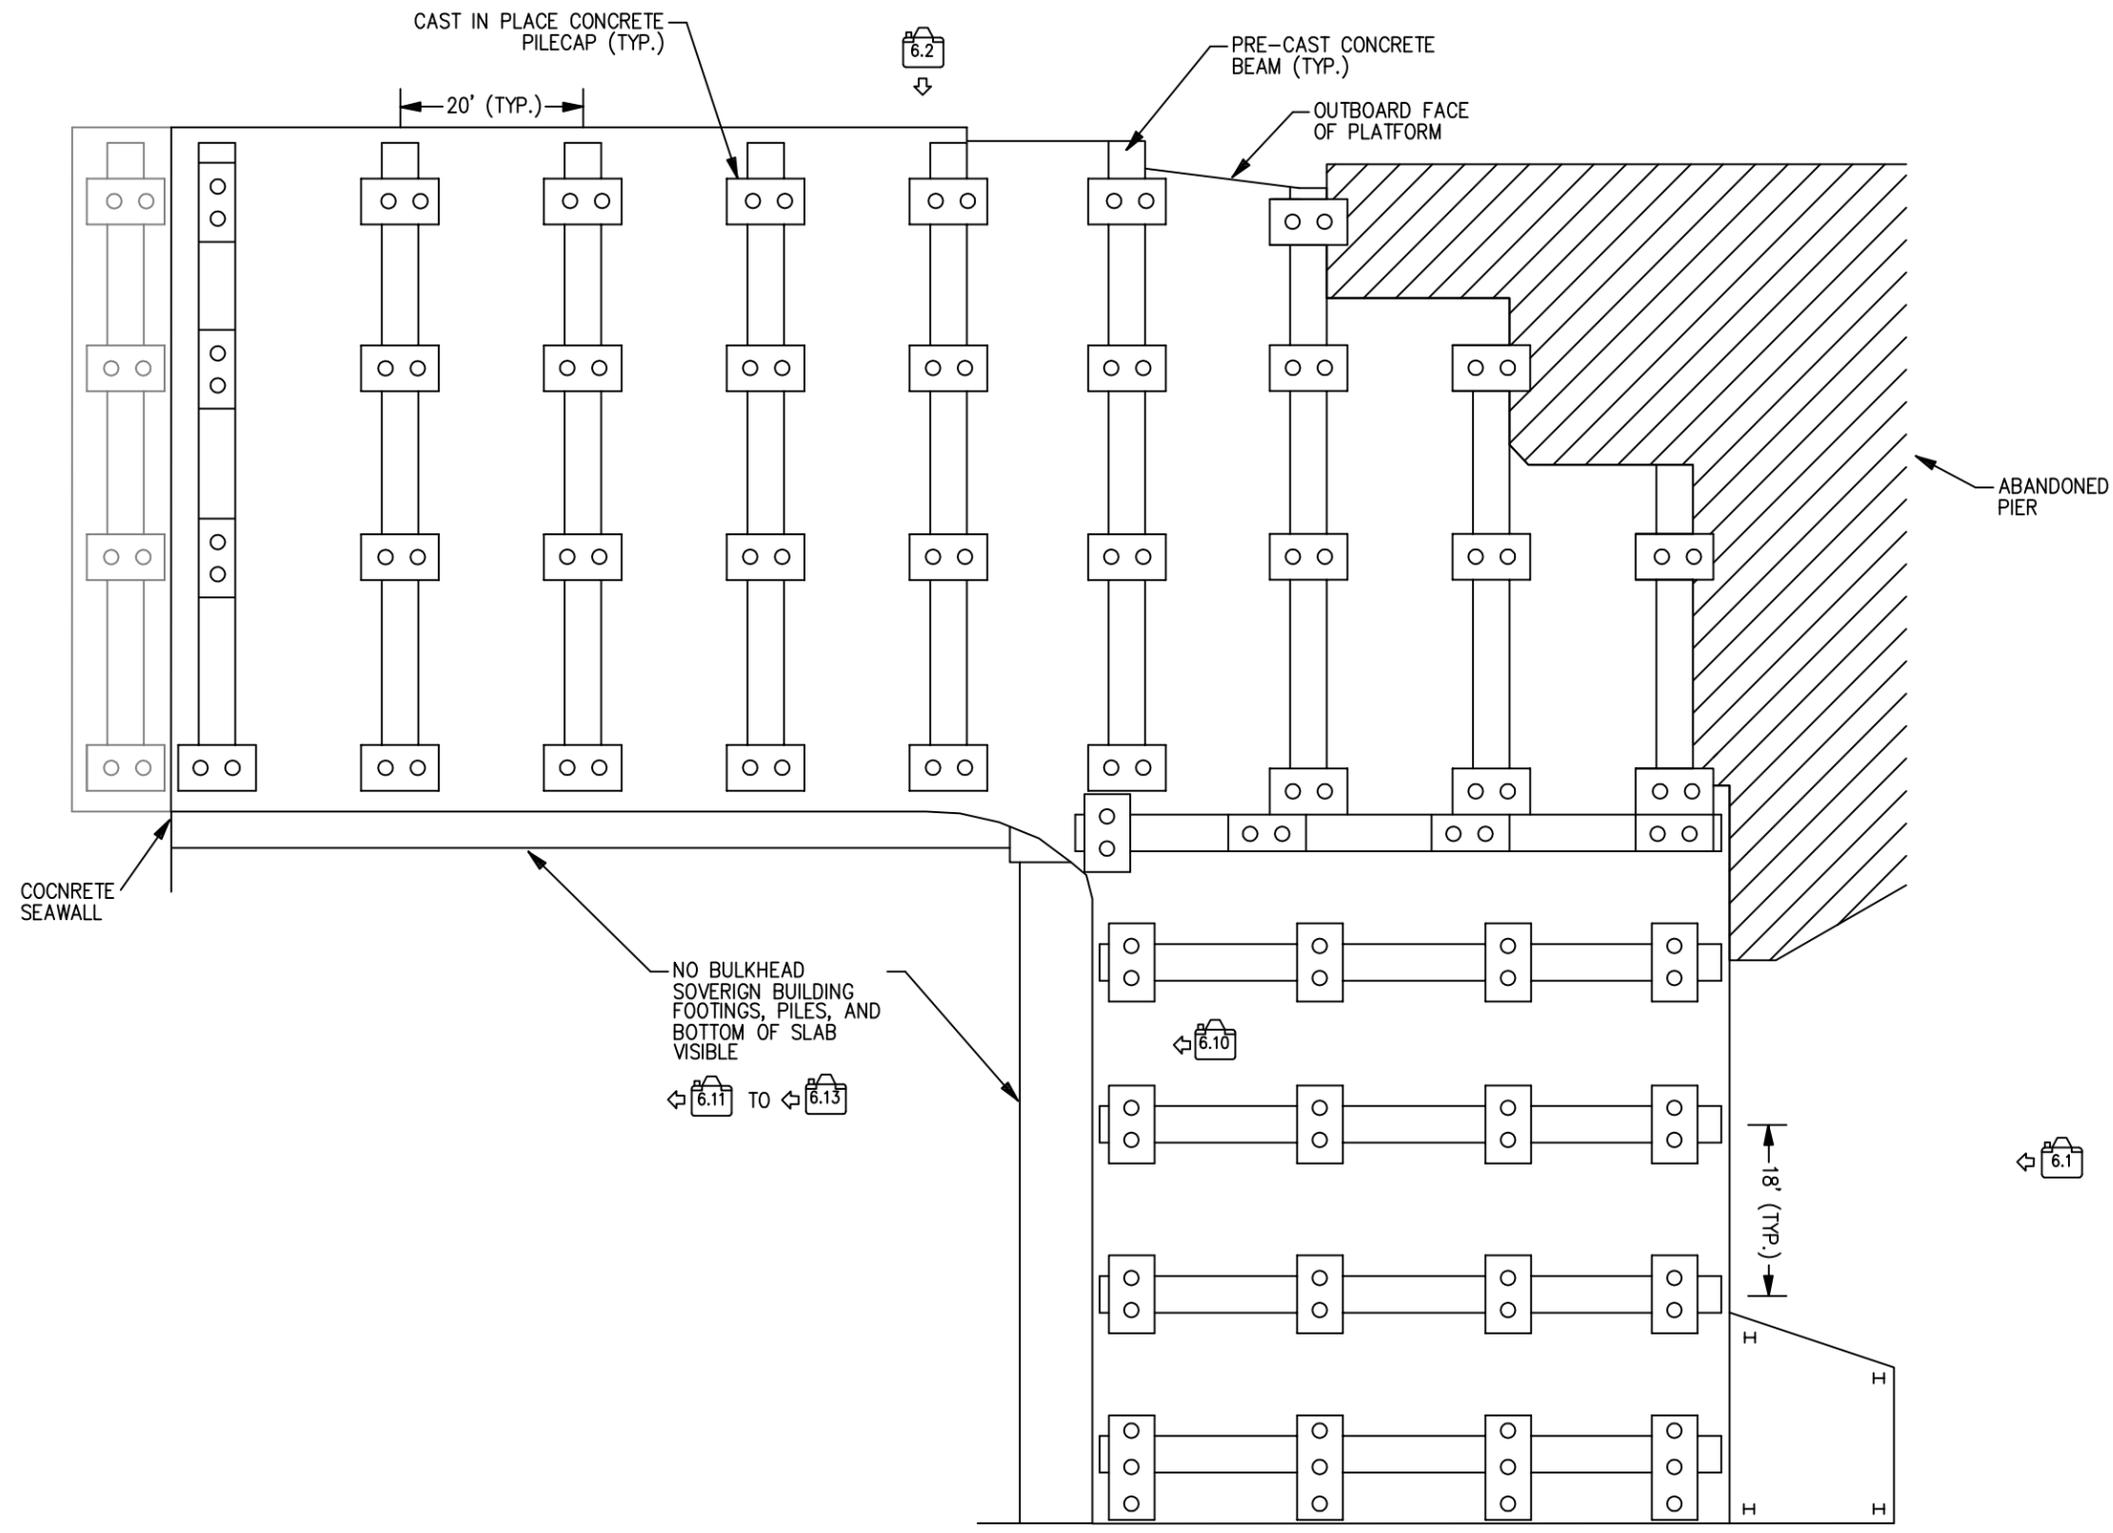
- NOTE:**
1. ALL PIPE PILES HAVE RANDOM, INTERMITTANT COATING LOSS AND MINOR CORROSION WITHIN THE TIDAL ZONE.
 2. HIGH-LEVEL PIPE PILE PLATFORM WAS BUILT OVER A PARTIALLY COLLAPSED STEEL H-PILE SUPPORTED PLATFORM, NOT SHOWN FOR CLARITY.

- Steel Pipe Piles – Clean and apply protective coating to the pipe piles within the tidal zone to protect from corrosion on a routine basis.

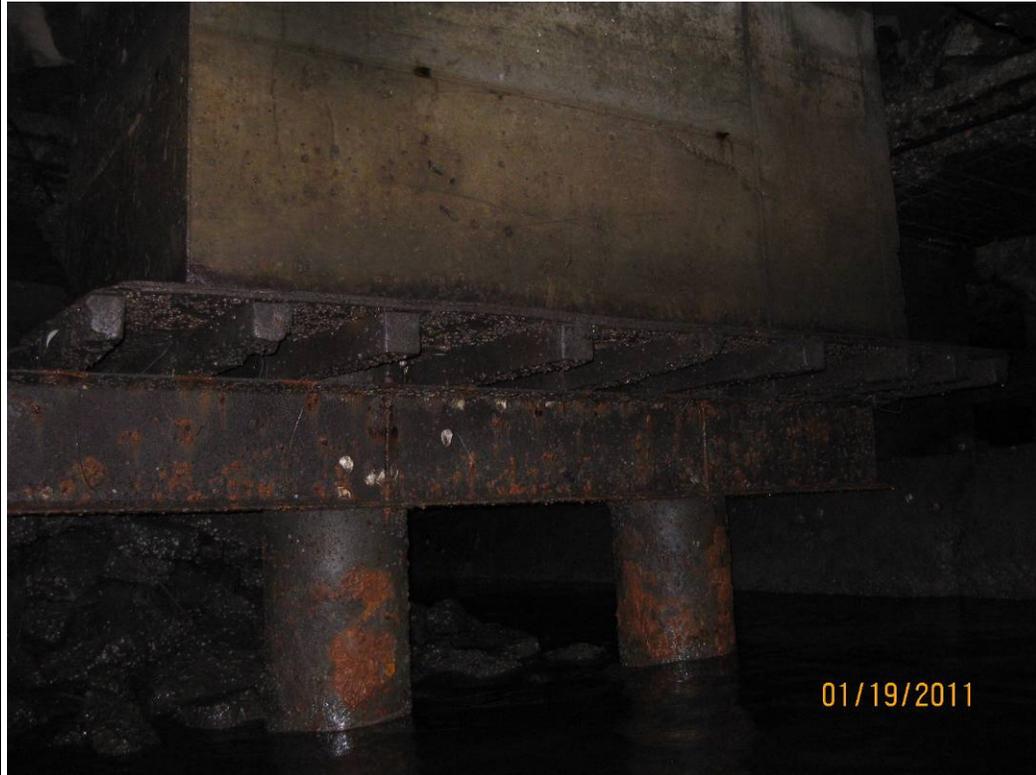
Photo No. 6.5

Typical view of cast-
in-place pile cap

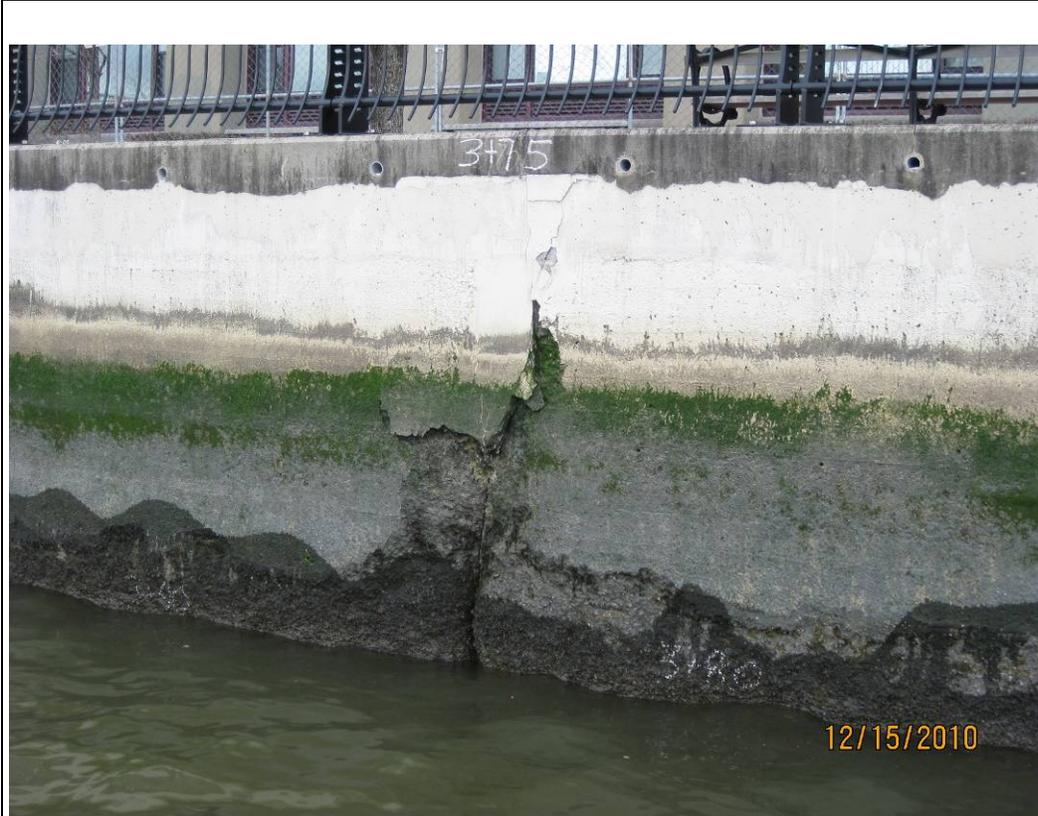
Photo No. 7.3

(Photo Nos. 7.2 and 7.3). From Sta. 4+05 to Sta. 8+30, the face of the seawall typically displays minor to moderate erosion, with a few isolated areas of more severe erosion. In this area, there are three locations where differential movement and cracking were observed in the seawall, Sta. 5+20, Sta. 6+47 and Sta. 7+07 (Photo Nos. 7.4 to 7.6). It is not clear if the movement is the result of deterioration of the timber cribbing that supports the concrete seawall, or from lateral soil pressure or overloading from behind the seawall. As design plans were not available, it is not known if the seawall has a tieback system to resist lateral forces. From Sta. 8+30 to Sta. 10+56, the condition of the seawall is fair due to moderate to heavy erosion and spalling with exposed reinforcing steel and areas of delaminations within the tidal zone (Photo No. 7.7). Additionally, the seawall exhibits vertical settlement from Sta. 8+30 to Sta. 8+50 as a result of deterioration of the timber substructure (Photo No. 7.8).

Severe erosion at
bottom of seawall

- Concrete Seawall – Repair concrete erosion/spalling at the face of the seawall on a routine basis.

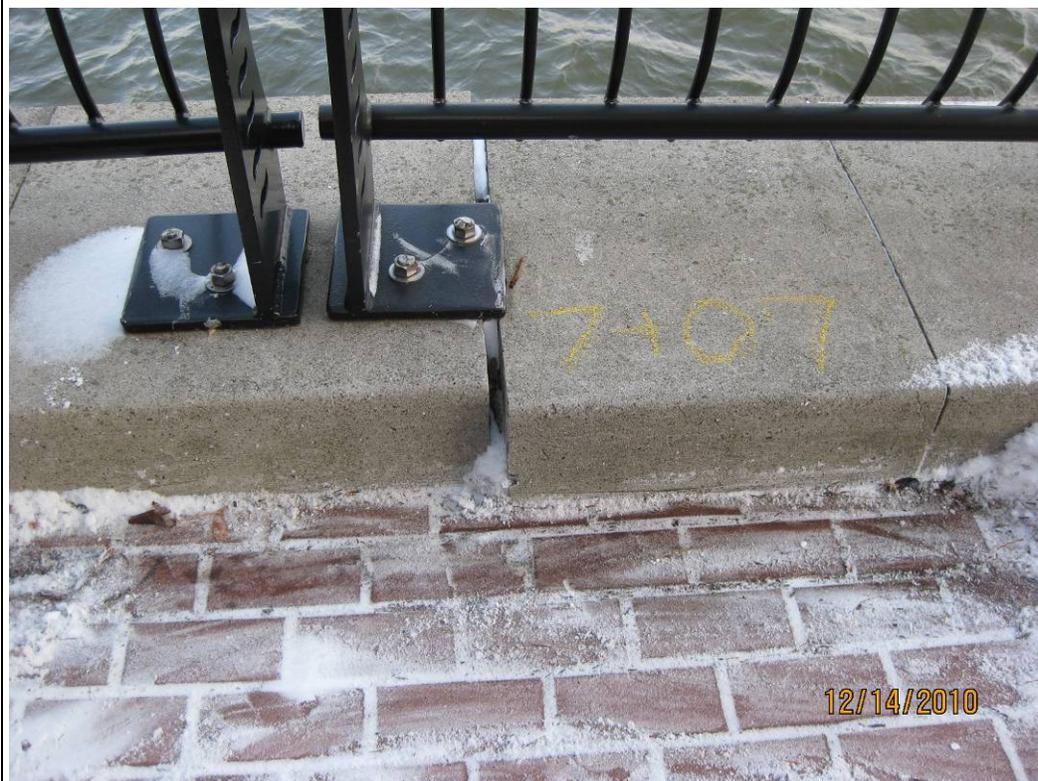
Photo No. 7.6

Differential
movement at joint

- Timber Piles, Sta. 8+30 to Sta. 8+50 – Repair six northernmost timber piles on an immediate basis.
- Concrete Seawall – Perform engineering evaluation to determine cause of differential movement in the seawall, the presence and condition of tie-back system, if any, and appropriate repair method to stabilize seawall on a priority basis. Movement of the concrete seawall should be monitored; and until such time that engineering analysis is performed and repairs are implemented, loads should be restricted to pedestrian loads from Sta. 2+79 to Sta. 3+30..

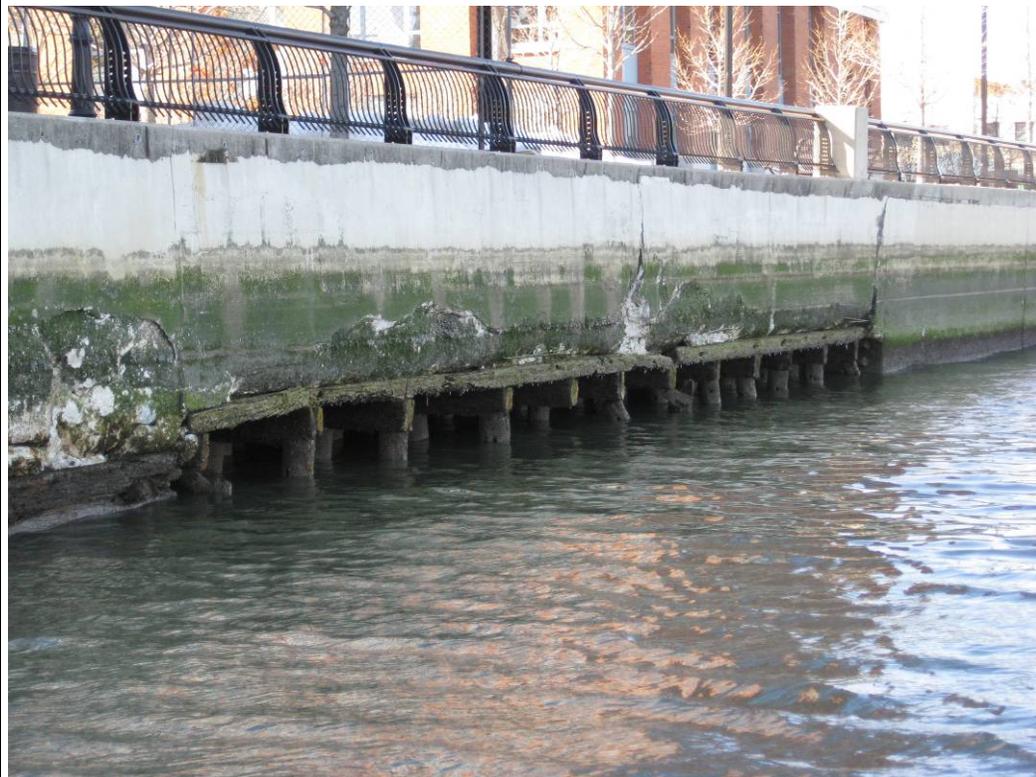
Photo No. 7.8

Erosion within tidal
zone, exposed
reinforcing steel

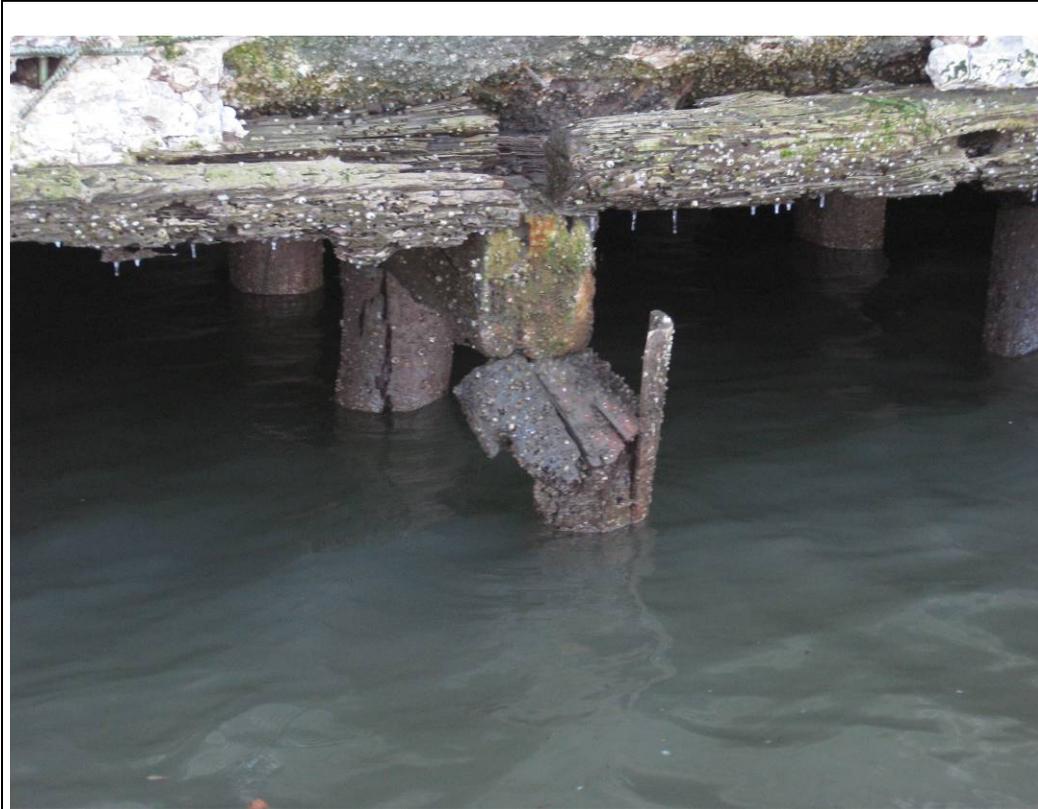
Photo No. 7.9

The general condition of the timber low-level relieving platform is serious. The timber piles supporting the structure all display severe marine borer intrusion. A total of 22 of the 74 inspected piles are broken, or have section loss in excess of 50% (Photo No. 7.9). Many of these piles have as much as 80% section loss. The most severe conditions were found at the three most outboard piles in each row, which are directly beneath the concrete seawall. The remainder of the timber piles typically have section loss between 10% and 50% due to marine borer infestation. Ice pick penetrations between 1 in. and 3 in. deep were common in the surface of the piles indicating severe Teredo infestation and section loss that cannot be fully assessed from a visual inspection alone. The timber pile caps also have severe marine borer infestation and significant section loss. Compression of the pile caps from 1 in. to 3 in. was observed at seven of the 12 pile caps within the platform. The compression damage is an indication that general settlement of the structure has occurred. The timber decking is also susceptible to marine borer infestation, and as a result, exhibits moderate loss of section. Gaps were observed throughout the structure between the deck planks up to 1 in. wide; and in some locations, there are signs that the gaps are allowing fill to escape. From Bent 12 to the crib wall to the east, the majority of the decking is severely deteriorated or missing. Geotextile fabric is visible and retaining the fill where the deck planks have voids or are missing.

General view

- Relieving Platform Sta. 2+17 to Sta. 2+79 – Repair or replace severely deteriorated, broken or missing piles, pile caps and deck planks on an immediate basis.

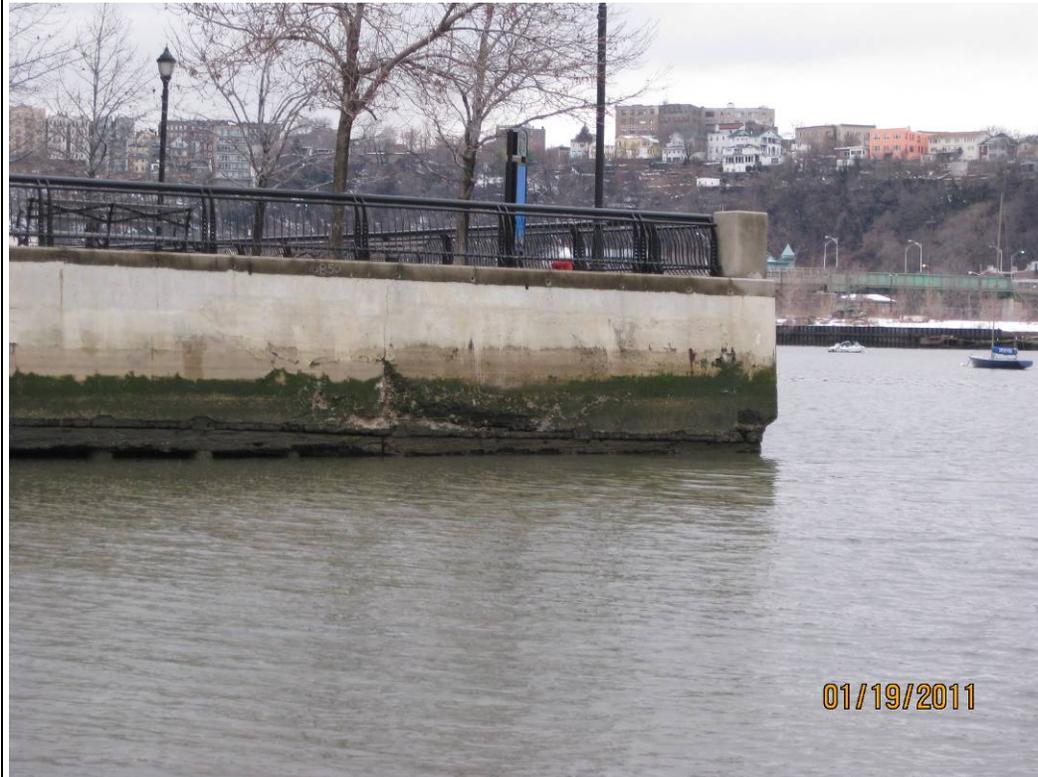
Photo No. 7.11

The condition of the timber piles supporting the timber deck planks and concrete seawall from Sta. 8+30 to Sta. 8+50 is critical. The northern six piles that comprise the single row of support piles are all in critical condition and are broken, completely non-bearing, or have section loss exceeding 50%. The pile cap in this area has severe marine borer infestation, visual signs of compression damage, and up to 50% loss of section. The corner of the structure has settled as evidenced by the pile cap relative to the waterline as shown in Photo No. 7.11.

Settlement at corner of seawall

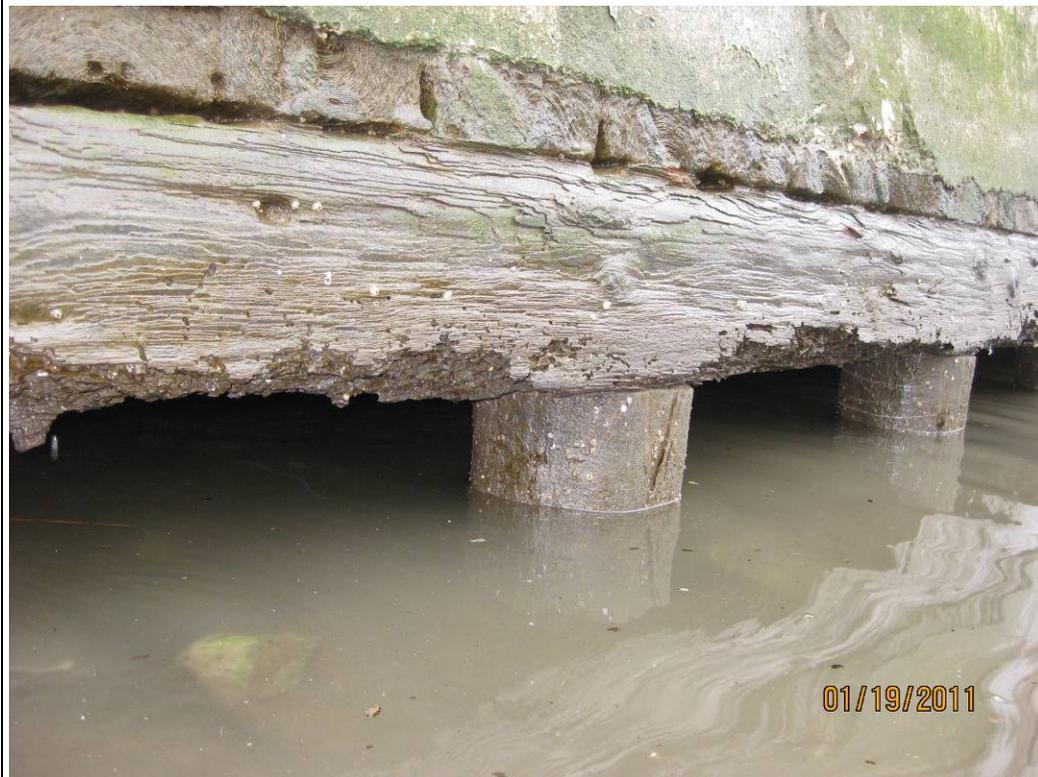
Photo No. 7.12

From Sta. 8+50 to Sta. 10+00, the timber substructure is in satisfactory condition with visual signs of marine borer intrusion (Photo No. 7.12); however, the resultant loss of section is generally less than 10% in the piles, pile caps and decking. South of Sta. 10+00, the timber substructure is buried beneath a sandy shoreline.

Settlement of seawall
